THERMAL PERFORMANCE OF FAÇADES

2012 AIA UPJOHN GRANT
RESEARCH INITIATIVE

Final Report | November 2014

PAYETTE

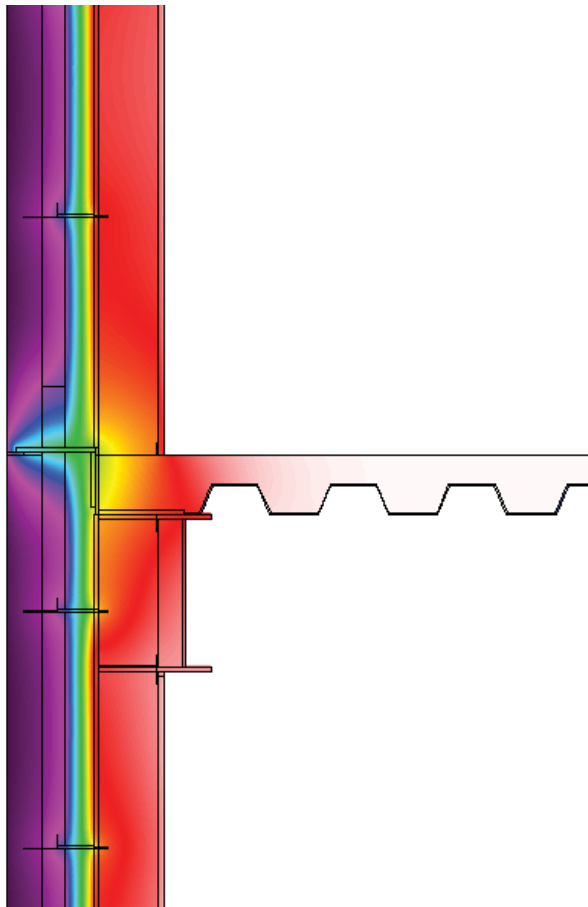
Traditional Masonry Wall with Galvanized Barrel Ties and a Continuous Galvanized Shelf Angle.

R-11.57
(-37%)

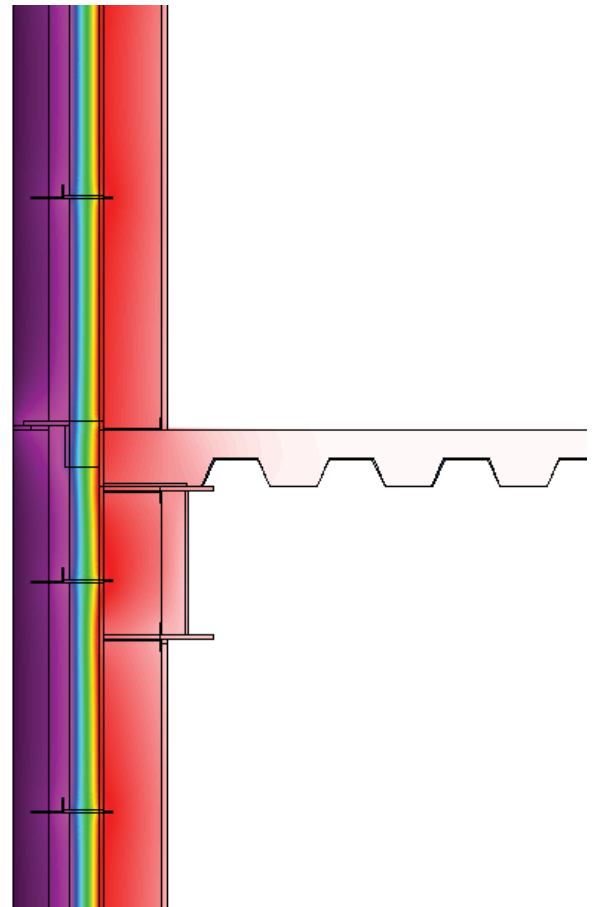
Improved Masonry Wall with Stainless Screw Ties and a Discontinuous Stainless Shelf Angle.

R-17.30
(-6%)

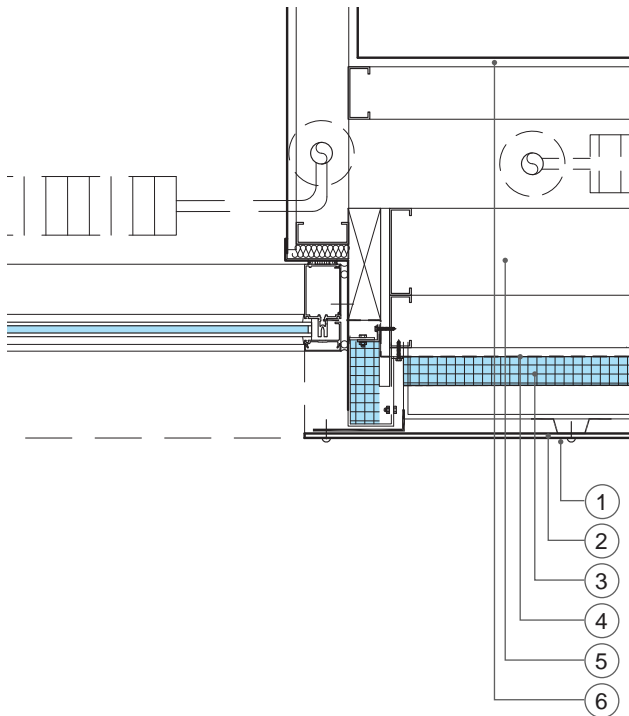
As-Built Condition

R-8.76

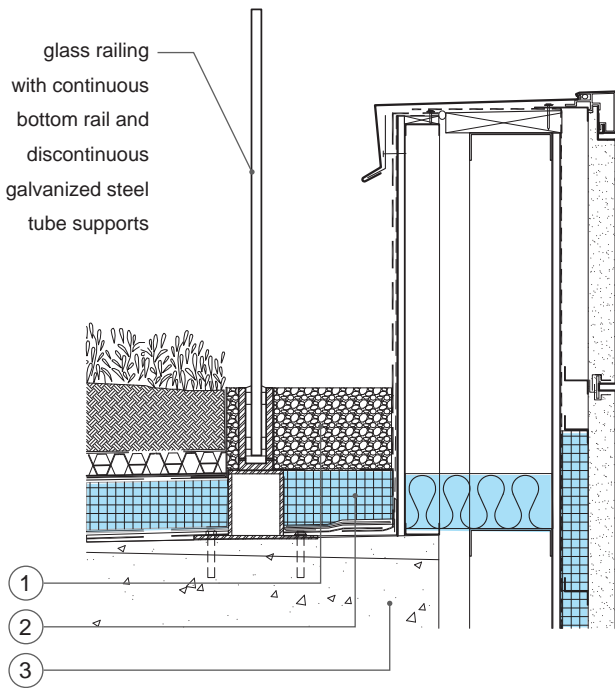
As-Built Condition

R-4.75

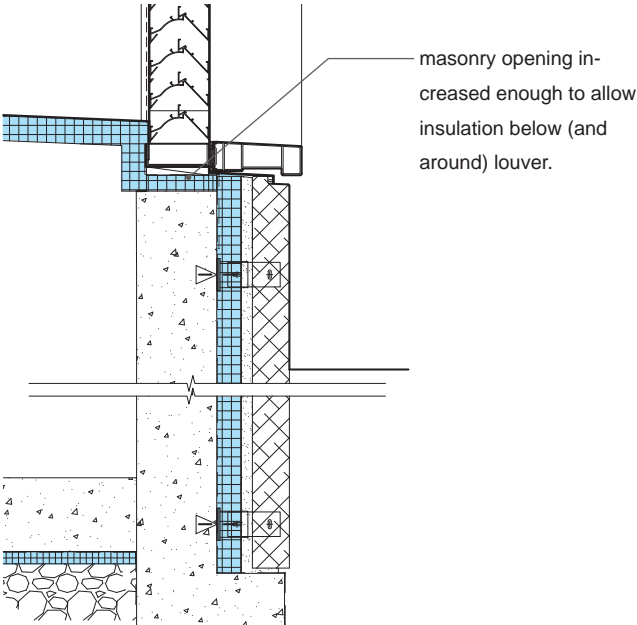
Thermally Improved Condition

R-6.53
(+15%)

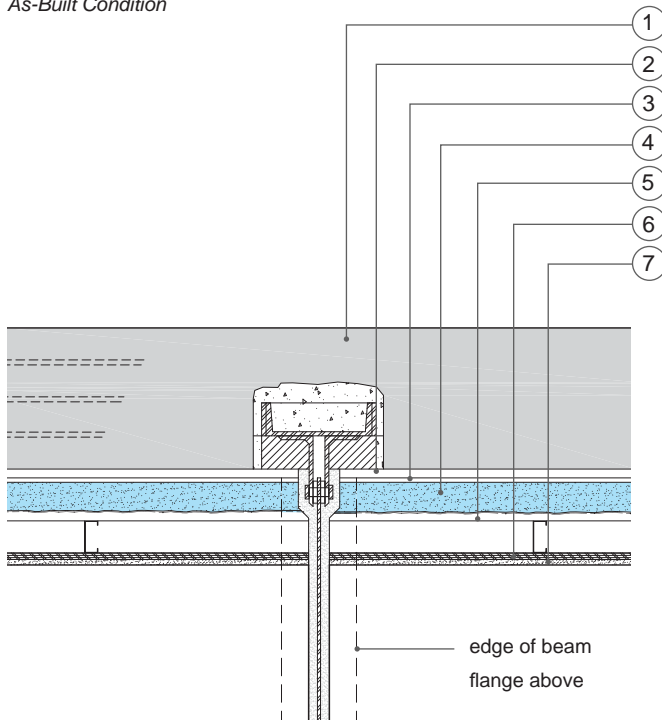
As-Built Condition

R-16.62

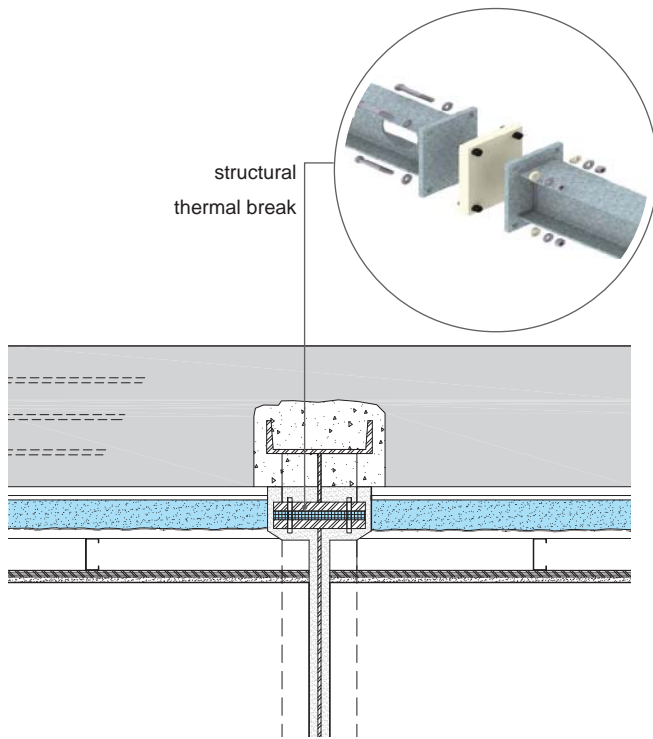
Thermally Improved Condition

R-22.66
(+36%)

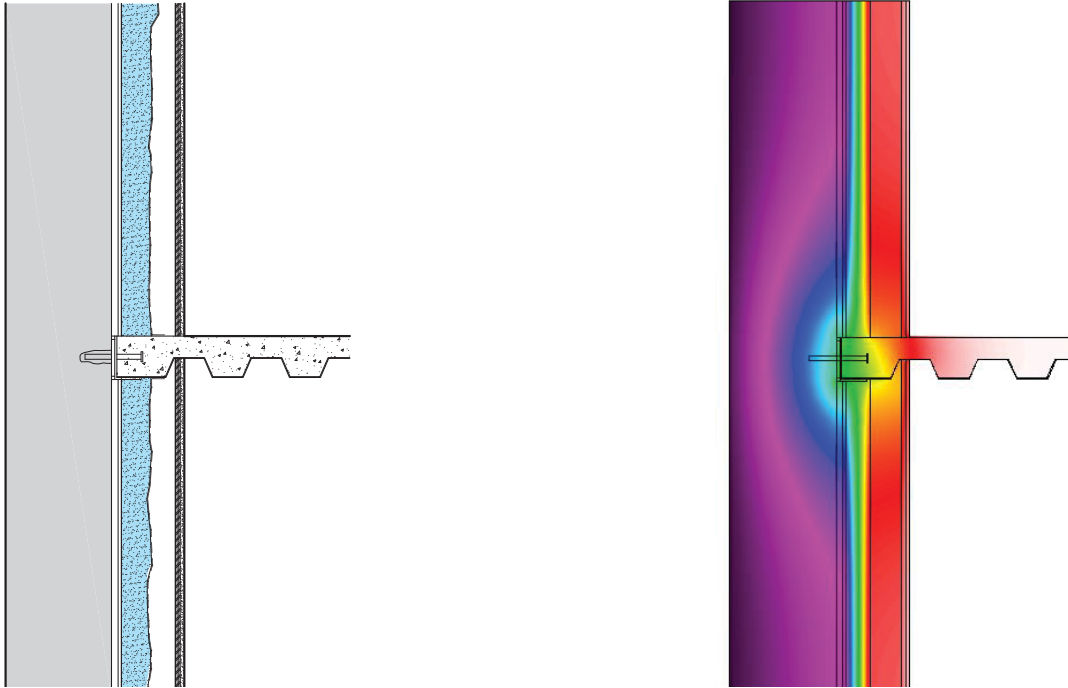
As-Built Condition

R-16.14

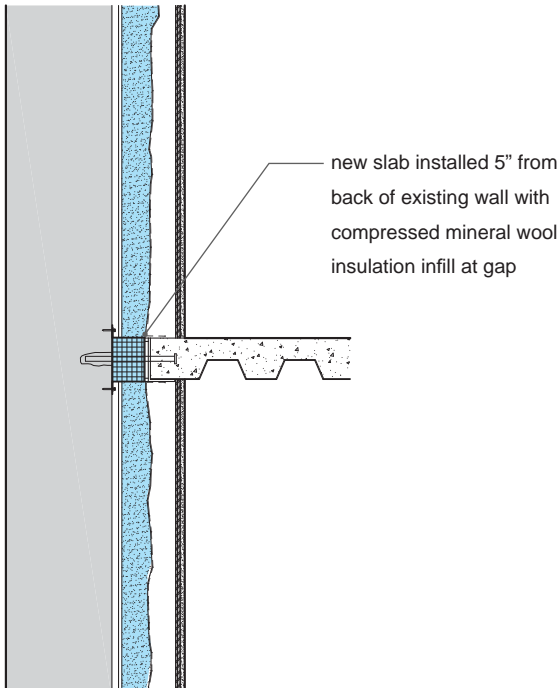
Thermally Improved Condition

R-21.10
(+30.7%)
