# Re-glazing of an All Glass Tower

**MICHAEL AOKI-KRAMER, BA, JD, LEED AP**  
RDH BUILDING SCIENCES INC, SEATTLE, WA

JAMES HIGGINS – RDH BUILDING ENGINEERING LTD.  
BRIAN HUBBS, P.ENG. – RDH BUILDING ENGINEERING LTD.  
GRAHAM FINCH, MASC, P.ENG. – RDH BUILDING ENGINEERING LTD.  
ED THIESSEN, P.ENG. – RDH BUILDING ENGINEERING LTD.

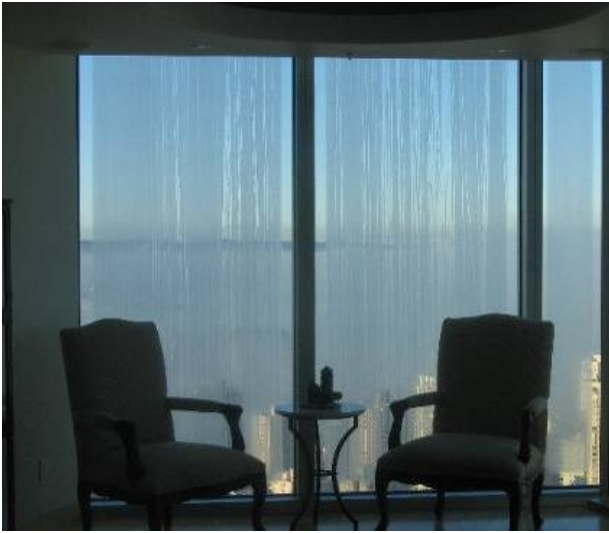
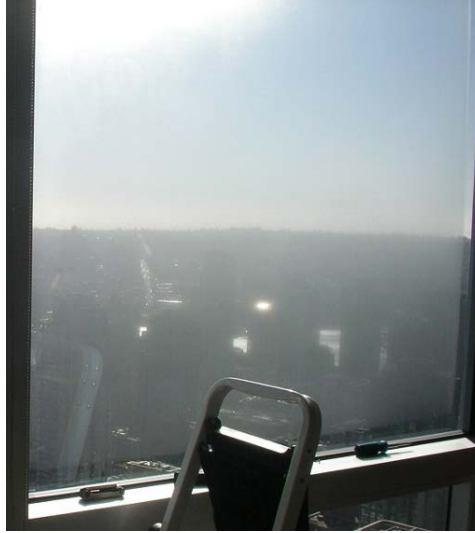
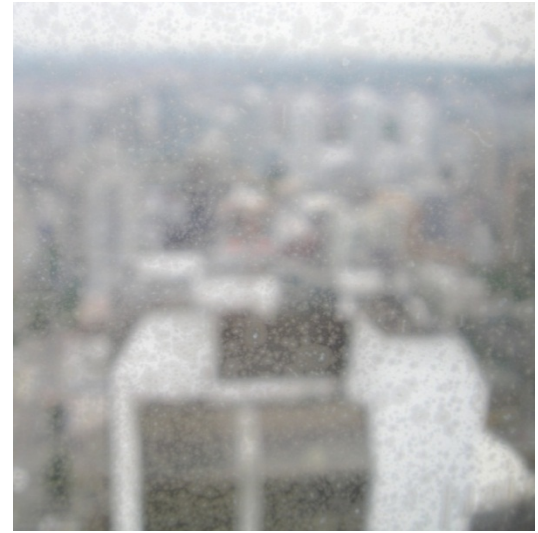
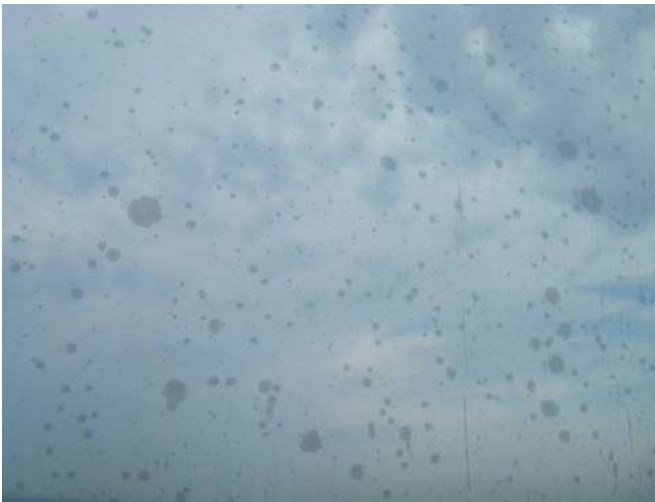
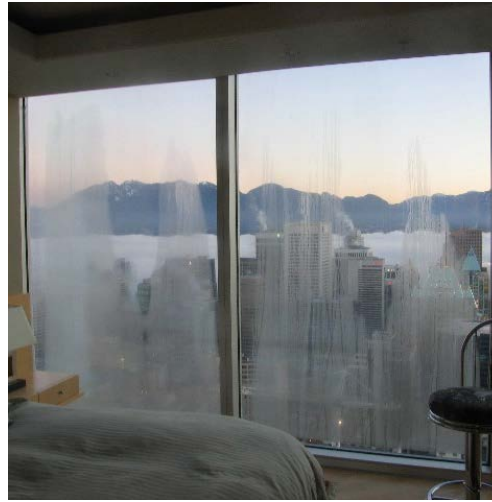
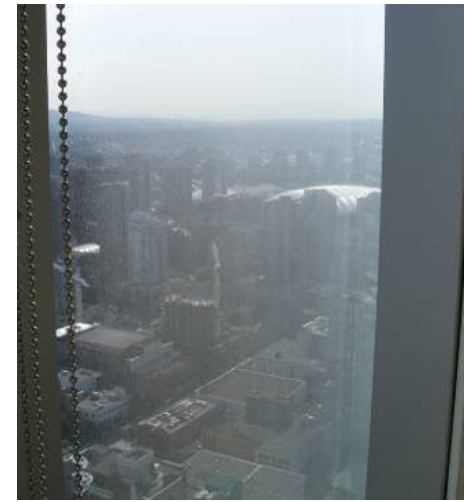
# Issues - Fogged and Corroded Glazing Units (Surface #2)

- Systemic failure of IGUs due to an inadequately sealed “thermally efficient” edge spacer
  - PVC, aluminum, stainless steel foil & hot-melt butyl differential expansion/contraction
  - No real durable structural edge seal
  - Removable desiccant tubes easily overwhelmed in service
  - IGU failure led to frequent fogging and permanent corrosion of silver low-e coating on surface #2
- All residential IGUs need to be replaced
- Cooling HVAC units and in particular ducting is undersized for the clear glazing used.
- Mechanical under design can be resolved using high performance glazing in most suites

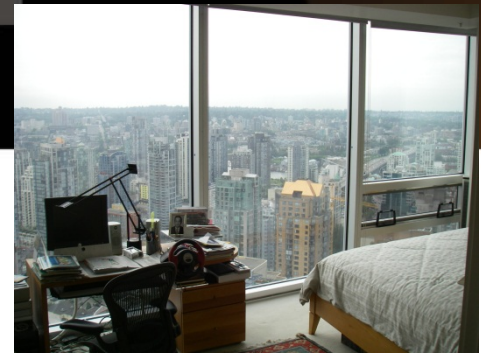
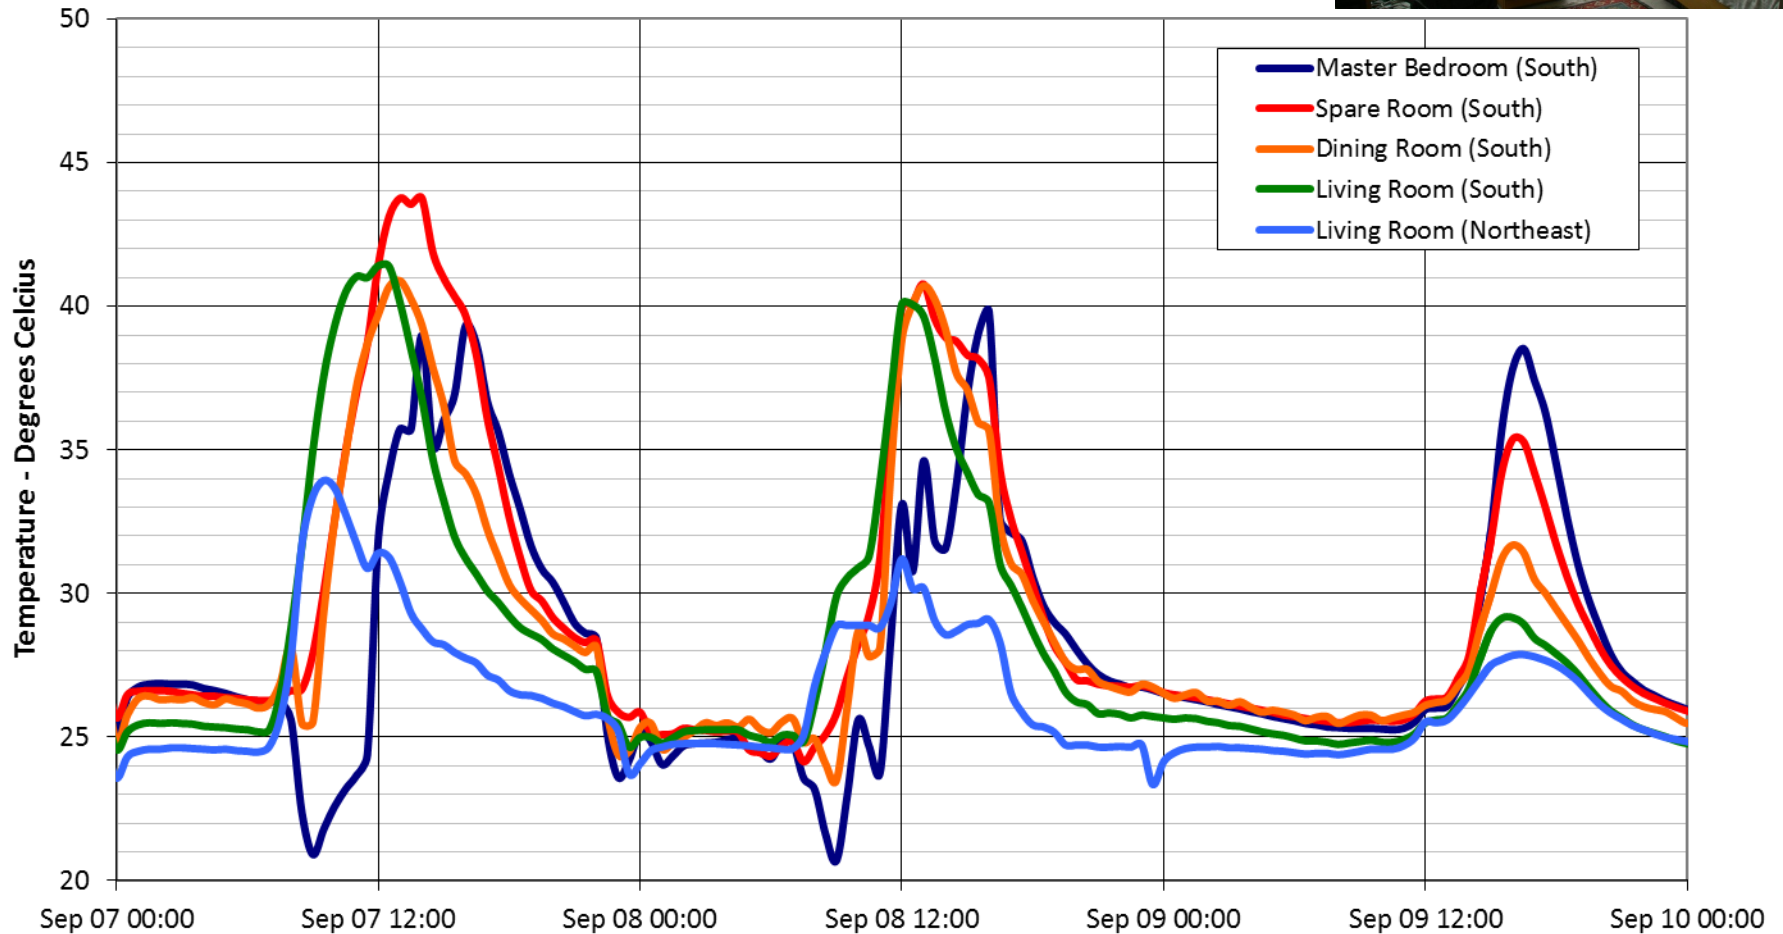
Suite 3903 - Summer 2008 Temperatures - Near Windows

# Issues - Overheating

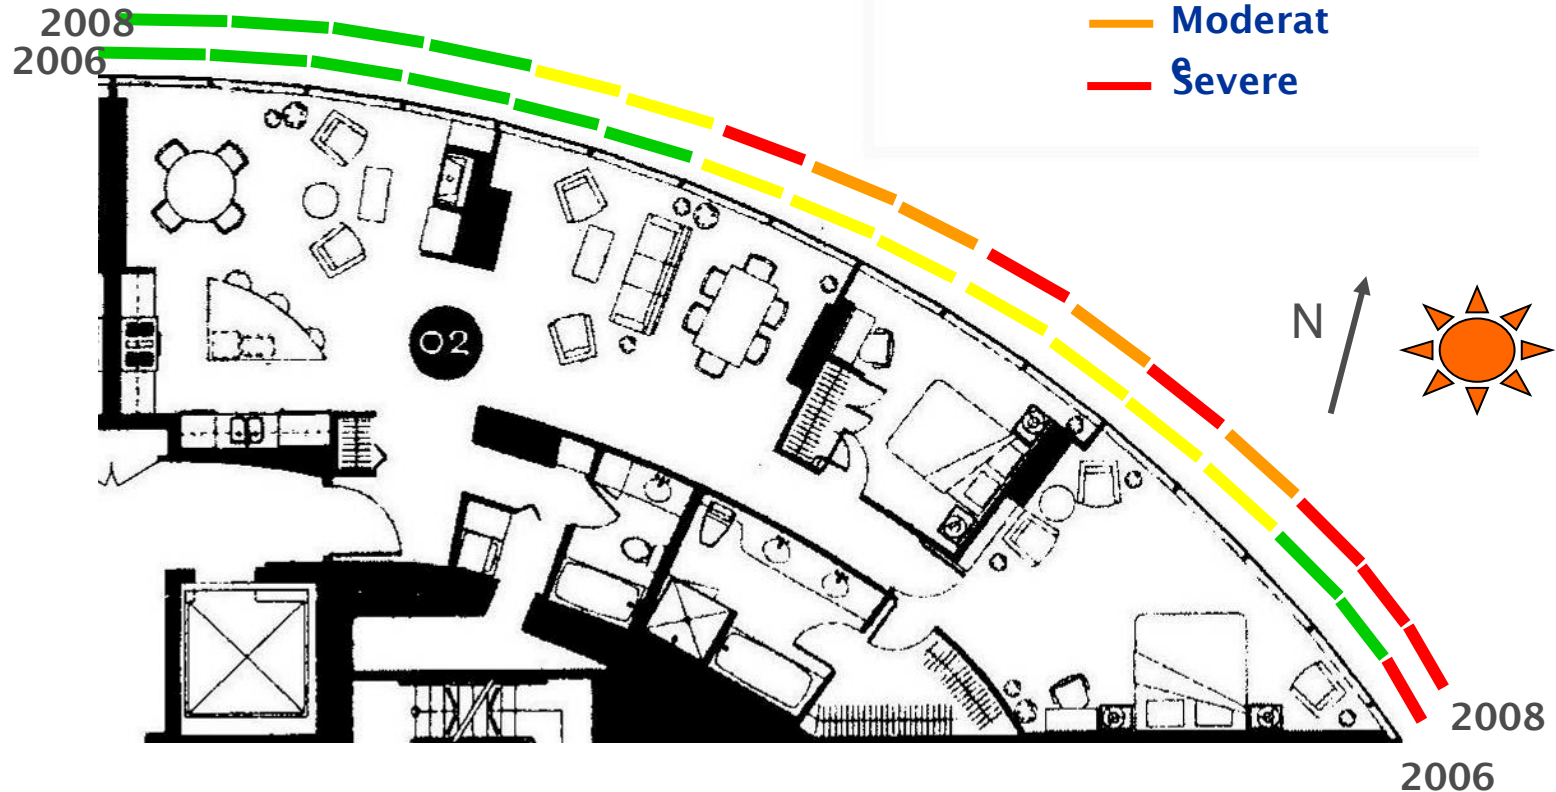
# Mapping IGU Degredation Over Time

2006 Frost points: -55, -10, -8 C

2008 Frost points: all between 2 and 6 C

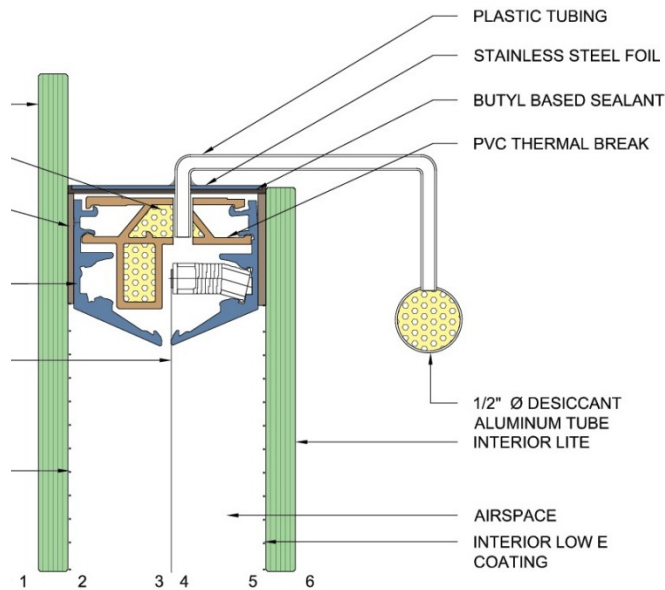
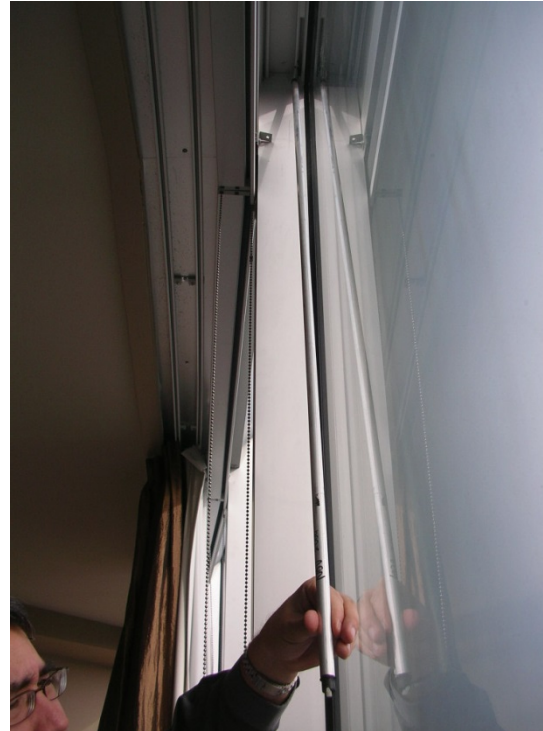
- Once desiccant reaches 80%, it no longer protects IGU from fogging – dewpoint above 0°C (32°F)
- Found saturated desiccant in all fogged units, and drier desiccant in clear IGUs

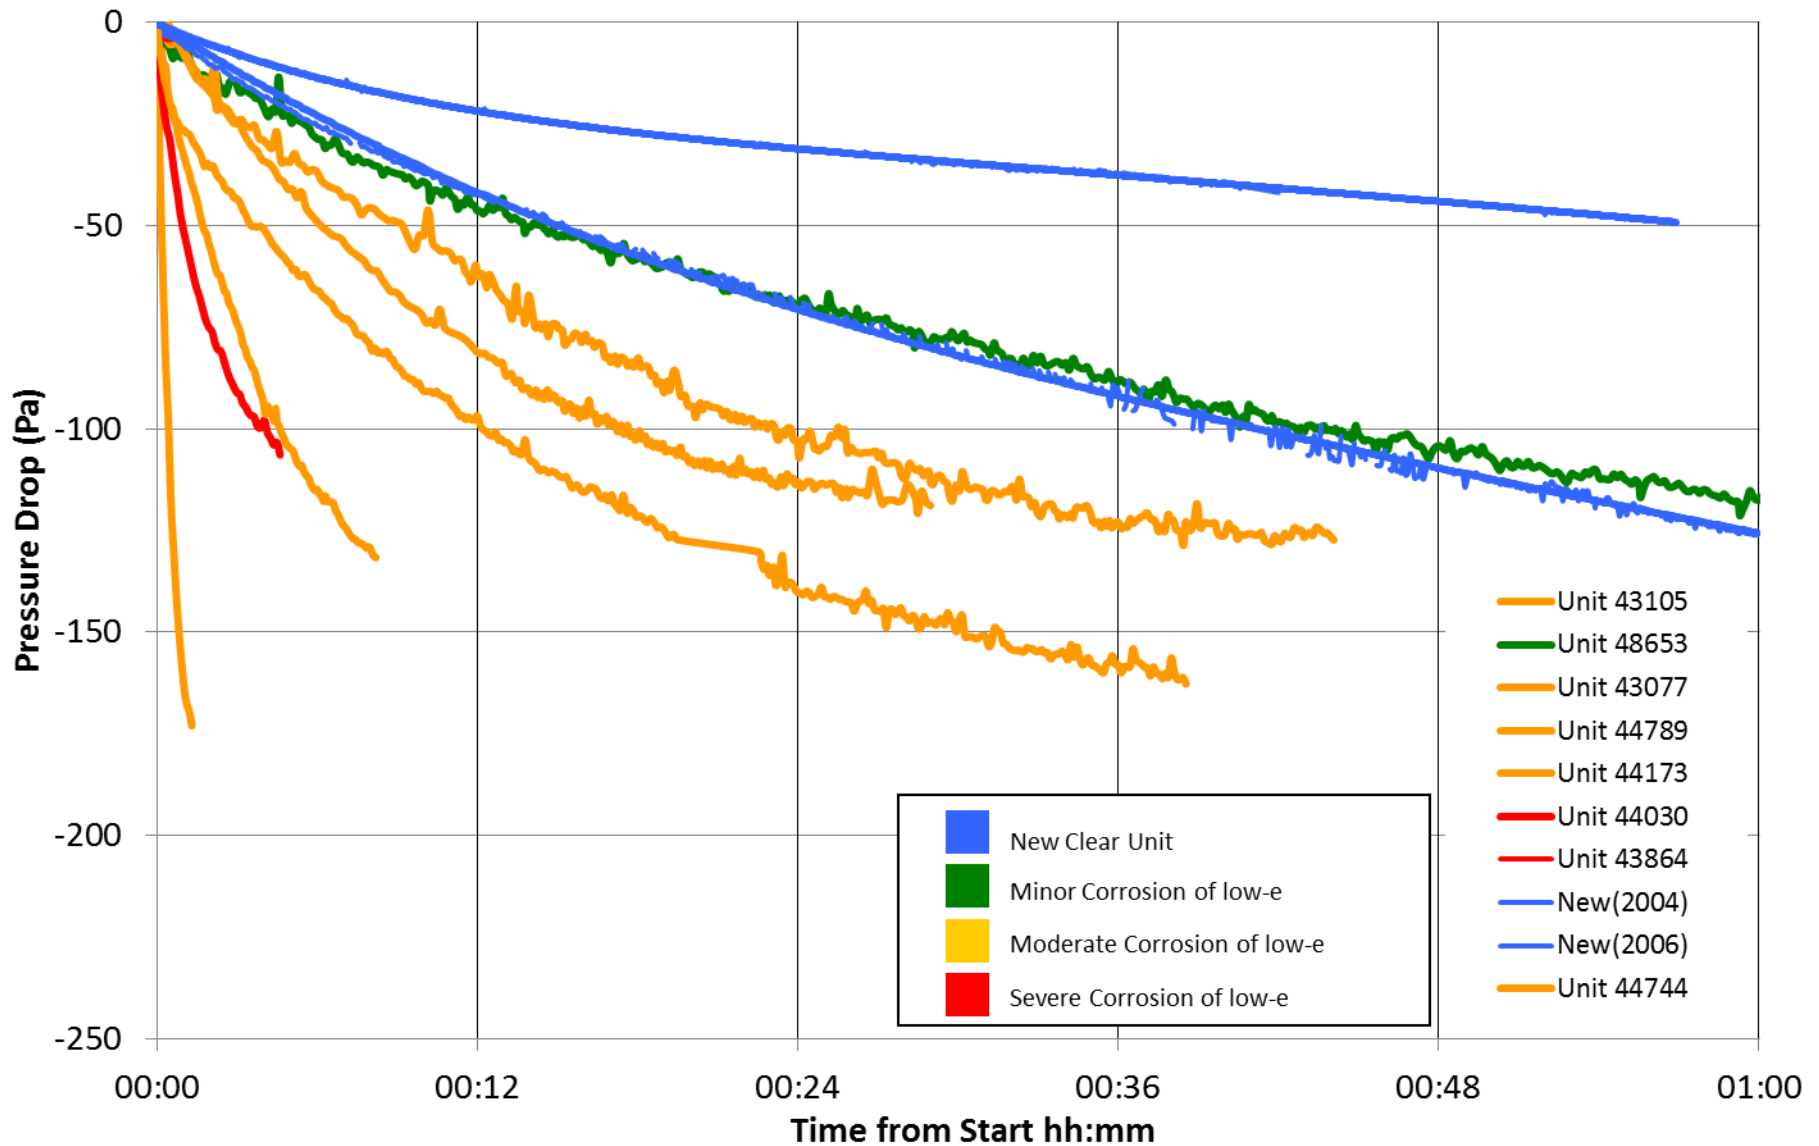
Pressure Test Data - Correlating Level of Low-e Corrosion to Pressure Decay - Suite 3903

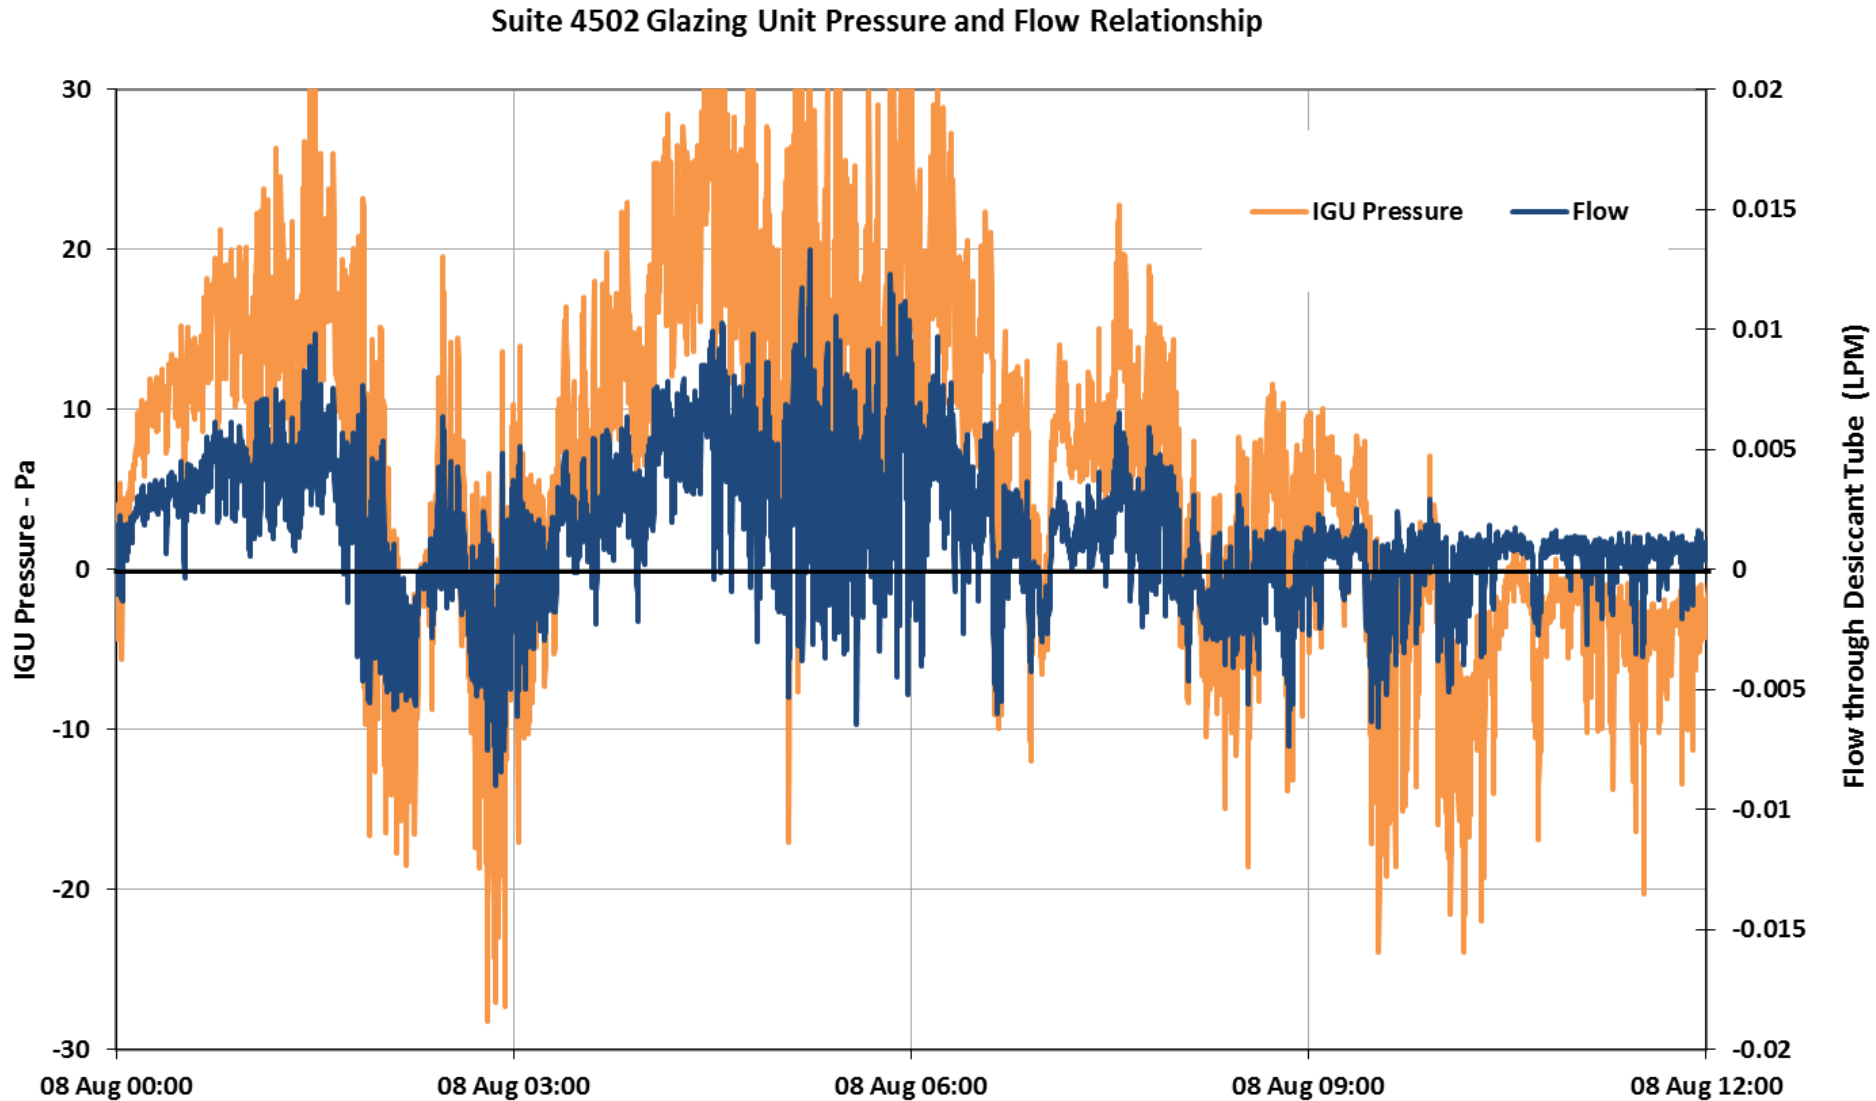
# Pressure and Flow Through Dessiccant Tube

- Air flows from outside into the IGU through edge seal defects then into suite through desiccant tube
- Desiccant tube flow rate of  $<0.01$  L/min = 1-5 Liters of air per day just from wind
- Estimated service life of external desiccant tubes with these average flow rates is  $<5$  years to saturation
  - Not accounting for other leaks (as indicated by pressure decay testing)
  - Could this replaceable desiccant tube design have worked in theory? No, not with 10x more desiccant by volume within IGU edge seal than desiccant tube.

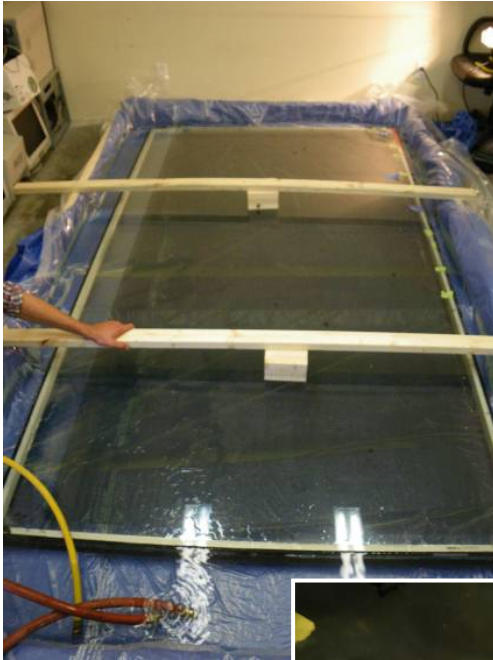
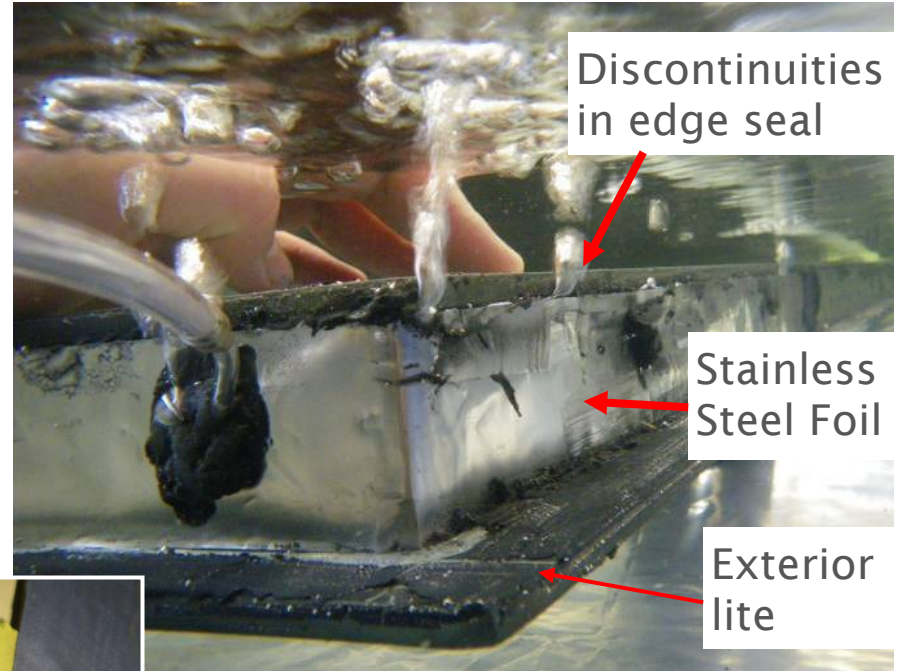
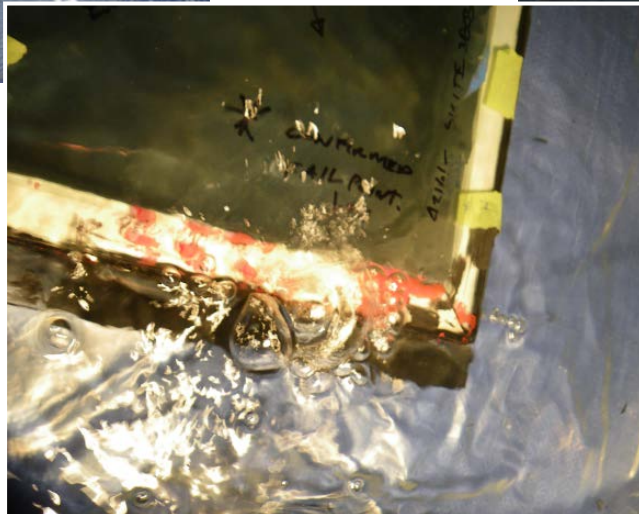
➔ Over 20 unique leakage locations observed in addition to the desiccant tube hole
