Moisture Investigations Using Thermal Cameras

By Lew Harriman

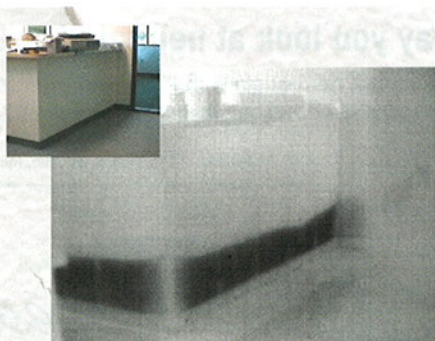
“Figure 1” (*see below*) shows a classic example of an IR image that helps locate areas of suspected excess moisture. The IR camera measures the heat coming from all surfaces and displays surface temperatures as one of 256 shades of gray (darker grays represent cooler temperatures). In this case, moisture from a flooded floor has entered the gypsum wallboard by capillary suction. As that moisture evaporates, it consumes some of the heat in the wallboard, slightly reducing its surface temperature.

Figure 1: Classic post-flood water damage.

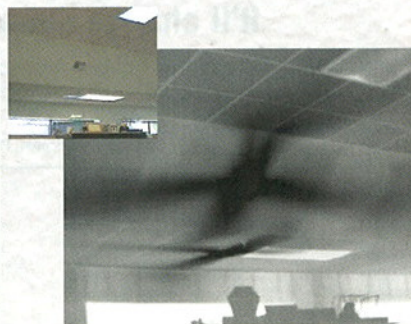
For instance, in that same water-damaged building, “Figure 2” (*see below*) pictures a thermal pattern that suggests moisture in the ceiling, and this image supports that expectation—until the IR investigator realizes the pattern is caused by cooled air leaving the four-way supply air diffusers.

Figure 2: Supply air diffusers.

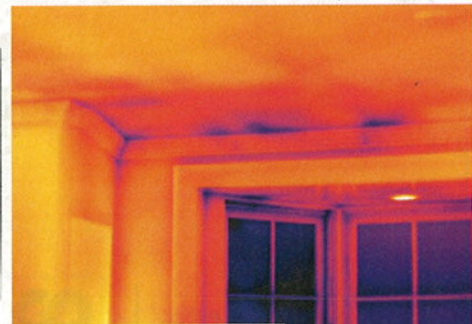
Similarly, “Figure 3” (*see below*) is a thermal image showing a pattern that suggests rain water leakage through an exterior wall. However, the dark areas do not indicate moisture. Rather, they show evidence of cool outdoor air being pulled into the ceiling through construction joints.

Figure 3: Cool air infiltration.

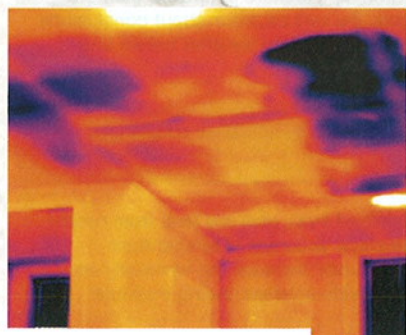
“Figure 4” (*see opposite page*) helps illustrate this point by showing the surface temperatures of a water-damaged ceiling. The 37-year-old caulking putty sealing the drain of the tub/shower combination in a bathroom above this ceiling was slowly leaking, which the homeowner (this author) realized when the ceiling began to show water stains. Fortunately, the wife of the homeowner reminded him that he—a building science consultant—has always cautioned his clients to never assume that a temperature difference in a thermal image is caused by evaporating moisture, until it is checked with a moisture meter.

Figure 4: Ceiling water damage.

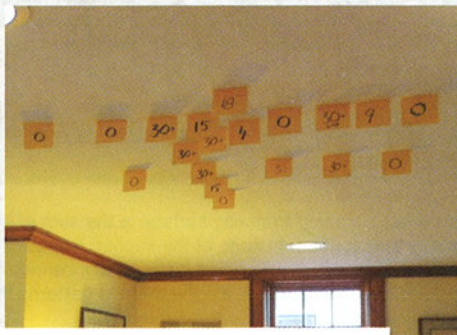
After such a useful spousal reminder, the investigator measured and documented the moisture content of the ceiling (*see “Figure 5,” opposite page*). That photo shows the current best practice for

confirming the results of thermal imaging. The line of adhesive notes is annotated with moisture content readings from a capacitance-based moisture meter, using its wood moisture equivalent (WME) scale. Note that at the center and right side of the image, meter readings confirm the presence of elevated moisture. However, readings at the left end of the line of notes show that the temperature difference there has nothing to do with moisture. Those cool surfaces are caused instead by cool air infiltrating through the building (cool air was being pulled by the stack effect in a long construction joint immediately above that location).

Figure 5: Ceiling moisture measurements.

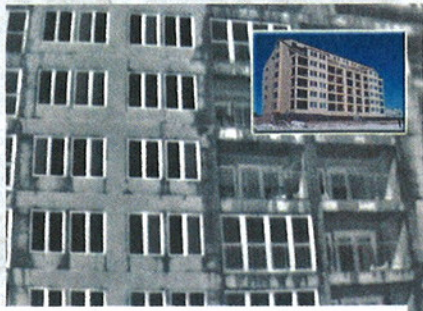
“Figure 6” (see page 14) is an example of water infiltration into an EIFS-clad building. The image was taken during the winter, on the east face of the building, immediately after sunrise. The radiant heat of the sun very quickly warms the surface of the EIFS—a cladding that excludes radiant heat from the building by reflecting or holding solar heat on its surface. Here, moisture has leaked into the system, and is illustrated by the greater thermal mass of the damp insulation (which keeps the surface slightly cooler than the surrounding dry insulation). Eventually—probably within an hour or less of sun exposure—the thermal patterns on the surface will be gone. The sun will heat the entire wall to nearly the same temperature, regardless of the differing amounts of moisture under the surface.

Figure 6: Moisture in an EIFS-clad building.

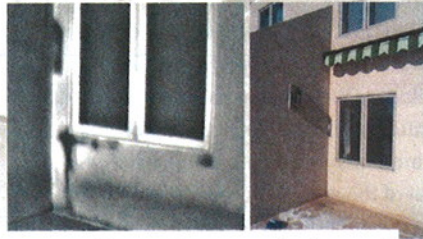
“Figure 7” (see page 14) shows another key aspect of exterior investigations: the importance of keeping track of the overall thermal environment, plus the sun's position as it creates shadows that move hour-by-hour. Meter readings here confirmed there is moisture below the corners of the window. But the pattern at the base of the wall is simply splash water from snow melting from the roof above. Without the visual image, it would be easy to assume—incorrectly—that the cool spot on the wall beside the window is caused by sub-surface moisture. The reality, though, is that the visual image shows the cool spot is simply a shadow cast by the light fixture on the adjacent wall.

Once again, an investigator cannot be 100-percent certain the shadow was the only cause of the cool surface pattern until the moisture content at that exact location is measured. In most cases, however, the difference between moisture and sun shadows will be readily apparent—as long as the investigator

Figure 7: Three patterns—sun shadow and splash water, along with moisture, in EIFS.
