## **A New Paradigm for the Design of Sustainable Buildings**

Warren Knowles, P.Eng., Brian Hubbs, P.Eng., Paul Kernan, MAIBC, Graham Finch, MASc, <sup>1</sup>

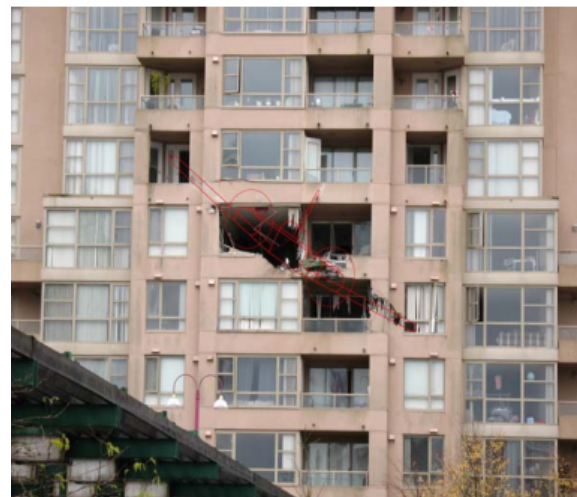
The authors were asked to investigate the results of a tragic small plane crash at a residential tower complex in Richmond, British Columbia. The impact of the plane at the 9<sup>th</sup> floor, north elevation of one of the buildings caused significant damage to the building enclosure assemblies in this area. The impact also resulted in breakage of water pipes, flooding of the building units at and below the area of impact, and associated damage. Although the damage as a result of the impact was significant, it was much less extensive than the damage identified during the investigation as a result of ongoing water ingress problems.

Figure 1: Partial elevation of building showing impact location of plane.

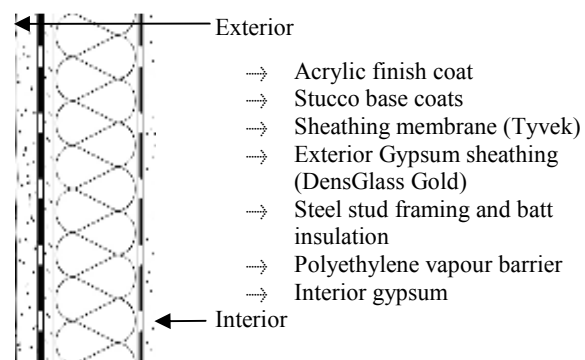
The exterior walls of the two buildings primarily relied on stucco cladding as shown in Figure 2. Poured-in place concrete walls, coated with an acrylic finish coat to match the stucco cladding also formed part of the building enclosure.

Figure 2: Section through typical wall assembly

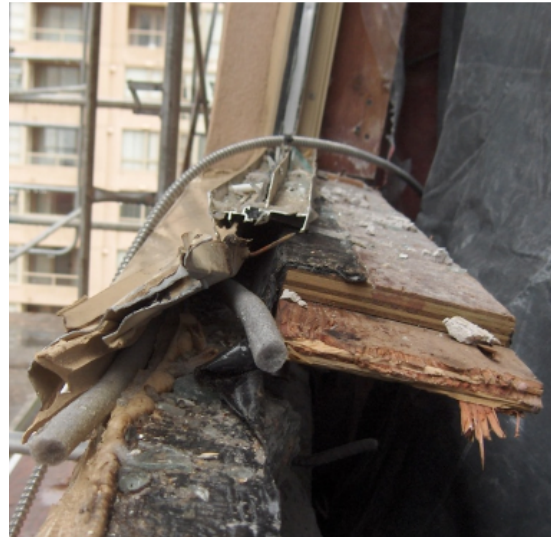
Figure 4: Cut section of a window sill at impact location

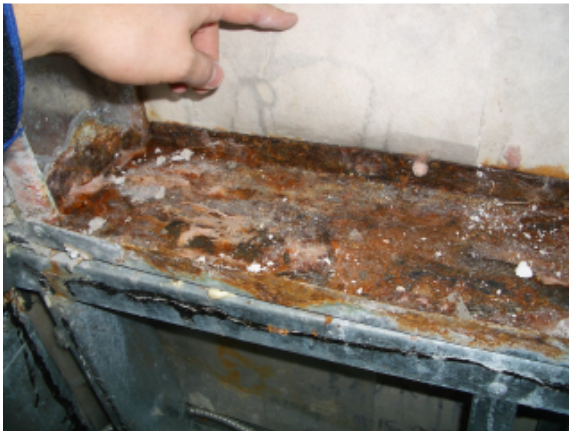
Widespread rain water leakage problems were identified, which resulted in damage to the interior finishes, steel stud framing, and other wall components. Examples of the damage are shown in Figures 5 and 6 below.

Figure 5: Corrosion of the exterior wall steel studs and deterioration of the exterior gypsum sheathing

Rehabilitation of the exterior wall and glazing assemblies is required to correct the water ingress problems at the building.

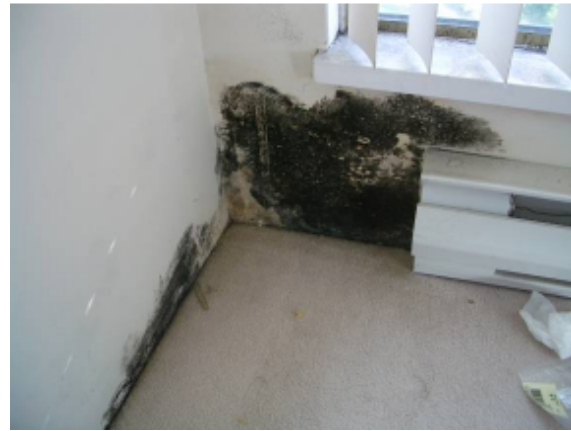
Figure 6: Fungal growth on the interior finishes below a window at an exterior wall.

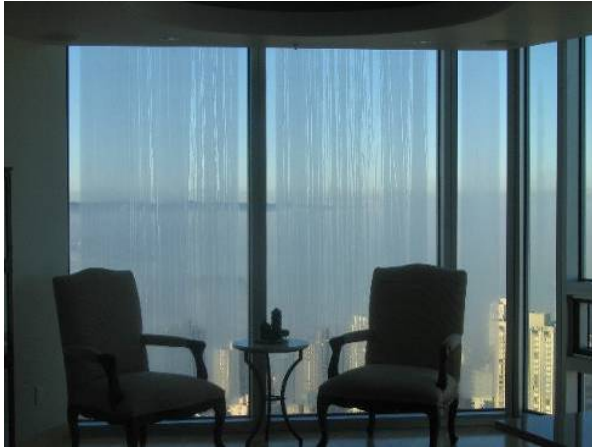
Figure 7: Visual condensation and severe corrosion of the low-e coating visible from the interior

Over the course of the investigation, visual clarity of the insulating glazing units was found to be progressively deteriorating to unacceptable levels on the majority of the building glazing panels. It was found that deterioration of the visual quality is a result of premature condensation forming inside the insulating glass unit and causing corrosion of the low-e coating on the glass. The condensation was caused by an excessive building up of moisture in the desiccant as a result of airflow through discontinuities in the perimeter seals. The discontinuities are a result of defects in the design and manufacturing of the insulating glass unit.

In-situ repairs such as desiccant tube replacement and sealant injection at the IGUs were previously attempted by the manufacturer and have not been effective at mitigating the problem. Replacement of the glazing units will be required, as well as adjustments to other building systems.

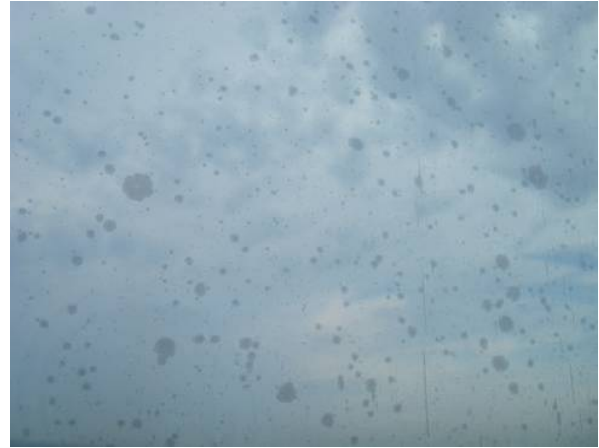
Figure 8: Large spots within the insulated glazing units

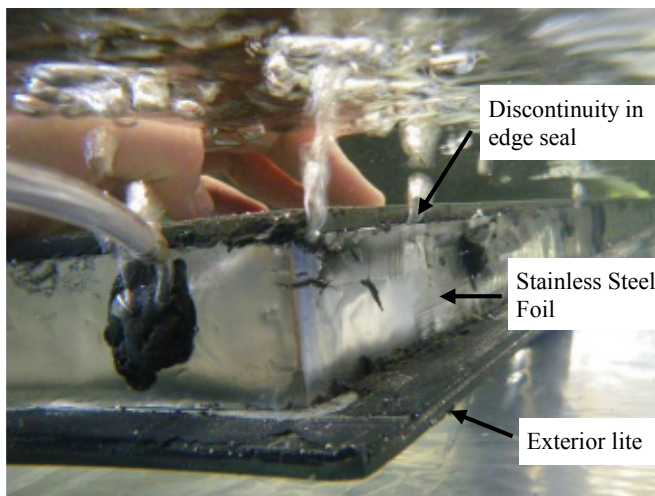
Figure 10: Air leakage during a pressure test of a submerged IGU with evidence of corrosion of the low-e coating

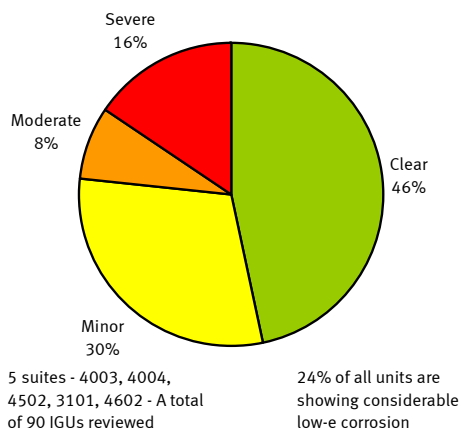
Figure 11: 2006-2007 visual review summary. Corrosion of the low-e coating within the glazing units (Review of IGUs at 5 Suites)

The majority of the insulating glass units (IGUs) reviewed exhibited moderate to severe corrosion of the low-e coating after several years of service. Many of the units where minor deterioration was observed were previously found to be clear only a couple of years earlier. The corrosion level on insulating glass units reviewed over multiple years indicates that these units have failed and are continuing to degrade. Test results indicate that the majority of the clear IGUs are near, or at the point where condensation and corrosion will start to occur.

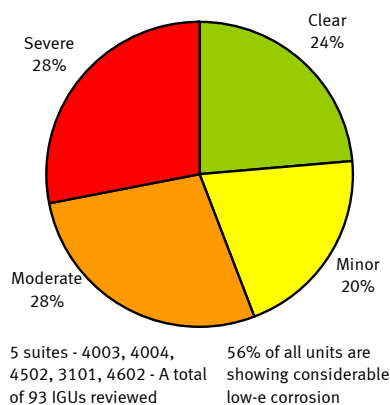
Figure 12: 2008 visual review summary. Corrosion of the low-e coating within the glazing units (Review of IGUs at the same 5 Suites)

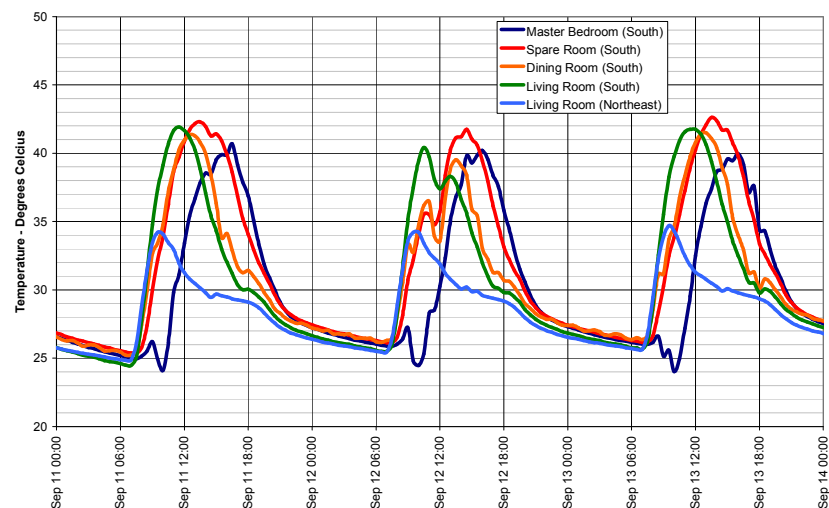
Figure 13 shows the temperature readings near the glazing panels in a sample suite on three sunny days in September. The suite heating, ventilation and air conditioning system was set to 21 degrees Celsius. The interior air temperatures at these locations reached 40 degrees Celsius during this time period.

Figure 13: Suite Temperatures, September 11 through 14, 2008

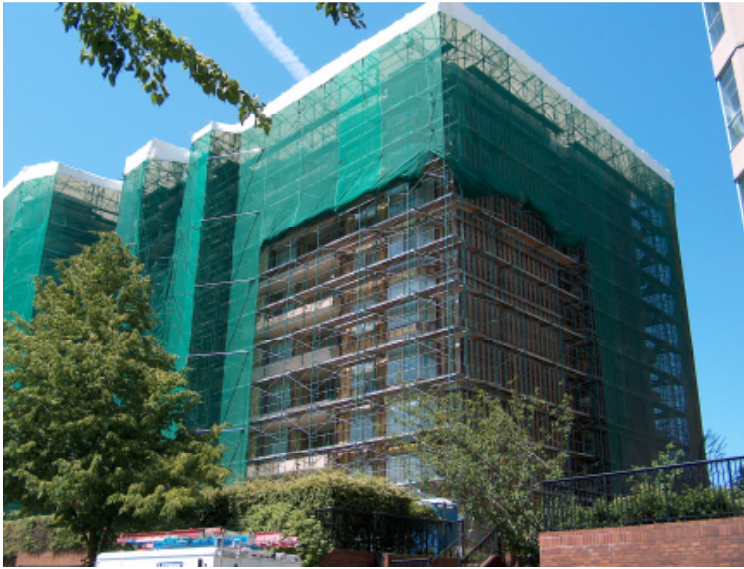
Building 19 of the Study is an example where the building failed to meet expectations. It is a 10 storey mid-rise residential building. It was originally intended that the building incorporate improved building enclosure, with the use of higher performance 'Thermo Stucco'. The use of the improved stucco cladding, along with the incorporation of a relatively low window percentage was expected to increase the overall R-value of the building enclosure. However, the actual overall building enclosure R-value was less than 3, and the as-built arrangements resulted in extensive water ingress related damage including severe corrosion of the supporting steel stud framing as shown in the Figures 15 and 16.

Figure 15: Overall corrosion of the exterior steel stud wall assemblies at Building 19.

Rehabilitation of the building enclosure assemblies was required to correct the damage.

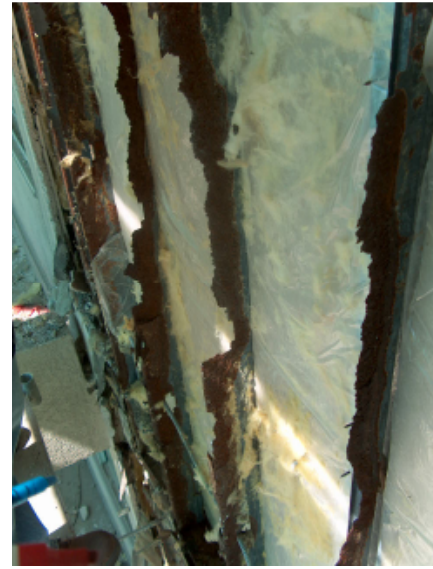
Figure 16: Typical corrosion of the exterior steel studs behind the cladding at exposed portions of the south elevation.
