## **Title: Building Envelope Upgrade at Frank Lloyd Wright's Solomon R. Guggenheim Museum**

William B. Rose (1) and Angel Ayón (2)

The Solomon R. Guggenheim Museum in New York, the last major work by Frank Lloyd Wright completed in 1959, was the focus of a major restoration effort from 2004 to 2008. Throughout its service life, the building has performed admirably, but with some prominent building-envelope flaws. In response to evidence of cracking, the museum undertook an extended study prior to remediation. The principal focus of the remediation was architectural and structural—heat and moisture analysis was part of the overall effort. One part of the heat and moisture analysis was investigation and measurement of conditions in the wall assembly.

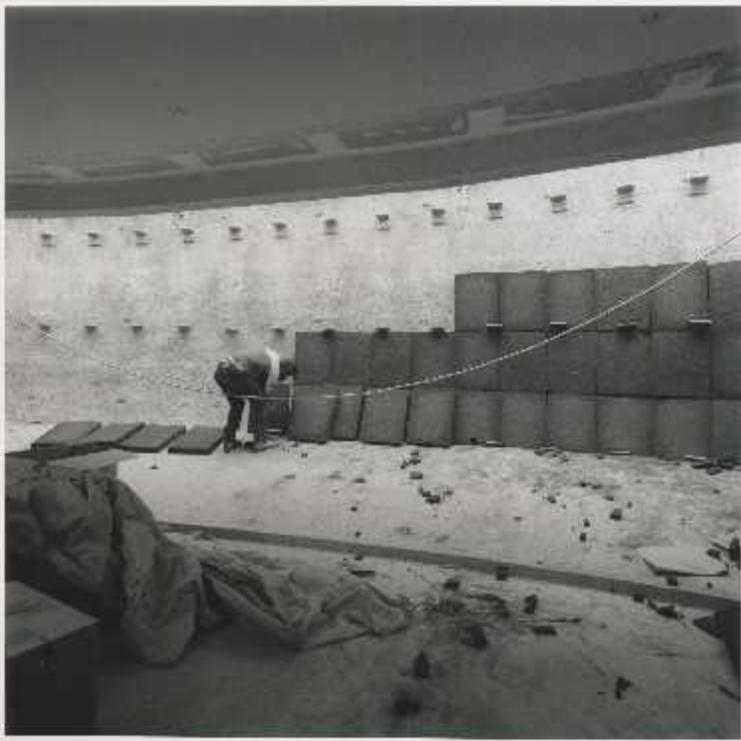
Over time, there have been several interventions in the building. In 1992, cellular glass insulation was added to the interiors of the Rotunda walls. The cellular glass was installed in 2 ½” thick panels adhered to the walls. The material itself is very impermeable to gas diffusion—even slight abrasion of the material releases hydrogen sulfide gas left from the original material production almost 20 years earlier. An air gap of variable size resulted from the flat panels being applied against the rough, curved wall surface. Mastic was used to seal the joints between the cell glass blocks. Other than the four gobs specified to adhere the insulation to the walls, no mastic was used between the cell glass and the wall itself. See Figure 2. Plaster was applied to structural lath inboard of the insulation. An accumulation of many coats of latex paint was applied over time to the interior plaster.

**Figure 2. Placement of cellular foam glass insulation against gunite walls in the Main Rotunda, ca 1992. © D. Heald. The Solomon R. Guggenheim Foundation**

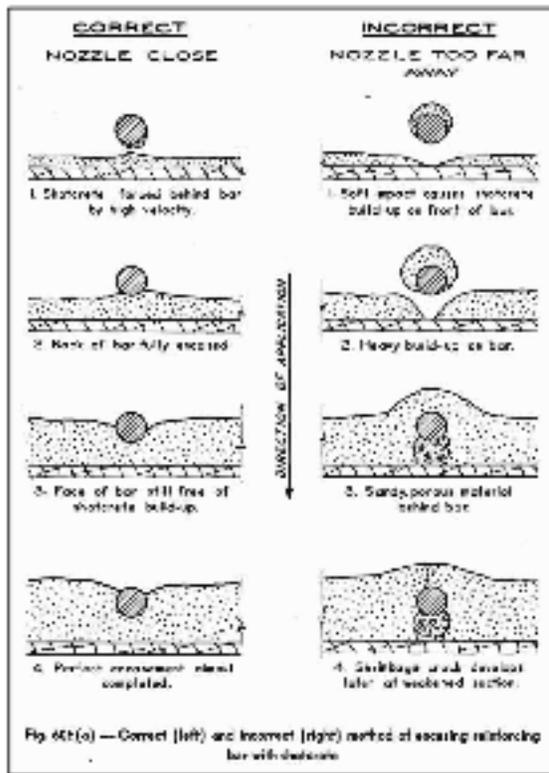
A specification for the “gun-projected concrete” is among the archived construction documents. The specification calls for best practices and highest standards of the trade, however it is not specific regarding avoidance of cavities or voids in the resulting concrete. In shotcrete, voids are possible since the metal reinforcing can prevent concrete from filling the space immediately behind the steel. See Figure 3 showing correct and incorrect methods of applying gun-propelled concrete.

2. There were pathways for air flow through the wall assembly
  - a. The gunite wall contains cavities. While best practice would indicate complete filling of the wall with concrete, several factors during construction led to less than complete filling, similar to the incorrect applications shown on Figure 3. This voiding was confirmed by field probes.

**Figure 3. Diagram from Yogy (2000) showing correct and incorrect methods of application of gunite.**

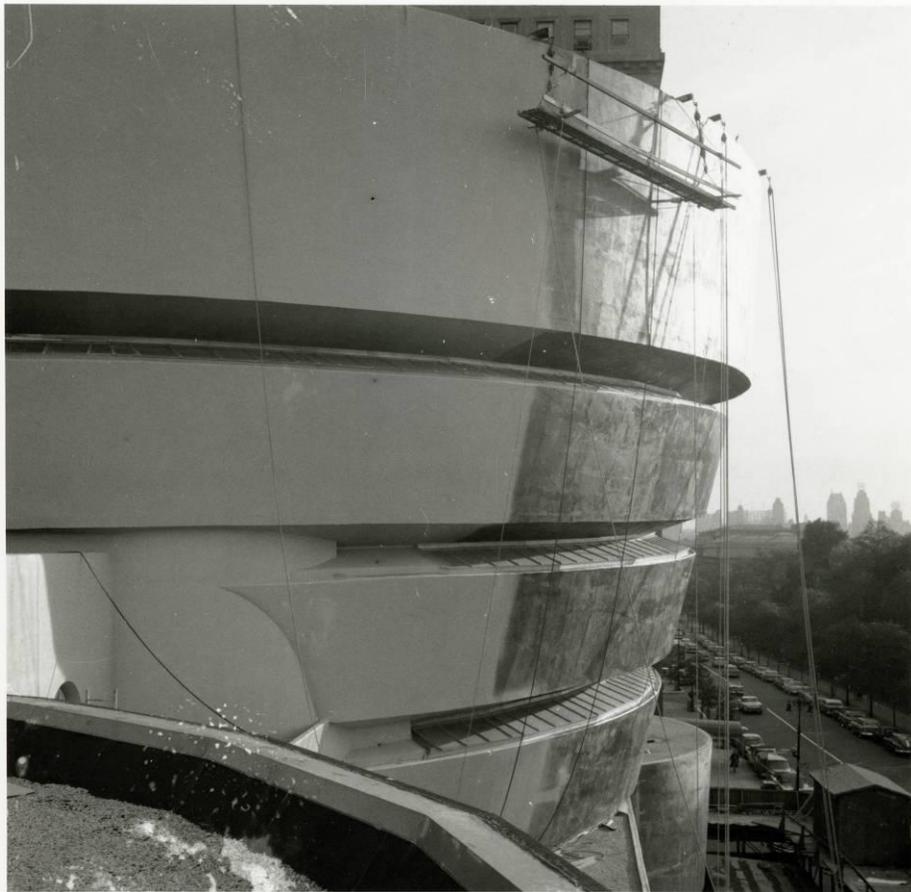
The exterior of the museum was painted with a primer, then a vinyl acrylic “cocoon” coating were spray-applied to the exterior of the building. See Figure 4. Subsequent to the original construction, several recoating campaigns ensued. The water vapor permeance of the gunite and cocoon were measured by Architectural Conservation Laboratory in 1993.

**Figure 4. Application of “cocoon” finish (one of several layers) to the exterior of the Main Rotunda, ca 1958. © William B. Short. The Solomon R. Guggenheim Foundation**

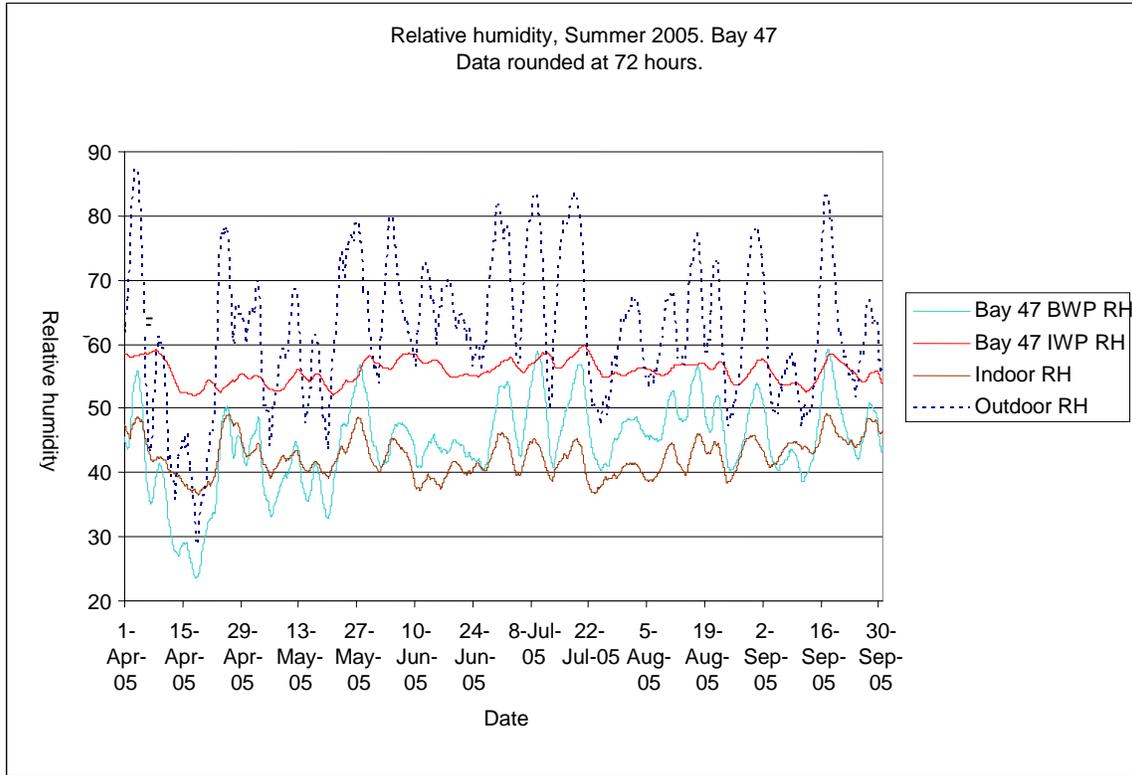
Results from this March-October monitoring campaign are shown in Figures 6 and 7. Figure 6 presents a timeline of relative humidity for Bay 47. (Results from Bay 44 were

similar.) The conditions within the gunite wall (IWP) showed stable RH; conditions at the cavity between the insulation and the gunite wall (BWP) were variable, but at lower RH than IWP. Figure 7 shows the same data, with vapor pressure plotted against temperature. As seen in Figure 6, relative humidity at the mid-thickness of the gunite wall remains somewhat constant.

**Figure 6. Timeline of relative humidity measurements, April to September 2005, Bay 47. Exterior “cocoon” finish was in place.**

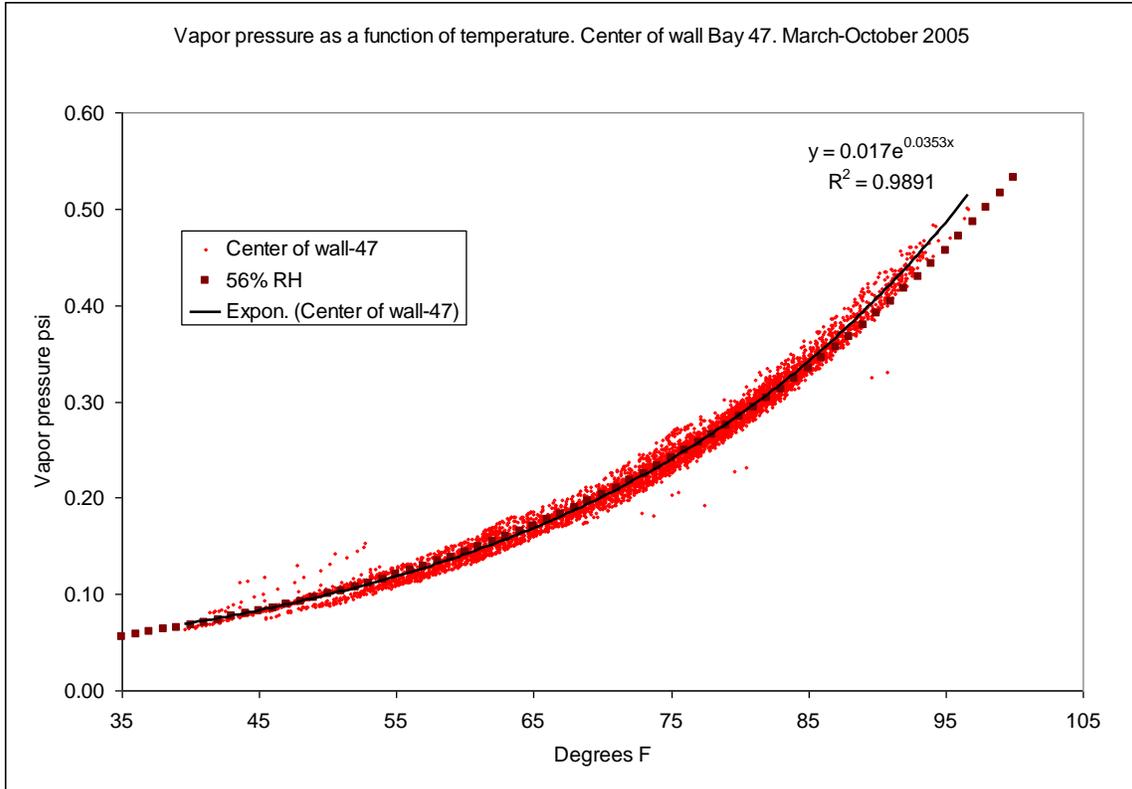
With the cocoon on the outside and foam glass insulation at the inside, the moisture content of the concrete remains practically constant. The concrete buffers the humidity in the wall, and overhanging ramps above provide protection against rain. Given the sorption isotherm relation between moisture content and relative humidity, it follows that the RH would remain practically constant. At the wall-insulation interface, conditions were not as stable. The air at that location was not contained tightly, but rather communicated to both the interior and exterior. Consequently, airflow affected temperature and humidity at that interface.

**Figure 7. Temperature and humidity results, March-October 2005, bay 47, within the thickness of the gunite wall (IWP position).**

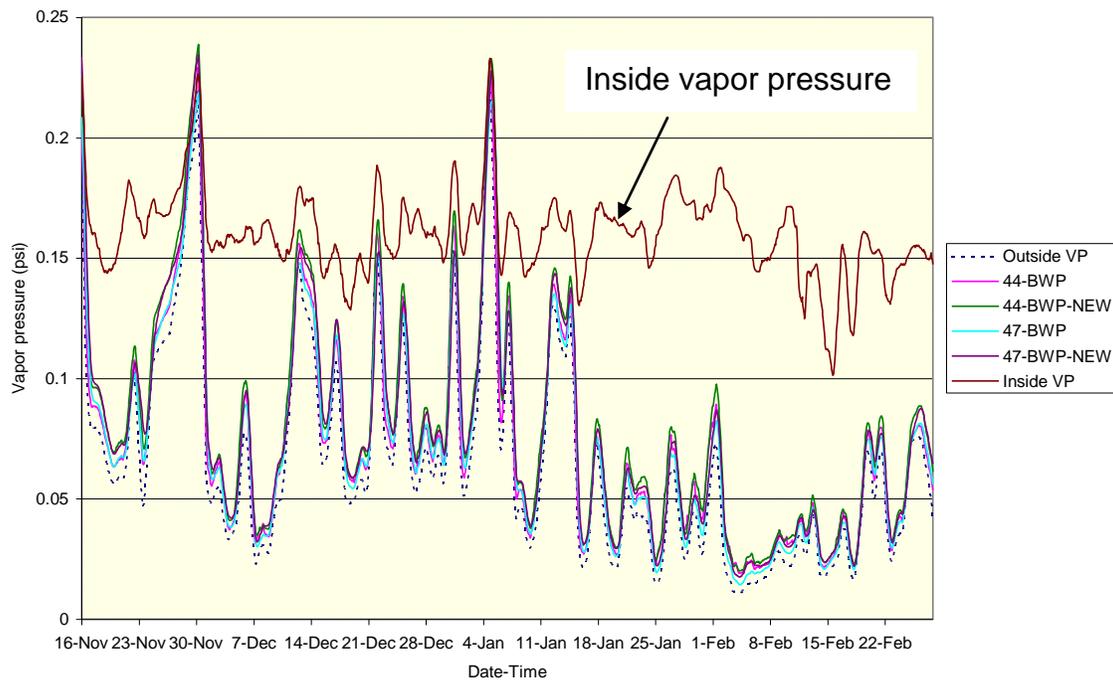
Monitoring data for the wintertime of the second campaign are shown in Figures 8 and 9. Figure 8 shows calculated vapor pressure at the BWP location for four sensors at Ramp 4. The cocoon had been removed. What is readily apparent is the fact that vapor pressure in the interface between the gunite wall and insulation is in equilibrium with the outdoors. This holds true for the original sensors and for the new sensors as well. (New and old sensors were paired to ensure similarity of data from the first to the second campaign.)

**Figure 8. Timeline of relative humidity measurements at the interface between the insulation and the gunite (BWP position) for winter 2006-2007, Bays 44 and 47. Exterior “cocoon” finish had been removed.**

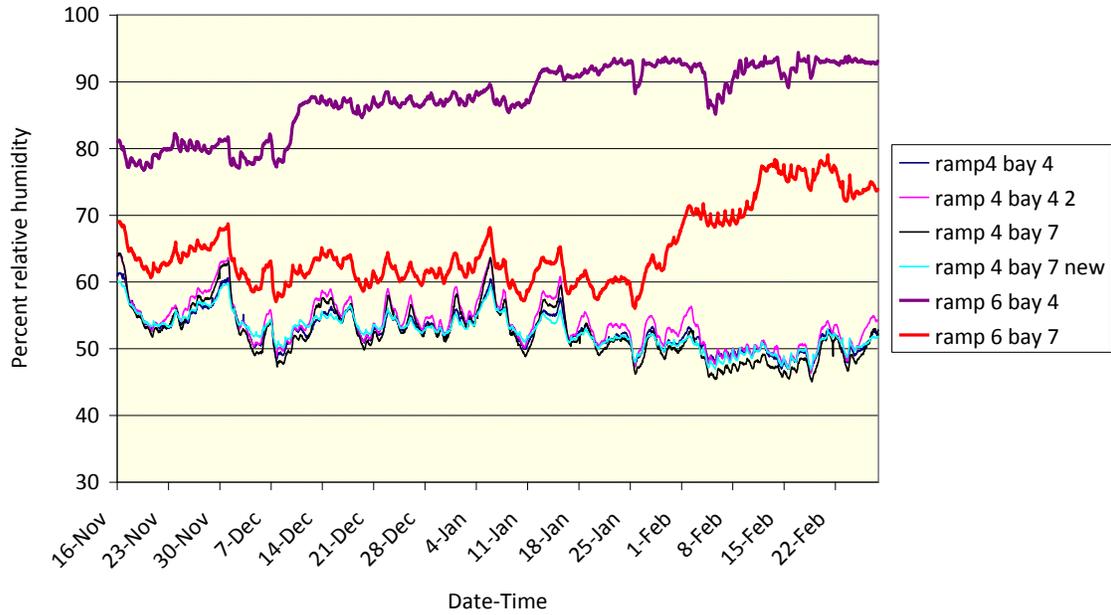
Following an exterior crack survey, (see Figure 11) greater concerns were raised for the 6<sup>th</sup> floor ramp, the uppermost ramp. For the second campaign, additional temperature and humidity sensors were placed in the walls of ramp 6, in Bays 64 (south-facing) and 67 (west-facing), using the same placement specification as below. Figure 9 shows the measured RH within the wall (IWP location) for the sensors on Ramp 6 and Ramp 4. The inside wall panel sensors for bay 67 remained between 60% and 70% RH until January, when a clear escalation in RH began, terminating close to 80% RH. More striking was the performance of the south-facing sensor, which showed RH at 80% at the start of the

winter, and climbed up to 95% RH by February. At the same time, the RH on the four sensors at the fourth floor ramp remained low, between 50% and 60%. The 6<sup>th</sup> floor ramp wall was performing much more poorly than the 4<sup>th</sup> floor ramps, at a time when it had excellent protection from rain by virtue of a temporary roof, and very high drying potential due to the removal of the cocoon. The fourth floor and sixth floor ramps were at the same temperature, so had the same temperature-driven drying potential.

**Figure 9. Relative humidity measurements in bays 44, 47, 64 and 67, winter 2006-2007, at the center of the wall thickness (IWP position).**

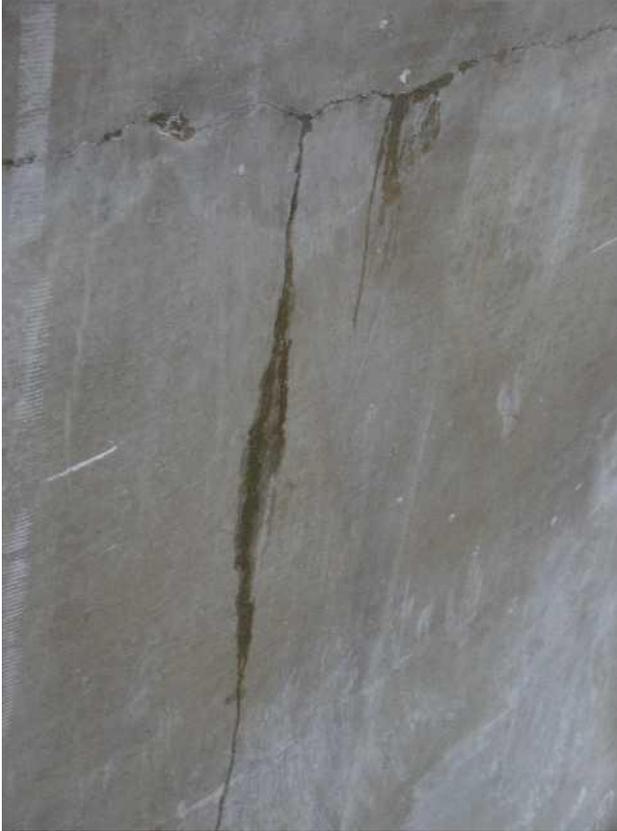
Two curious wetting events were observed to occur, one in December 2005 and a second similar event in January 2007. See Figure 10. On both occasions, water was seen to be “bleeding” out of horizontal cracks in the wall at the 6<sup>th</sup> floor ramp level, on the southeast side of the building. In both instances the wall was fully protected against rain and snow by a roof that was part of the scaffold. Monitoring data indicates that both “bleeding” events occurred when a severe below-freezing cold snap came to an end.

These conditions suggest the following scenario: During cold weather the gunite is cold and may be sub-freezing. Humidified air moves through the network of voids on the “shadow” side of the steel reinforcement. When the surfaces surrounding the exfiltration pathways are above freezing, the moisture content of the concrete becomes elevated, as seen in Figure 9. When surfaces surrounding those pathways are below freezing, frost is formed. With temperature changes, the frost may become water and refreeze to ice. Frost and ice will accumulate during cold spells. With a strong warming trend, the resulting liquid water cannot all be absorbed into the already wet concrete. It drains out of cracks, under gravity and air pressure difference, particularly at the leeward areas.

**Figure 10. “Bleeding” event at the exterior surface of Bay 62. Scaffold roof provided full protection against rain and snow at the time of the photograph.**

The recommended repairs for the building as a consequence of this study included 1) treatment for all exposed cracks, and 2) an installation of an air and moisture barrier at the interior of the gunite. The authors’ involvement in the project was limited to the early design phase, so we are unable to report on the execution or performance of the completed wall assembly.

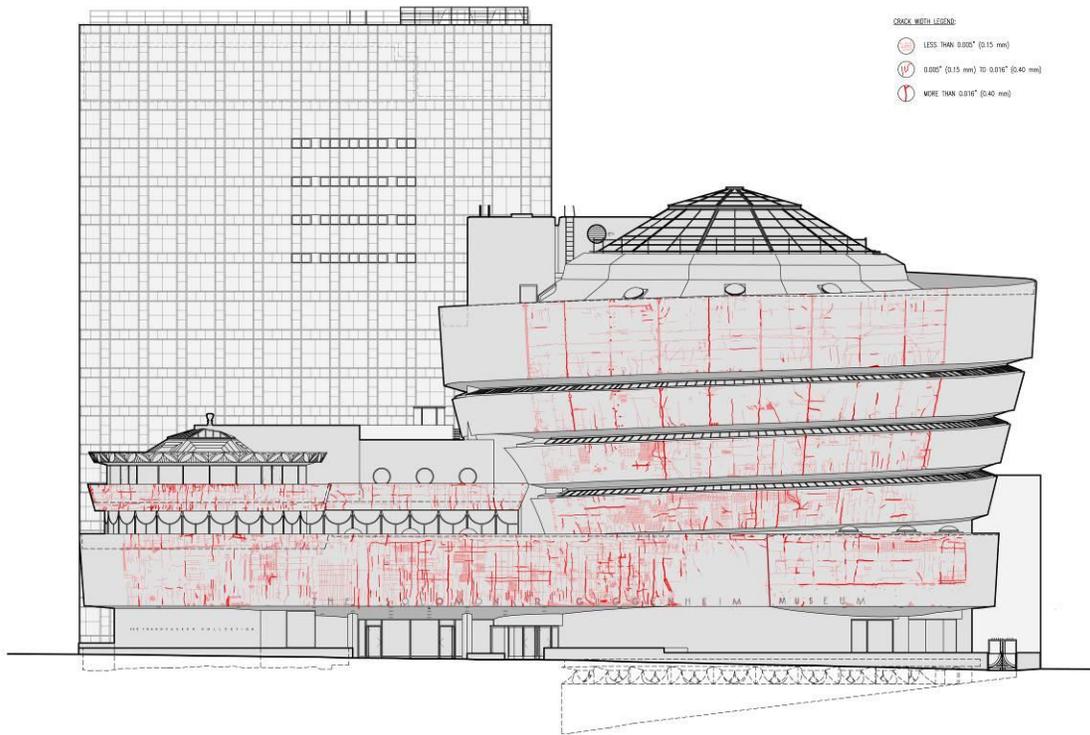
- b. A crack survey (see Figure 11) showed the greatest amount of large cracking at the 6<sup>th</sup> floor ramp, of all the ramps in the Main Rotunda. Most of the cracking was vertical, but horizontal cracks were found, often at the locations of the circumferential reinforcing steel.

**Figure 11. Extent of exterior wall cracking at the Guggenheim's Fifth Avenue (West) façade. @ WASA/Studio A.**

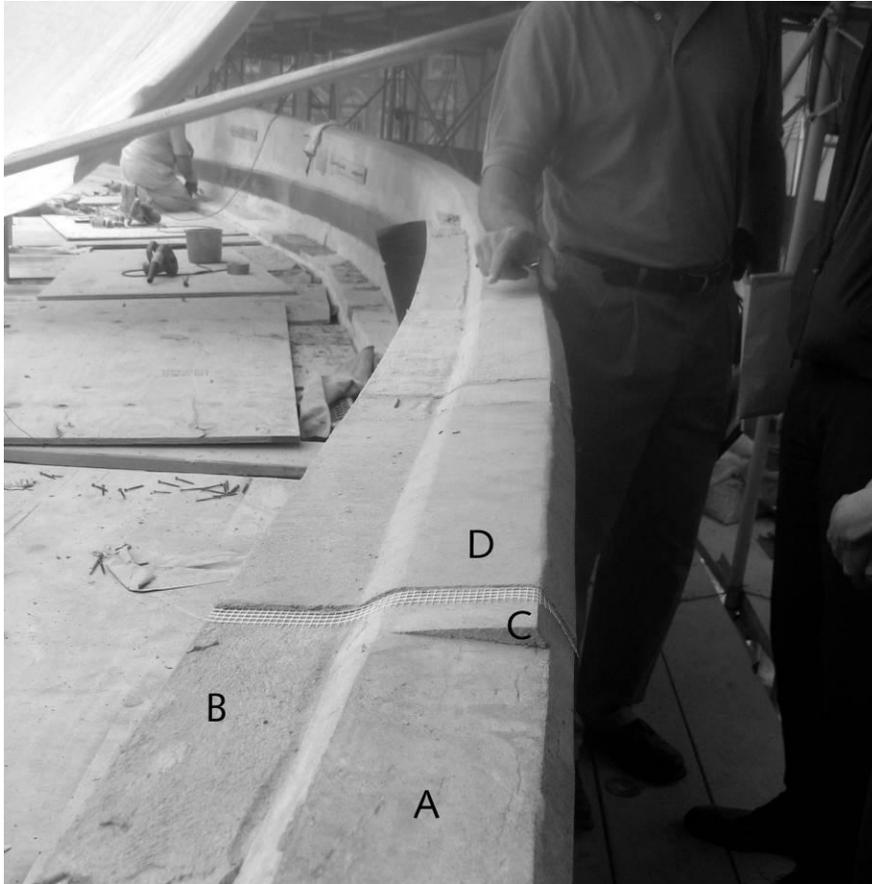
The study did not include the impact of rain on the structure. The first campaign was conducted on Ramp 4 which was protected from rain by overhanging ramps above. The second campaign was done while the building was under a temporary roof structure. Concerns for rain effects on the wall led to the design and construction of an inward-sloped parapet coping to replace the original flat coping. See Figure 12.

**Figure 12. Onsite mockup of new cementitious topping along full-length of Rotunda parapet. © A. Ayón, WASA/Studio A, 2007. Observers in the foreground are standing on the scaffold, facing the exterior of the Rotunda roof parapet. The worker in the foreground is facing the interior (roof side) of the parapet.**

**A: Top of existing outward-pitched Rotunda roof parapet.**

**B: Top of new inward-pitched stucco covering surface-applied structural reinforcement.**

**C: New inward-pitched resin-based mortar over top of existing parapet.**

**D: New reinforced fluid-applied waterproofing membrane over new top of parapet.**
