Louis Kahn's Stainless Steel Glazing System: Performance Upgrades in the Richards Building

Aaron Davis, AIA

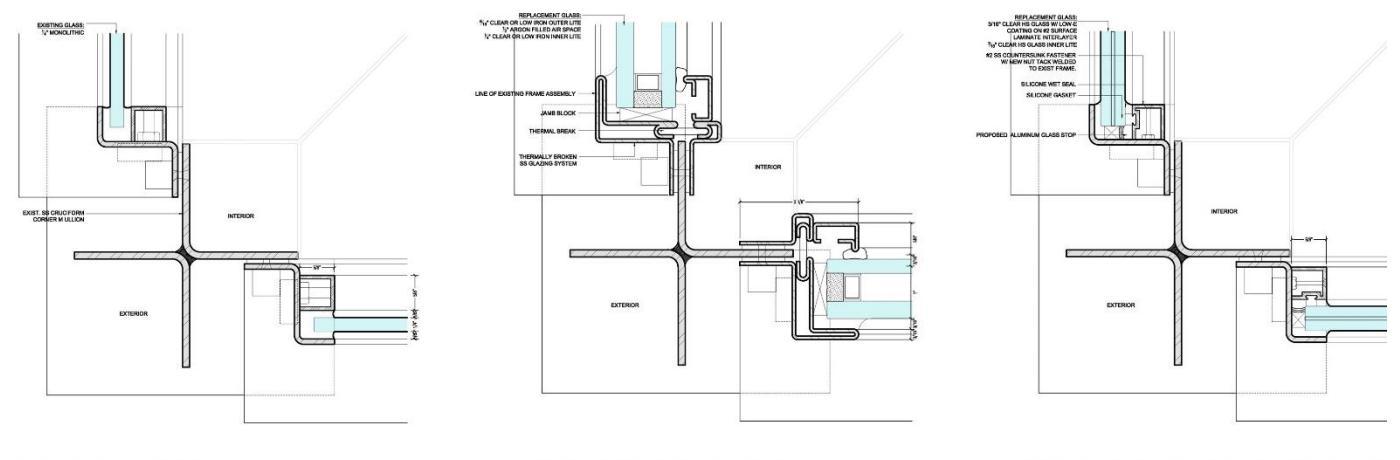
Figure 4 Comparison of existing and potential frame remediation options. Note the profile change required to allow for thermally broken frames.

One important caveat is that using the existing frames meant that IGU's were precluded due to the frames' shallow profile relative to the IGU depth; the IGU would project farther than the innermost face of the existing frame. Acknowledging performance improvements as secondary to historic restoration and sustainability, the decision was made to keep the existing frames. Replacing the monolithic glass with IGU's and replacing the frames with new members of different thickness and sight lines would have been tantamount to installing a system installing a system designed by another architect.

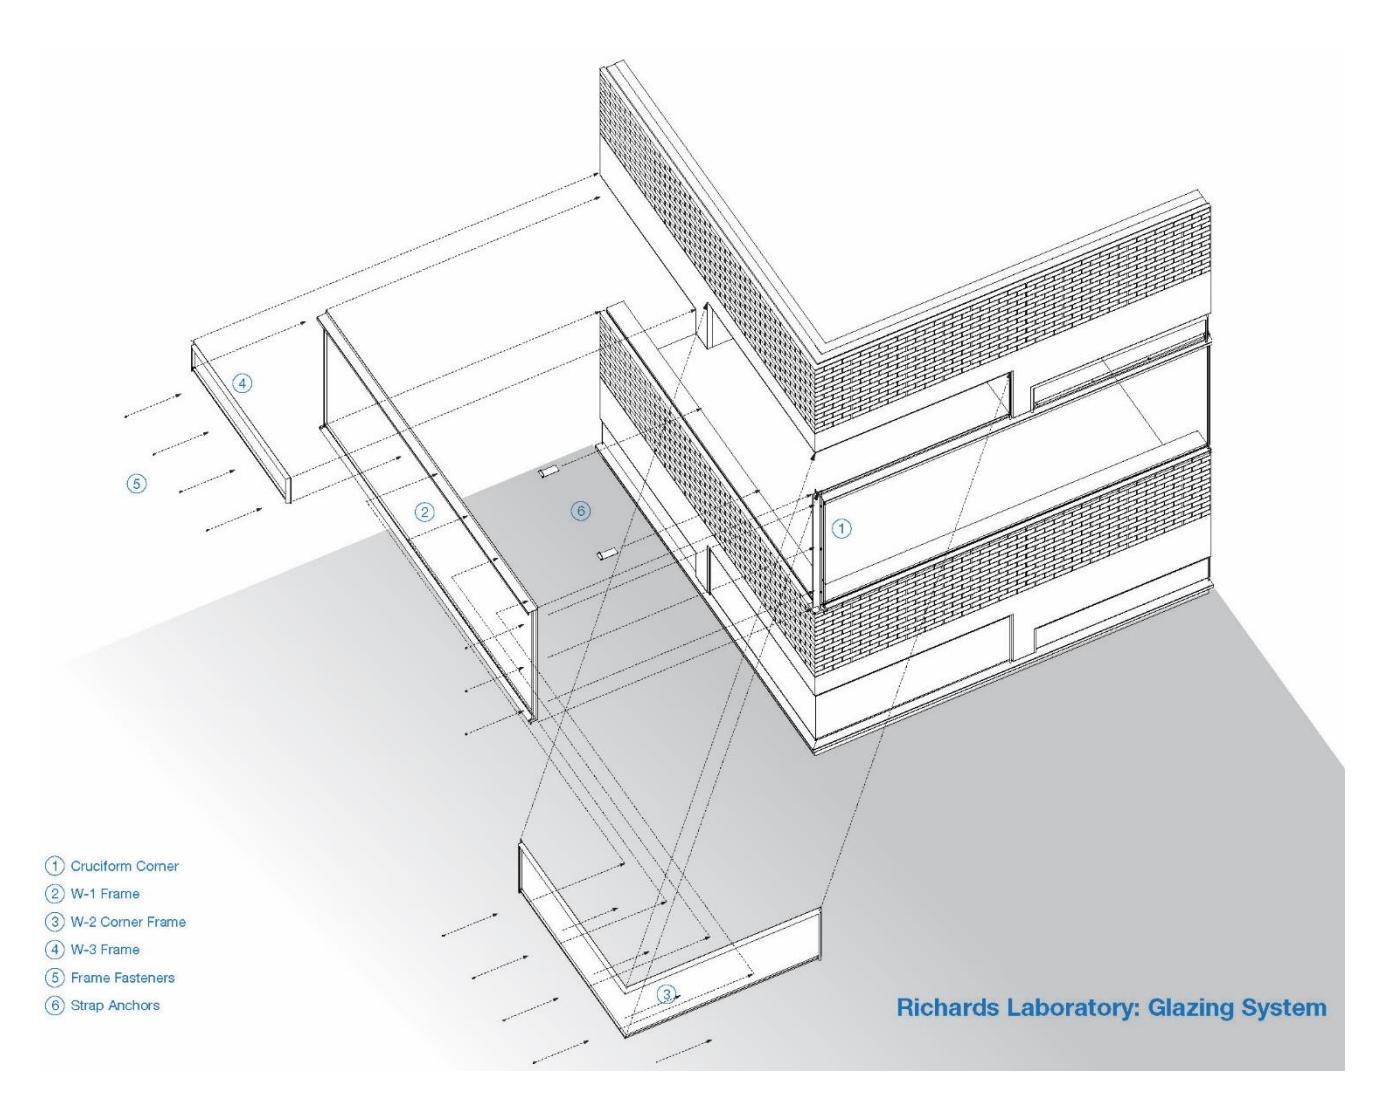
Vision Glass: Investigation and Analysis. The corner labs are comprised of three main glass types: Corner Vision Glass (W-1), and Clerestory Glass (W-2 and W-3). (Fig. 5). Conformance with the original specification of 1/4" (6mm) plate glass was confirmed through field measurements and observation of telltale "score-and-snap" edge work concealed behind the glazing bead. Comparison of historical strength characteristics of polished plate glass suggests parity with contemporary annealed float glass. Therefore, annealed glass characteristics were used for analysis of glass stress and deflection. Wind loads calculated in conformance with ASCE 7 and based on a 50-year wind event reflect positive and negative pressures of +20 psf (9.6 x 10-4 N/mm2) and -35 psf (1.68 x 10-3 N/mm2) respectively. Under these loads, 1/4" (6mm) thick annealed or polished plate glass would be overstressed. However, because a large number of the original lites had been observed intact, the 50-year wind event may not have been experienced yet and the replaced lites may represent statistical breakage pattern at a lower pressure. A comprehensive record of historical glass breakage was not available, but anecdotal evidence shows reports of periodic breakage during extreme weather events, the most recent of which was Hurricane Irene in 2011. Where replacement glass was visible, two narrower lites had been installed by adding an intermediate vertical mullion- this deviated from Kahn's original intent.

From a performance standpoint, the original glass was uncoated and provided little thermal benefit.

Figure 5 Exploded diagram showing the three main glass types and their assembly methodology.

Vision Glass: Remediation. The original monolithic glass was replaced with a laminated lite of twice the nominal thickness. The replacement glass addresses concerns of the glass being overstressed in a wind event. Various treatments to optimize the potential performance of the replacement glazing were considered:

Option V1: High-performance low-E coating on the #2 or #3 surface of the laminated replacement lite. Option V2: High-performance pyrolytic low-E coating on the #4 surface of the laminated replacement lite. Option V3: High-performance XIR film integrated into the PVB interlayer of the laminated replacement lite.

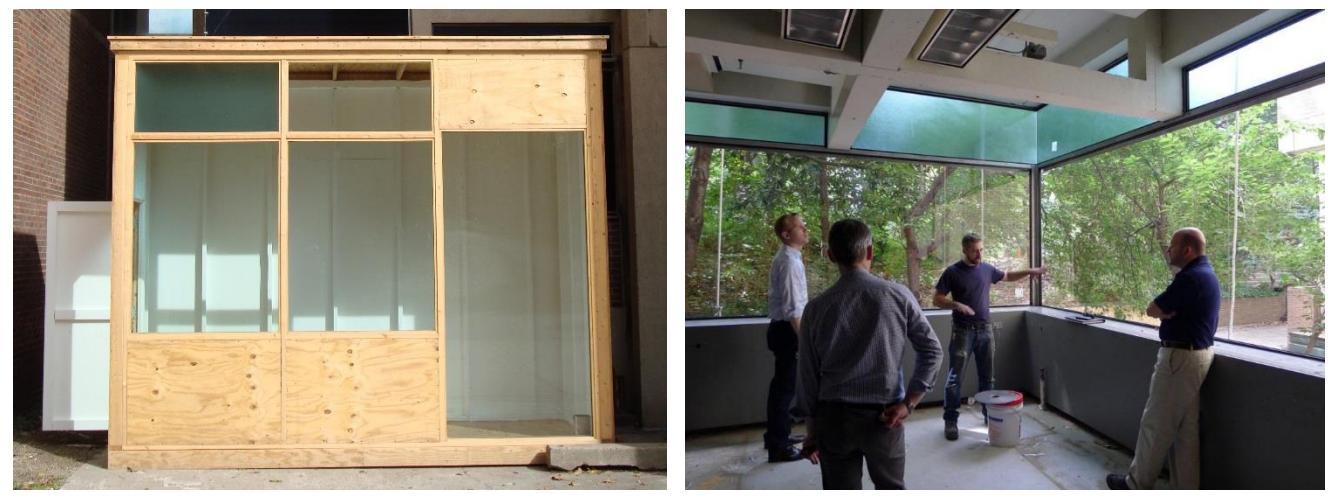
Figures 6 & 7 Visual Mock-up for review of replacement glass options; selected options installed on in-situ mock-up.

Full size mock-ups were constructed on-site (Figs. 6&7) and reviewed by the design team and the University to ensure that the character of the original glazing was maintained. The low-E coatings were favorable due to their neutrality and the minimal workmanship concerns – the inclusion of an XIR film in the laminate exhibited the tendency to "orange peel" during production, and the elimination of this effect could not be guaranteed by the manufacturer. Comparing color neutrality with the existing uncoated glass was also of particular importance. Ultimately, the first option (V1) was selected, utilizing coated heat strengthened substrates of both clear and low iron composition:

W-1 Replacement Glass ¹/₄" (6mm) Clear Heat Strengthened Glass with VE-85 coating on the #2 Surface 0.060" (1.5mm) Clear Polyvinyl butyral (PVB) interlayer ¹/₄" (6mm) Low Iron Heat Strengthened Glass

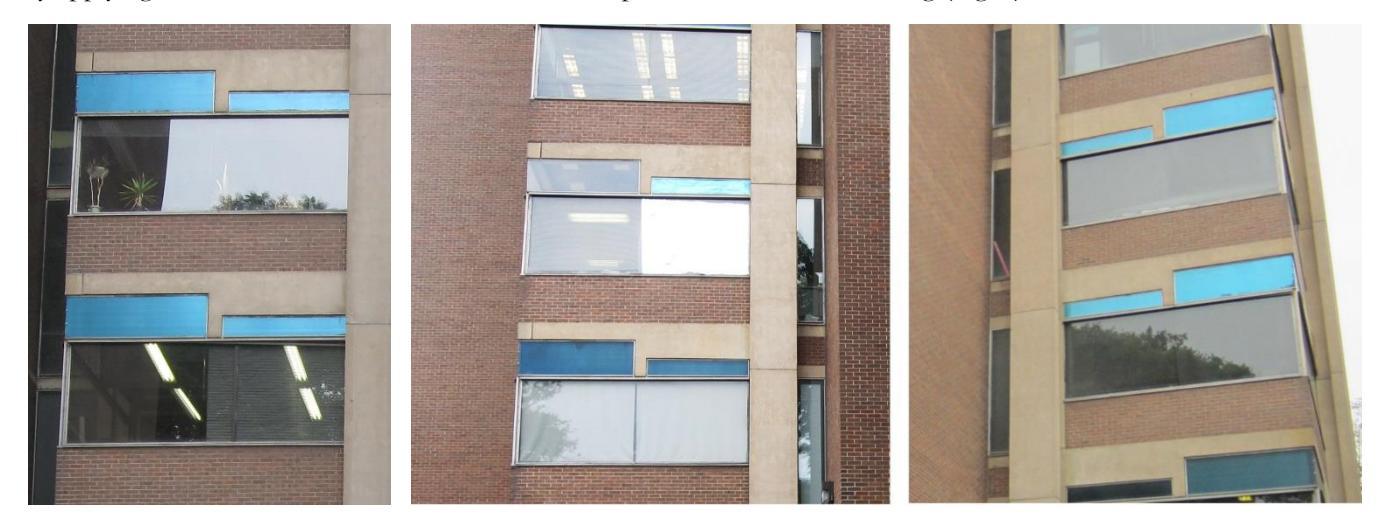
Clerestory Glass: Investigation and Analysis. The clerestory glass set above the W-1 units consist of two types (W-2 & W-3) and two finishes based on location. Clear vision glass was installed at all locations on the North elevation. On the South, East, and West elevations, Kahn used a textured, blue-tinted, cast glass ostensibly to cut down on solar heat gain and address user comfort. Though a canny design decision, in the absence of the fixed external shades originally designed, the glass alone did not provide enough solar heat reduction. Over the years, the users responded by applying various foils and films in an effort to keep the labs from overheating (Fig. 8).

Figure 8 Over time, laboratory users applied various foils and shades to minimize solar heat gain.

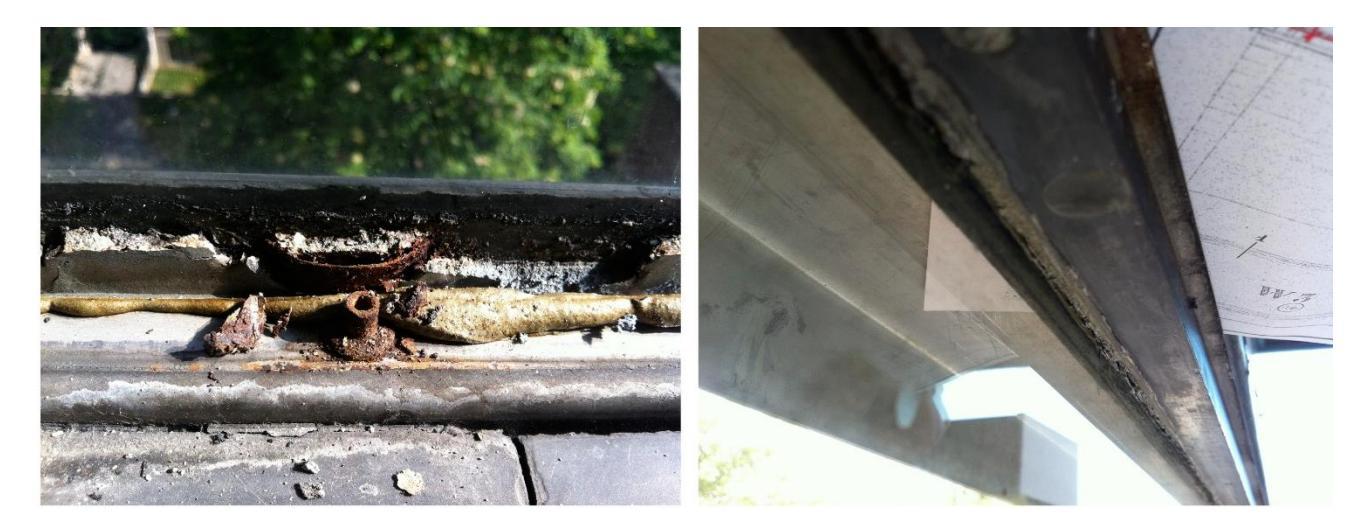
Seals and Accessories: Investigation and Analysis. The specification for the original glazing putty stipulated "Elastic Glazing compound Federal Spec TT-P-781a, Type 1. Probes were conducted to remove representative samples of existing glazing putty and fibrous backer materials for asbestos abatement testing. The materials tested negatively for asbestos, but had either cracked, reacted negatively with remedial over-seals, or deteriorated completely leaving large holes in the primary air seal of the façade system.

Other gaps in the air seal were present between joints in the welded unit frames allowing air and moisture to migrate through the frames at the perimeter of the glass. At the interior, extruded aluminum glass stops were held in place by a carbon steel threaded receiver welded to the frame and secured into the receiver with stainless steel fasteners. Whether by condensation, water infiltration, or both, the carbon steel receivers were found to be uniformly corroded and in need of removal or replacement. (Fig. 9)

Figure 9 Condition of existing frame assemblies and materials; corroded glazing bead receiver, metal shim, and gap in metal-to-metal frame connections.

Seals and Accessories: Remediation. Coupled with the poor condition of the original components, increasing the thickness of the glass necessitated a reconsideration of the glass stop attachment strategy:

- Option GS1: Two-part extruded aluminum glass stop with snap attachments. Mock screw heads installed in the snap trim to mimic the existing condition.
- Option GS2: Single aluminum extrusion structurally silicone glazed to the replacement glass and affixed with "Very High Bond" (VHB) tape to the existing frame.

Reviewing the options, it was apparent that a mechanical attachment was no longer possible without encroaching on the character and appearance of the original frame. Furthermore, the extremely small dimensions of the area (approximately 5/8" (16mm) x 7/8" (22mm)) would make installing a two-part stop with any level of precision a difficult if not impossible process. Option GS2 was selected with the qualification that structural testing be included as a "proof-of-concept" that the silicone and VHB tape could adequately support the glass under wind loads.

Addressing the existing issues with air and water infiltration, a heel bead of sealant was provided to act as the primary air seal at the perimeter of the laminated replacement glass. The existing inconsistencies in the frame welds allow a measure of protection from liquid water and pressure-equalize the glazing cavity to the exterior. Finally, the gaps between the connections of individual unit frames were sealed with clear narrow joint sealant to provide continuity with minimal aesthetic impact.

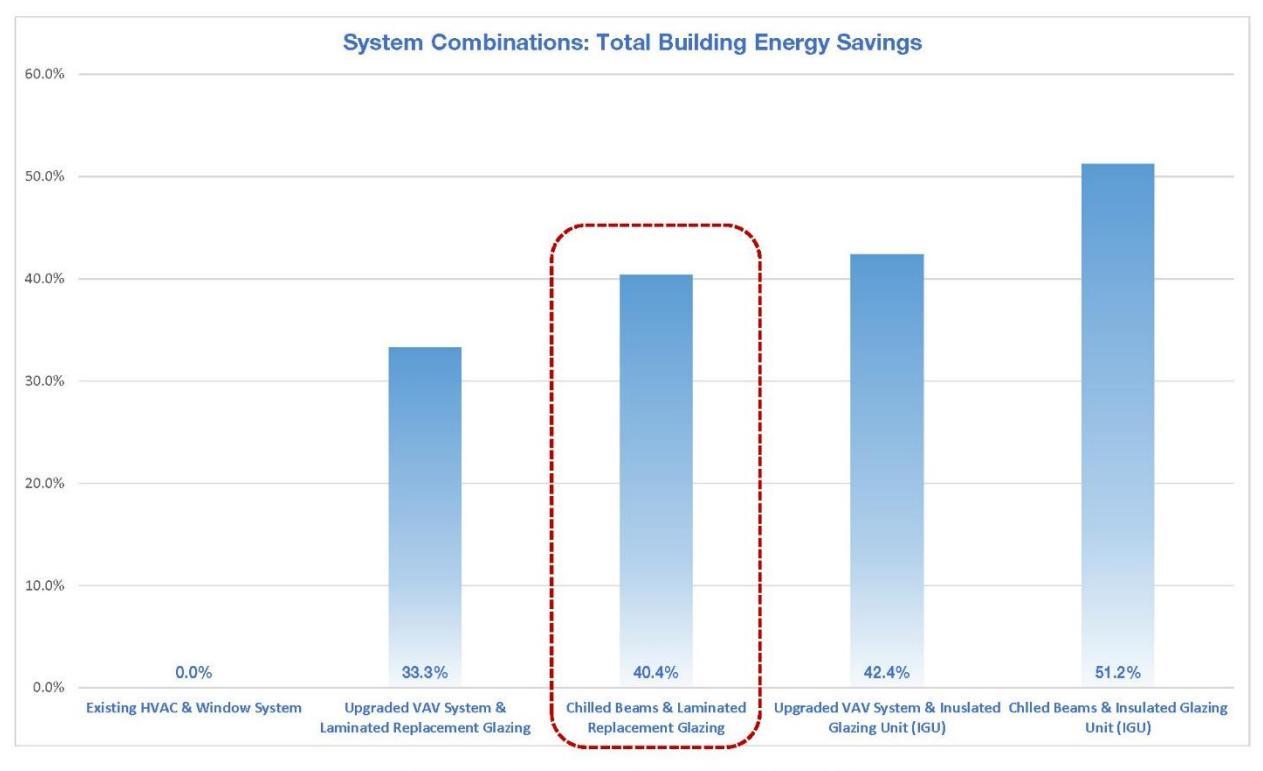
The biggest improvement with the laminated glass replacement option is in lower cooling loads reflecting the improvement in SHGC. Improvement in system U-value is limited when compared to the existing condition because the effective thermal transmission is not reduced to any appreciable degree without the addition of the air space attending use of an IGU. Comparisons were conducted for two domestically supplied coatings which could be fabricated against the interlayer of a laminated lite:

As anticipated, there was parity between the system U-values for each coating. The SHGC of the VLE-70 coating was a 30% improvement over the VE-85, 0.60 vs 0.43 respectively, but was not selected due to the negative visual impact of this coating relative to the appearance of the original glass.

Figure 10 Energy analysis comparing various glass and MEP remediation options.

The stainless steel frames are not thermally broken, so retaining them also meant accepting a higher risk of condensation. At the interior system surface, a dew point temperature of 32° F was determined using preliminary indoor air criteria of 70° F and 25% Relative Humidity. The exterior boundary condition was determined using the 99.6% Heating Dry Bulb and Mean Coincident Wind Speed design conditions for Philadelphia in 2005 ASHRAE Fundamentals. Based on these conditions, condensation would be limited to the stainless steel frame when the temperature drops below 25° F (-4°C). To address these concerns, the original perimeter radiant heating elements were replaced with more efficient and better-located units to increase the surface temperature and convection currents adjacent to the glazing. Taking the façade and MEP upgrades together, an overall energy savings of 40% was achieved when compared to the original existing conditions. (Fig. 10)
