WB4-2: Best Practices® and Quality Issues in Residential Stucco Application

Abstract

Case Study 1: “Monster” Cracks

Case Study 2: Paint Burning

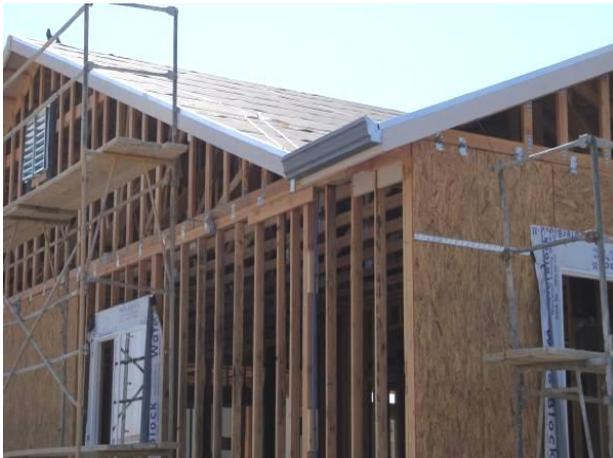
Figure 1: Sheathing only at shear locations

When wood sheathing is installed continuously and fastened correctly, it provides shear strength for the home and creates a good foundation for the stucco. If sheathing is installed only at corners of the building or above and below windows, as seen in **Figure 1**, it creates an uneven surface for applying the stucco. It is difficult to apply stucco at a uniform thickness across an uneven surface. Ideally for a stucco installer, sheathing should be continuous as seen in **Figure 2**. A 1/8" space should be left between the edges of the boards to allow for moisture expansion of the OSB. Sheathing should be the proper moisture content and grade to help prevent unnecessary dimensional changes, possibly leading to cracking.

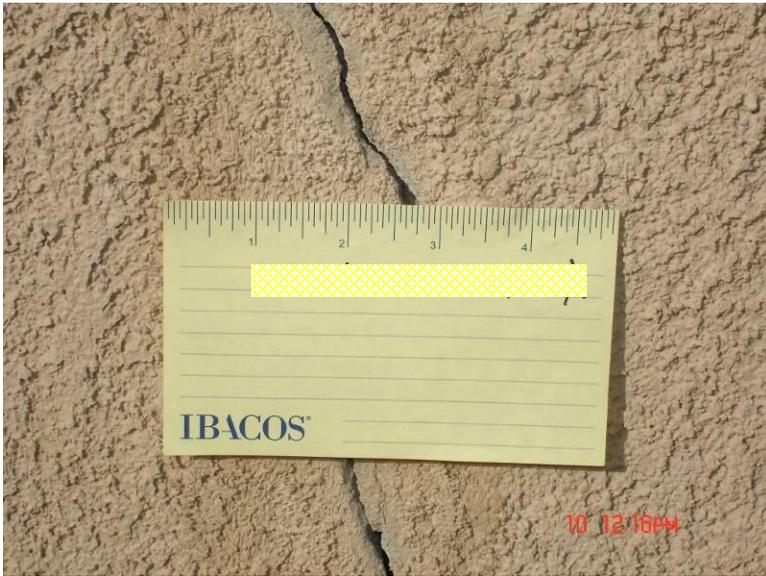
Figure 3: “Monster” crack

In January 2007, at the request of a builder, IBACOS began to investigate what became known as “monster” cracks affecting a number of homes in a large community. These were characterized as cracks in the stucco cladding as large as 0.3 inches and in some cases sheared the metal lath supporting the stucco system. The homes affected were large single story homes that were framed with shear panels only at required locations, as opposed continuous sheathing. IBACOS, with the help of a third party lab began to analyze samples of stucco from these homes in order to determine the cause and origin of the issues.

The fundamental causes of the “monster crack” in **Figure 3** were the fact that the stucco mix had too little sand and the scratch coat was not hydrated enough before the brown coat was applied. The strength of the stucco mix is controlled by the ratio of sand to cement. Lab analysis showed that the scratch coat contained significantly less sand than specified in the Uniform Building Code (UBC) (**Figure 4**), and the amount of sand scarcely met the proper sand-to-cement proportions. In an effort to make the stucco easier to pump for spray application many applicators will alter the proportions of the scratch coat so it is stickier when it hits the wall. These proportions must be carefully controlled to build a stucco system that, when adequately hydrated, will allow each layer of stucco to relieve stresses within the system through a dispersed pattern of small cracks that are developed prior to the application of the next layer of stucco.

1. Plan for control joints at key cross section reductions and a maximum of 144 square feet between joints.
2. Carefully control the amount of sand in each coat. The scratch coat should have less sand than the brown coat. The ratio for the scratch coat should be 2.5 to 4 parts sand for each part cementitious material. The brown coat should be between 3 and 5 parts sand for each part cement (Refer to the mix proportion chart and bag mixing instructions).

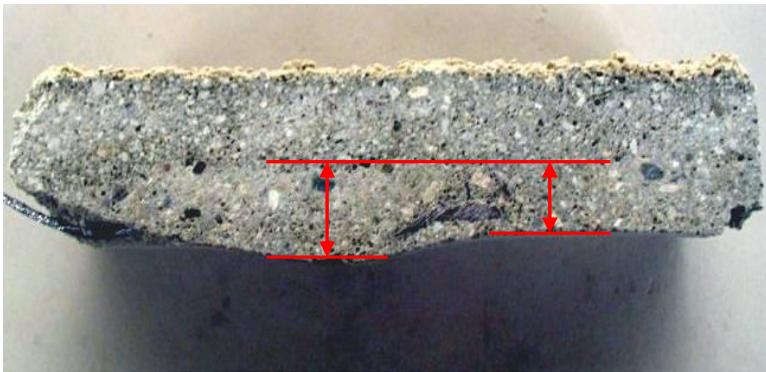
Figure 5: Variable thickness at shear panel locations

The scratch coat in this case study contained less sand than required. This lack of sand made the scratch coat stronger, forcing cracks to occur farther apart. Even a properly mixed brown coat would not have been able to overcome the excessive shrinkage that resulted from an incompletely hydrated scratch coat. However, the brown coat contained even less sand than the scratch coat. Also, since the scratch coat was not adequately hydrated before the application of the brown coat, the two layers acted together. When layers act together, it is as if the stucco thickness has doubled and even almost tripled, since the brown coat does not encase any lath. Therefore, the stresses are increased threefold, causing the distance between cracks to increase as well. Since stresses are not released within the system through a series of small cracks, the stucco stores the energy until the forces exceed the tensile quality of the lath-cement combination. This excessive force occurs at locations where the cross section of the stucco is reduced, such as at a window. The presence of a window in a large uninterrupted field of stucco reduces the cross section of the stucco to one half. The cross section is also reduced when the back sheathing layer changes thickness (**Figure 5**), which is why cracks also frequently show up along the edge of an underlying shear panel.

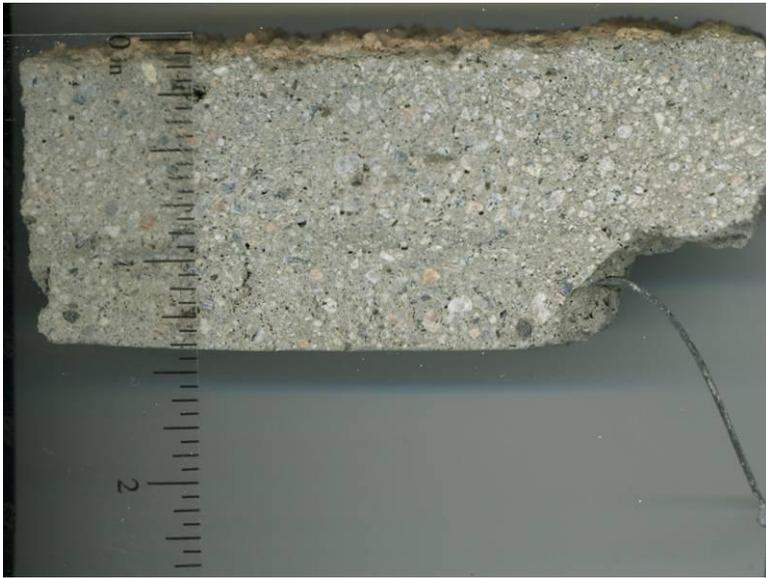
Figure 6: Disproportionately thick brown coat

Also worth noting is that based on samples taken from the damaged homes, the scratch coat was intermittently applied too thin and its thickness varied from completely absent to more than 3/8". When a brown coat is applied to a scratch coat that is in this state, the stresses now develop in a thickened brown coat. All of the stresses from hydration are being driven by a single hydration event, rather than two separate ones. The strength of this combined coat forces large cracks to occur that are concentrated at the cross section reductions (**Figure 6**).

4. Control water-to-cement ratios to minimize dewatering stresses.
5. Apply a uniform 3/8" scratch coat, making sure that the lath is embedded in it and that there is a uniform base for the brown coat. The physical character of the scratches or trowel marks serves as keys for the brown coat to adhere to.

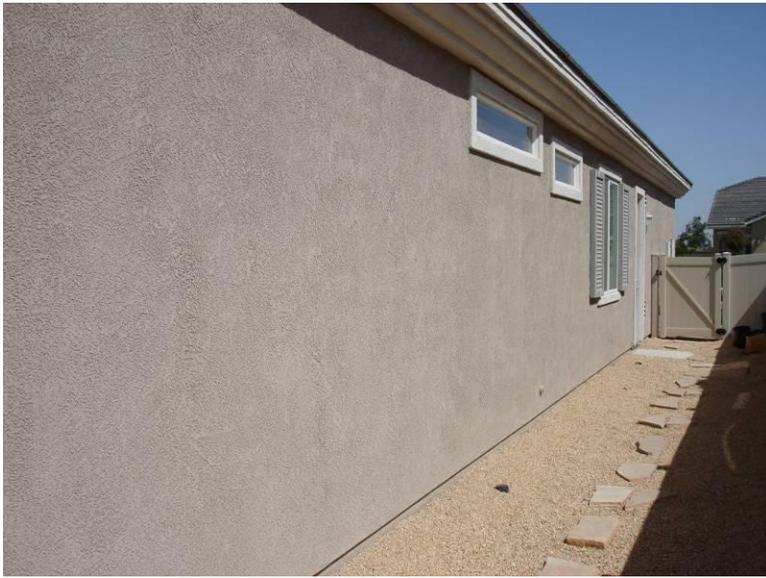
Figure 7: Wall area that required control joints

In some cases, homeowners reported hearing the metal lath snap as the stucco cracked. The breaking of the lath, while unusual, was consistent with the fact that there was very strong stucco on the side walls where there are no other areas with a reduced cross section, forcing the stresses to concentrate. In these areas of extreme stress, IBACOS recommended a repair which included control joints (**Figure 7**). For the repair of small cracks (1/16” or less) sealing with an elastomeric latex sealant is recommended. Following the required drying period a fog coat of paint can be applied to blend with the existing coat. The builder may have to consider fog coating the entire elevation in order to achieve a uniform color.

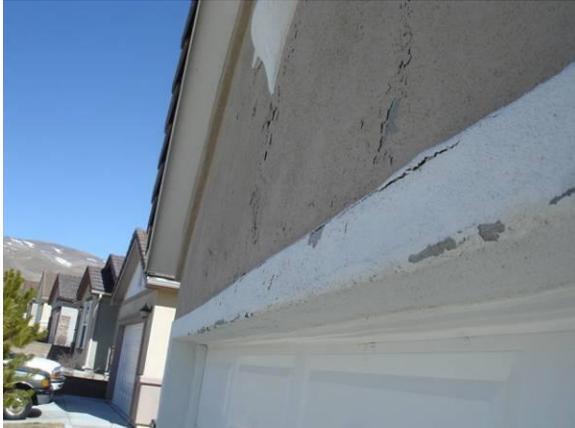
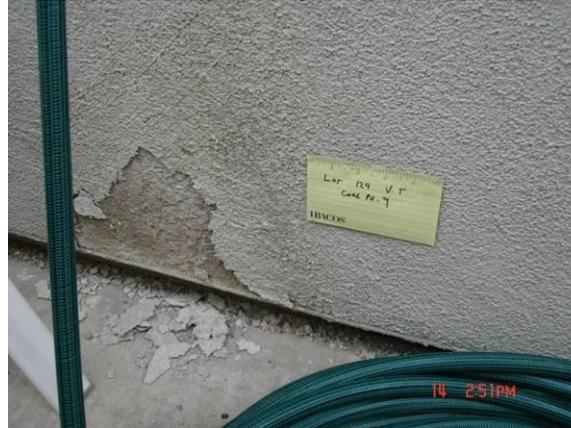
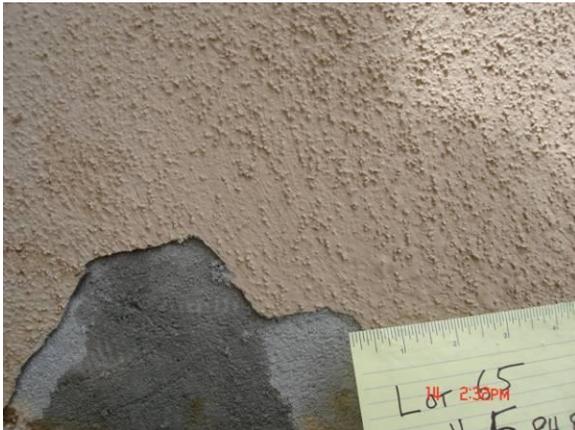
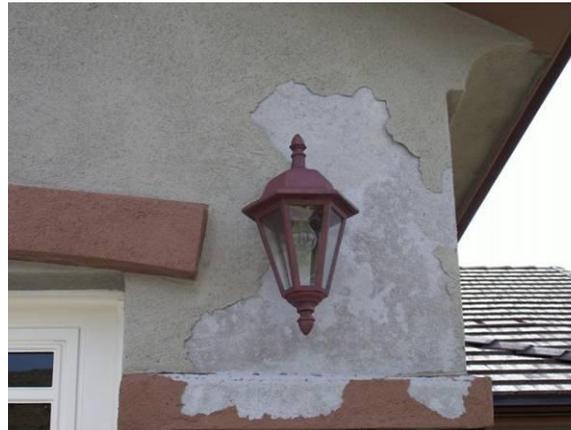
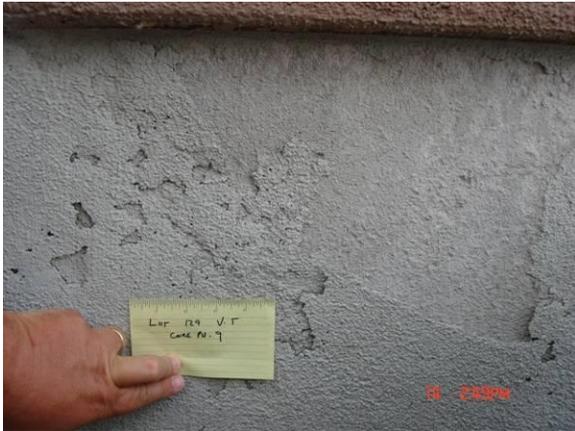
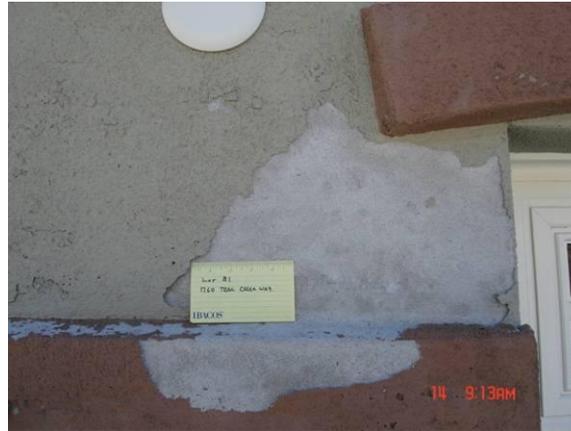
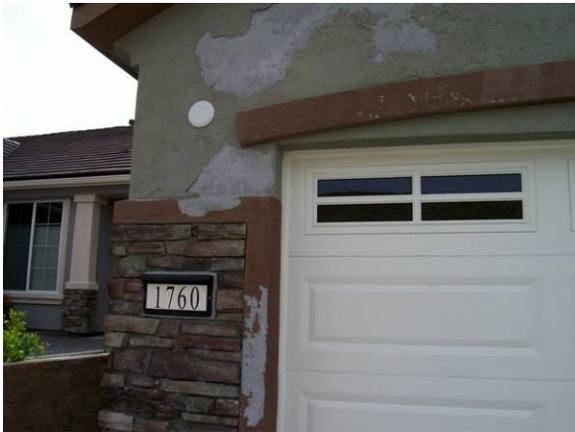
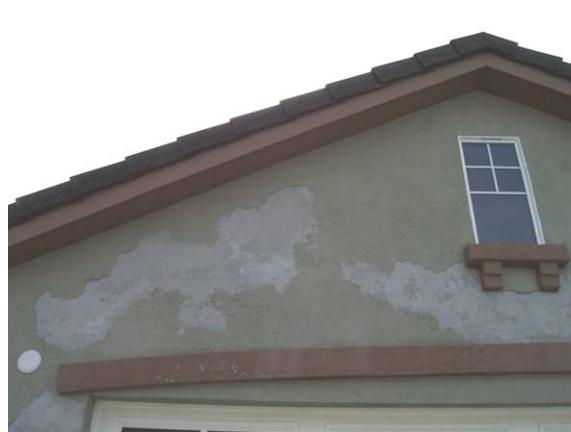
Insufficient priming and painting is what led to the accelerated manifestation of the durability issues on the surface. While these issues were inevitable due to the stucco's quality, there is evidence that shows the homes were not primed and painted according to specifications. Specifications required the painter to apply the primer at a 5 mil wet thickness in order to dry to a 2

Figures 8 through 15 that follow represent the typical paint and stucco durability issues confronted in the community. Notice the delamination of the paint and finish coat. The stucco base coat below was very sandy and weak to the touch.

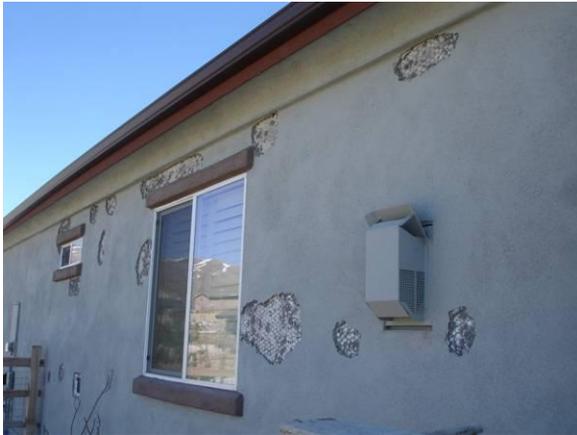
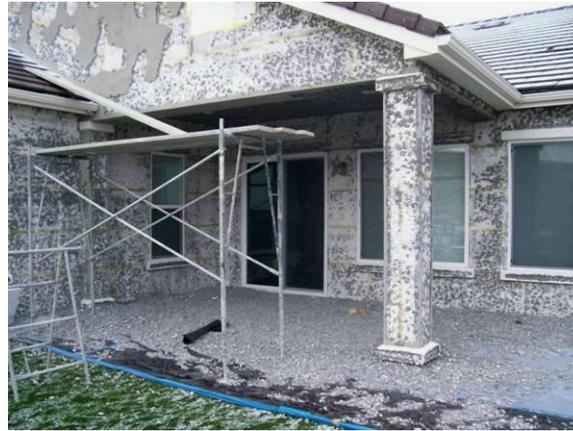
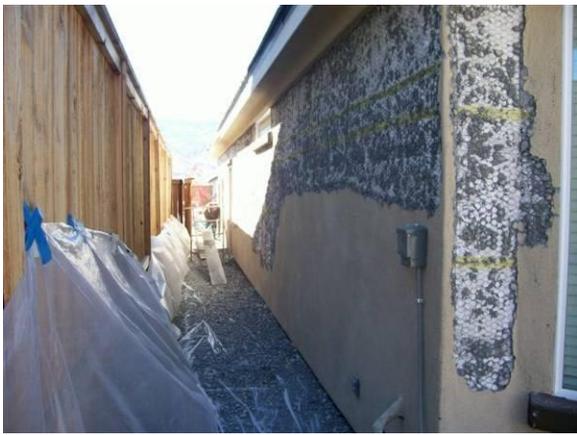
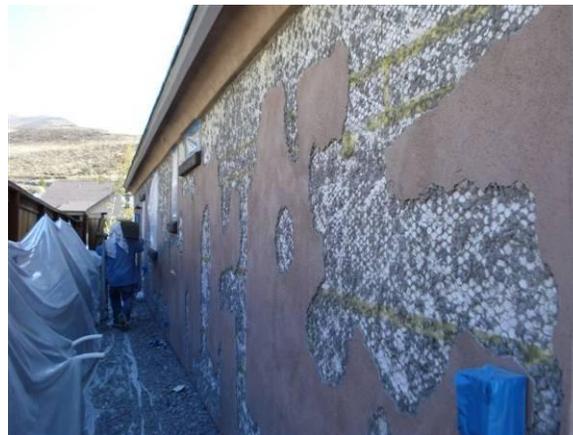
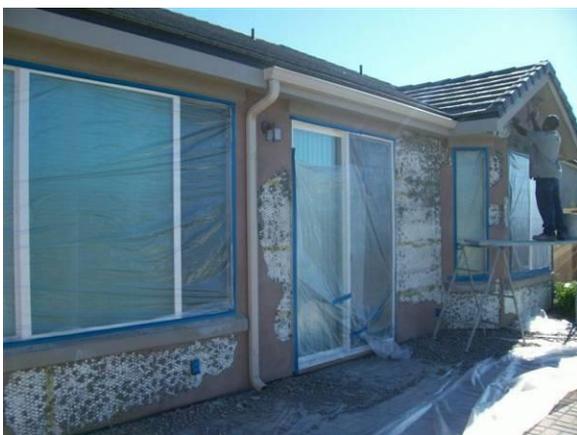
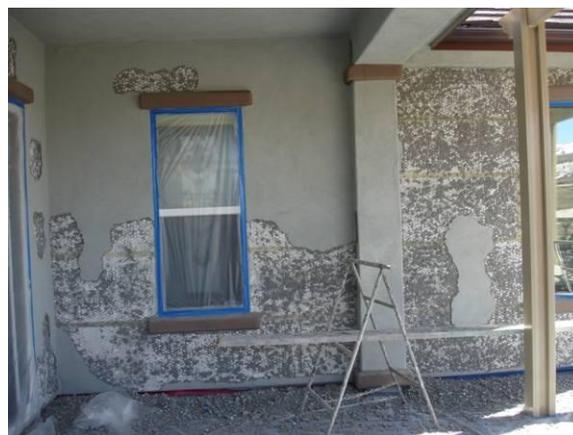
In addition, various homes in the community underwent a repair protocol that involved “sounding.” Sounding is a test that checks for weak stucco that pulls away from the wall and leaves voids and pockets behind. Following a power wash at 2000 psi to identify areas susceptible to failure; sounding was conducted by hammering on the stucco in areas that were weak or deteriorated. Weak areas fractured into sandy chips and were removed. The varying extent to which the stucco was found to be weak is illustrated in **Figures 16 through 21**. Areas that resisted the impact of the hammer were judged as adequate in strength.

The paint burning can also be tied to low strength of the stucco. In IBACOS’ opinion, low strength stucco is the result of an excessively sandy mix and too little hydration. Hydration is required to properly cure stucco and lower its pH level. This conclusion is supported by lab results that showed the stucco had an excess of un-hydrated cement particles. Following hydration, cement particles act to bind the stucco together as a system. Hydration immediately after placement is critical to the long-term durability of a stucco system. Also noted in lab testing was a moderately high to excessive sand-to-cement ratio. The specification of this ratio is set by ASTM standard C 926 and should not to exceed 4:1. Tests of certain samples found the ratio to be as high as 5.3:1.
