Journal of Hazard Mitigation and Risk Assessment

Spring 2011

Lessons Learned from Recent Damaging Earthquakes

By William T. Holmes

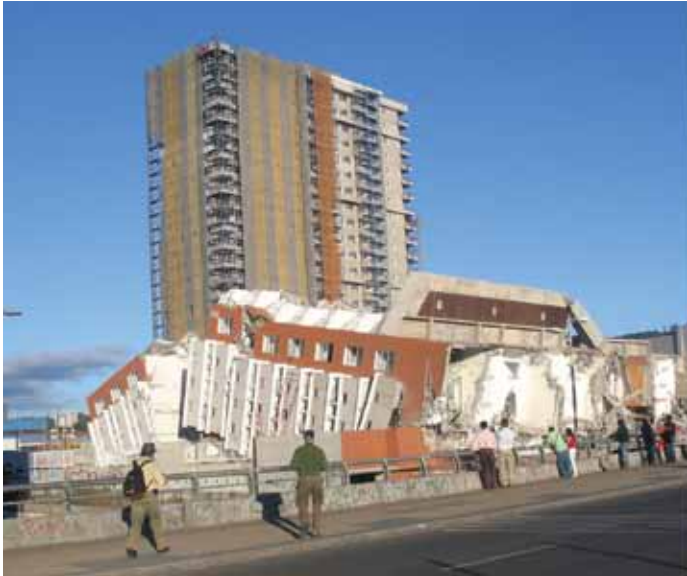
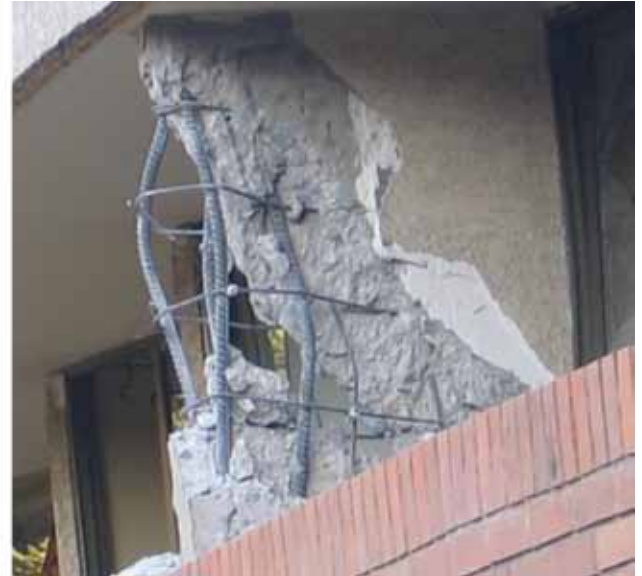
Figure 2. (Left) A toppled building in Concepcion, Chile. This failure is clearly unacceptable performance. But is the damage shown in the image on the right acceptable? It did not cause a collapse but the building is possibly unrepairable.

However, marginally or completely irreparable damage to a few of these buildings highlighted the issue of identifying acceptable damage from rare events (FIGURE 2). Codes in the United States are primarily intended to protect life safety in rare events with no specific goal related to control of damage or economic loss. Is this life safety goal acceptable or is the public expecting low economic loss as well? Except in special cases of buildings with occupancies critical to the public or to the building owner, it is probably not cost-effective to provide seismic protection to achieve low economic losses for rare events. A concise definition of the expected performance of buildings designed to meet U.S. seismic code requirements has been difficult to define due to the large number of building types used and the wide range of potential earthquake

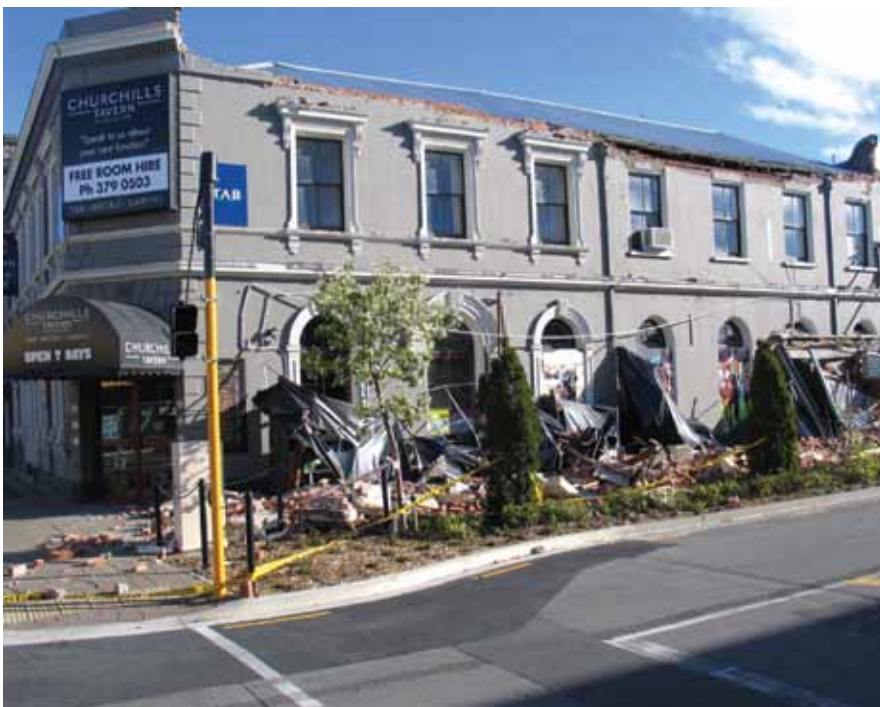
Figure 3. A portion of this unreinforced masonry wall in Christchurch, New Zealand fell onto an outdoor café. Fortunately, no one was there. The U. S. has many buildings like this.

First, older and unreinforced masonry buildings, very much like many older U.S. buildings, are extremely vulnerable to damage, even in moderate shaking. The exterior walls of these buildings tend to fall away from the floors and roofs onto adjacent streets, sidewalks and buildings, creating severe life safety risks. No one was killed

in this event because it occurred at 3:30 a.m., when no one was on the streets or sidewalks or in commercial buildings. Dozens of life threatening situations were noted and one significant injury was reported—from a masonry chimney falling into a residence (FIGURE 3). Many areas of high and moderate seismicity in the United States should study ways to reduce the hazard from this building type.

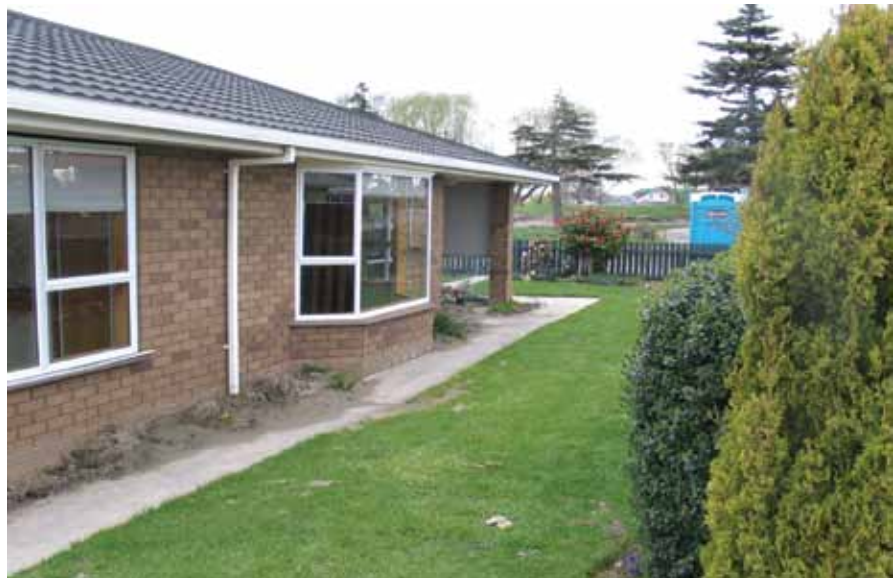
Figure 4. Subtle but expensive damage from liquefaction in Christchurch, New Zealand. The house, relatively undamaged, has settled about eight inches, which will cause storm drainage from the entire lot to run to the house. Regrading the lot is not always an option due to the adjacent street elevations.

The second vulnerability highlighted in New Zealand is the potential economic loss caused by liquefaction and other soil failures related to earthquake shaking (FIGURE 4). Liquefaction occurs when certain water saturated sands “liquefy” during shaking. Buildings, bridges, pipelines and other infrastructure supported on such materials may move downwards (sinking into the liquefied soil), upwards (floating on the liquefied soil) or slide sideways (when near a slope). The movement normally causes damage to the structure and often creates secondary problems. For example, if a house sinks 6 inches (15 cm) or more into the ground, surface water that originally ran away from the building will now flow into the building. Similarly, gravity flow sewers or storm drains may flow the wrong way or have high points that prevent normal drainage.
