DOCKING STATE OFFICE BUILDING: REVISITING THE ENERGY PERFORMANCE OF THE MODERN GLASS TOWER

ABSTRACT: The Docking State Office Building, a 12-story state office building immediately adjacent to the historic capitol building in Topeka, Kansas, was completed in 1957 as one of the region's earliest examples of tall, curtain wall glazed modern architecture. The Docking's glass curtain wall was innovative for its time, and the design exhibits an elegant composition of stone planes and glazed skin.

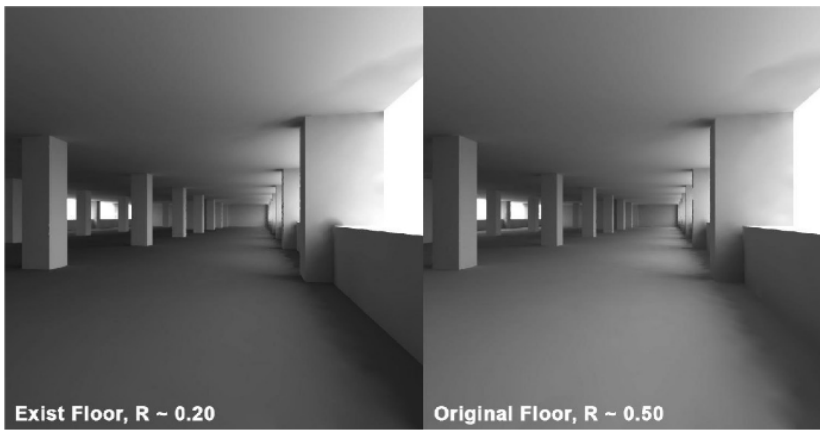
Figure 6: RADIANCE visualizations in a typical floor, without blinds. The image at left shows the existing floor, a dark carpet; the image at right shows a more reflective floor like that originally used in the building. The sky condition for the simulation was overcast. (Source: Author)

Early daylighting design principles borrowed from Europe didn't consider direct sunlight. In cloudy sky conditions, the illumination in the Docking is evenly distributed, though relatively low: an average of 38.3 lux across the daylight zone, and 10.3% of the floor area within the useful range of 75 and 150 lux (Fig. 5). If the floor's reflectance is changed to 0.50 (versus the estimated 0.20 reflectance of dark carpet) much more daylight reaches the interior: an average of 88.1 lux is achieved, 33.5% of the floor area is between 75 and 150 lux, and 18.3% of the floor area reaches the recommended level of 150 lux for ambient office lighting (Fig. 6)

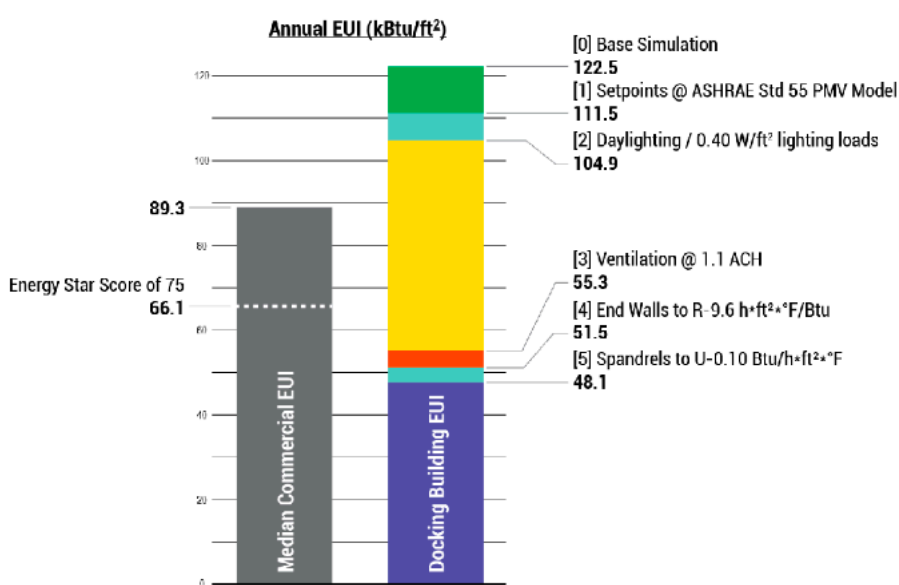
Figure 8: The resulting EUI of from various simulations, compared to median commercial EUI as estimated by Energy Star Target Finder. Simulation 6, using Low-E glass, increased EUI to 52.3 kBtu/ft² thus is not shown. (Source: Author)

At the end of this detailed analysis, it may be argued, with evidence, that the basic architectural premise of the Docking State Office Building is quite sound. More importantly, its innovative curtain wall may be absolved as the source of energy and comfort problems. As results in Figure 8 demonstrate, efficiency gains from reducing lighting loads via daylighting may be greater than adding insulation to the curtain wall. Further, reskinning the building with Low-E glass appears to increase energy usage overall. Rather than an expensive reskinning, the Docking can take advantage of minor modifications (and preservation) to become an impressively efficient, passive office building – matching the performance of more advanced contemporary buildings. It should be no surprise, as the Docking fits the basic recipe for many of today's high performance commercial buildings: a resilient, high mass structure; narrow, open, and daylit floor plates; and appropriate amounts of double-pane glazing. One might contemplate the time and resources spent on new buildings pursuing benchmarks like Energy Star; the Docking offers this possibility for what could be a fraction of the cost.
