# Field Monitoring of Embedded Wood Members in Insulated Masonry Walls in a Cold Climate

Kohta Ueno<sup>1</sup>, Joseph W. Lstiburek, Ph.D., P.Eng.<sup>2</sup>

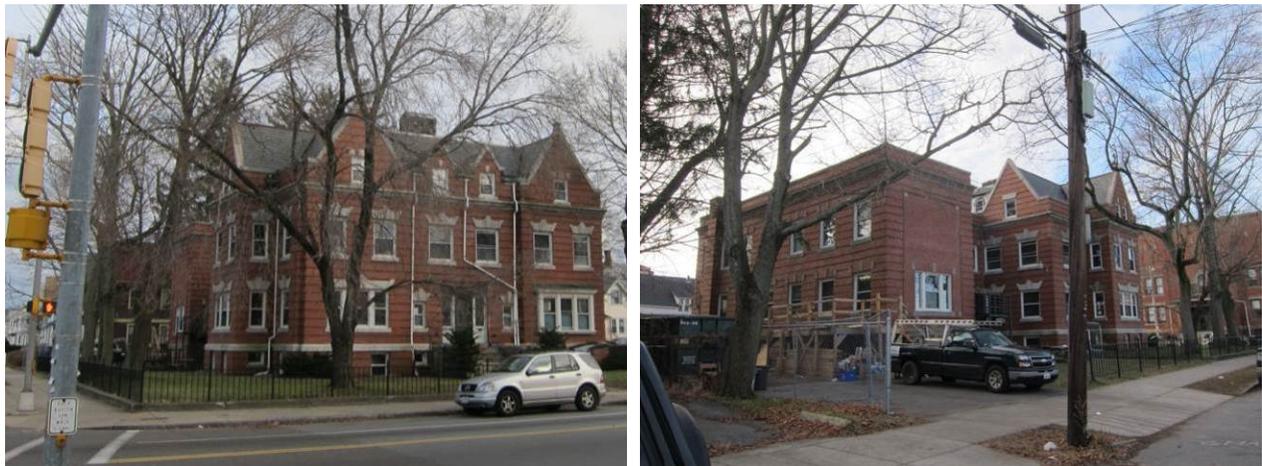
**Figure 1: Mass masonry retrofit building from west /front (left) and northeast (right)**

The field monitoring work was done at an existing brick mass masonry building in Lawrence, MA (DOE Zone 5A), which is being renovated into ten condominium units (Figure 1).

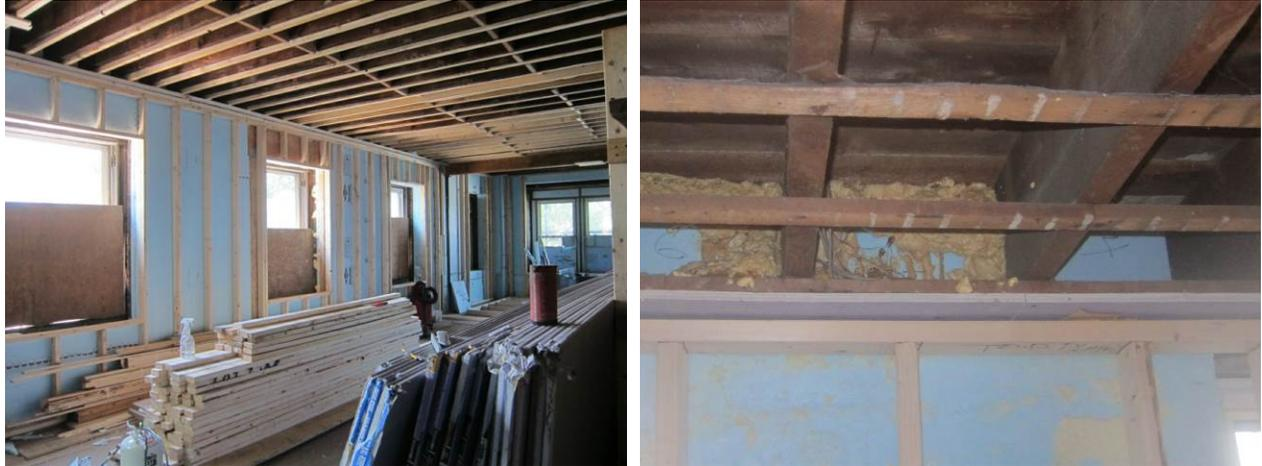
Figure 2: Framing installed inboard of insulation (right); insulation and air seal at joists (right)

cavity is left uninsulated (Figure 2, left).

The embedded floor structure consists of dimension lumber (roughly 2"/50mm thickness) joists at 16"/400 mm on center (as opposed to large, widely-spaced timbers). The joist bays are insulated with scraps of rigid XPS foam insulation, attached with polyurethane adhesive; the perimeter of each block is then air sealed with a spray foam kit (Figure 2 right).

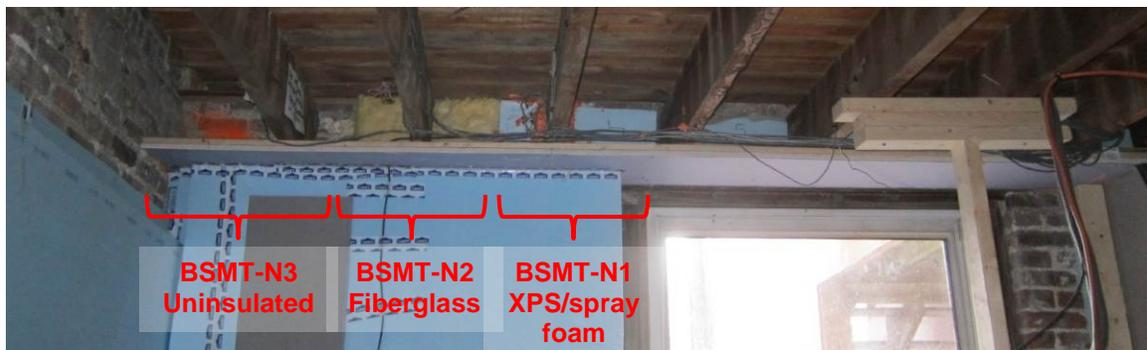
Figure 3: Comparison of insulation strategies for joist ends BSMT-N-1/2/3, pre-drywall

BSMT-N1/N2/N3 are joists with identical exposure, but using different retrofit strategies. BSMT-N1 is insulated as per the remainder of this project (board and spray foam); BSMT-N2 is insulated with air-permeable insulation (R-26 fiberglass), which insulates but allows airflow; BSMT-N3 is left uninsulated (see Figure 3).

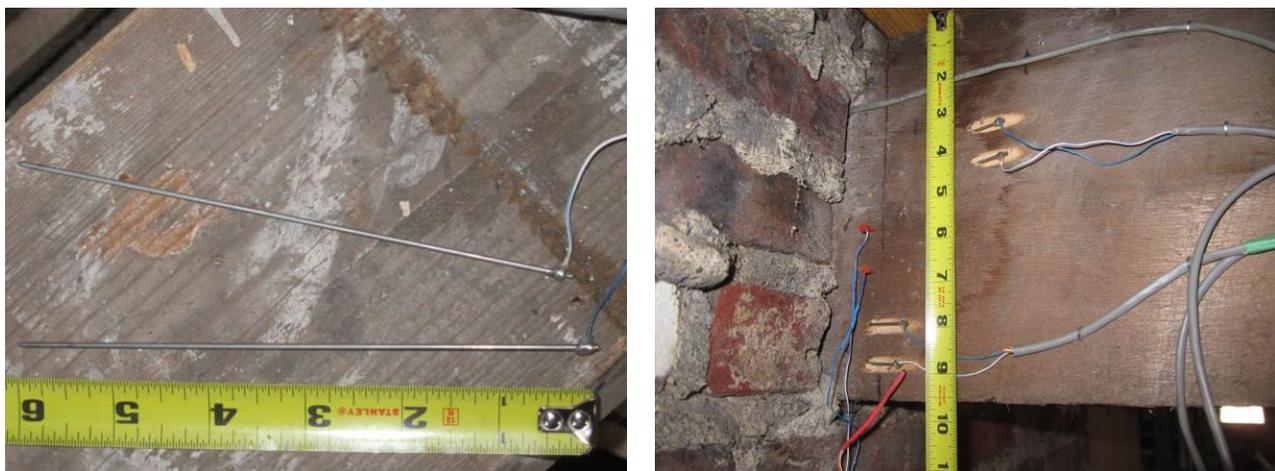
**Figure 7: 6” extended moisture content pins (left) and installed moisture content pins (right)**

The joist ends moisture pins are 6”/150 mm long sharpened stainless steel pins attached to wire

leads, as shown in Figure 7 (left). Pilot holes were drilled at an shallow angle in the beam, using a pocket hole jig; a 1/8"/3 mm diameter hole was then drilled for clearance for the pin, but the joist end was left undisturbed, so that the pin would be driven directly into wood fibers. Figure 7 (right) shows the upper and lower joist end moisture content measurements and the "cheek" moisture content/temperature measurement.
