Inward Vapor Drives in Adhered Veneer Wall Assemblies with Continuous Exterior Insulation

ABSTRACT

EXPERIMENTAL PROGRAM

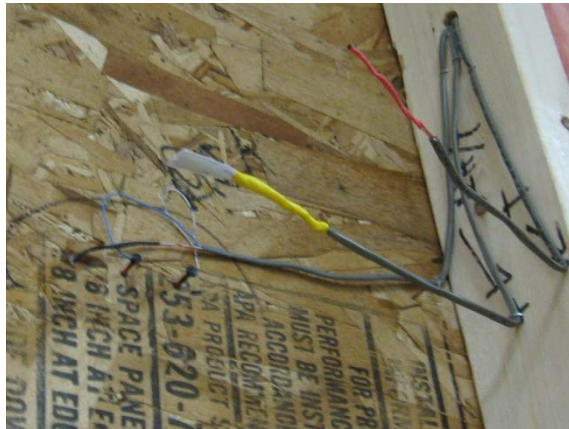
FIGURE 1: Sheathing MC/T and Cavity Space RH at Mid-Depth and Interior Temperature-Only Sensor for Walls 3a and 3b

Each of the test walls was outfitted with a series of temperature, relative humidity (RH), and wood moisture content sensors. These sensors were continuously monitored at given intervals and recorded throughout the testing period using a data acquisition system. Photographs of the individual sensors are shown in Figure 1 and Figure 2.

Wood moisture content sensors were installed in the sheathing of the comparison walls that were constructed with OSB sheathing, and a surrogate wood wafer with moisture content pins was installed directly against the XPS in the exterior-insulated comparison wall. This allows measurement at the same depth through the assembly for wall-to-wall comparison. Where wood-based measurements were recorded, wood moisture contents were determined from the

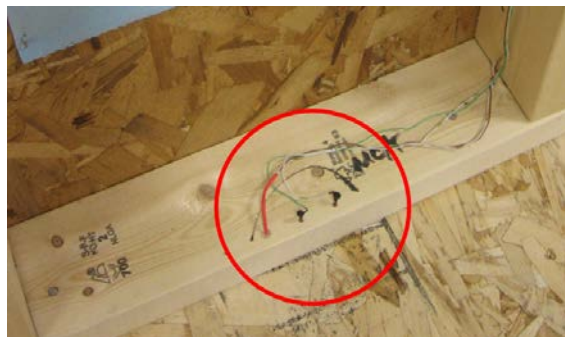
FIGURE 6: Moisture Content Sensor at Interior Edge of Bottom Plate

Previous field testing has confirmed that inward vapor drives can be a durability issue with adhered stone veneers. In these previous tests, moisture accumulation was measured at the interior surface of the stud and the interior edge of the bottom plate. Both of these locations were monitored in the current test as shown in Figure 5 and Figure 6. In Walls 3a and 3b, moisture that is driven in could condense on the interior Class I vapor control layer of polyethylene if there was sufficient vapor. If sufficient condensation occurred in this situation, water would drain to the bottom of the poly where it would accumulate in the bottom plate and cause an increase in measured moisture content.

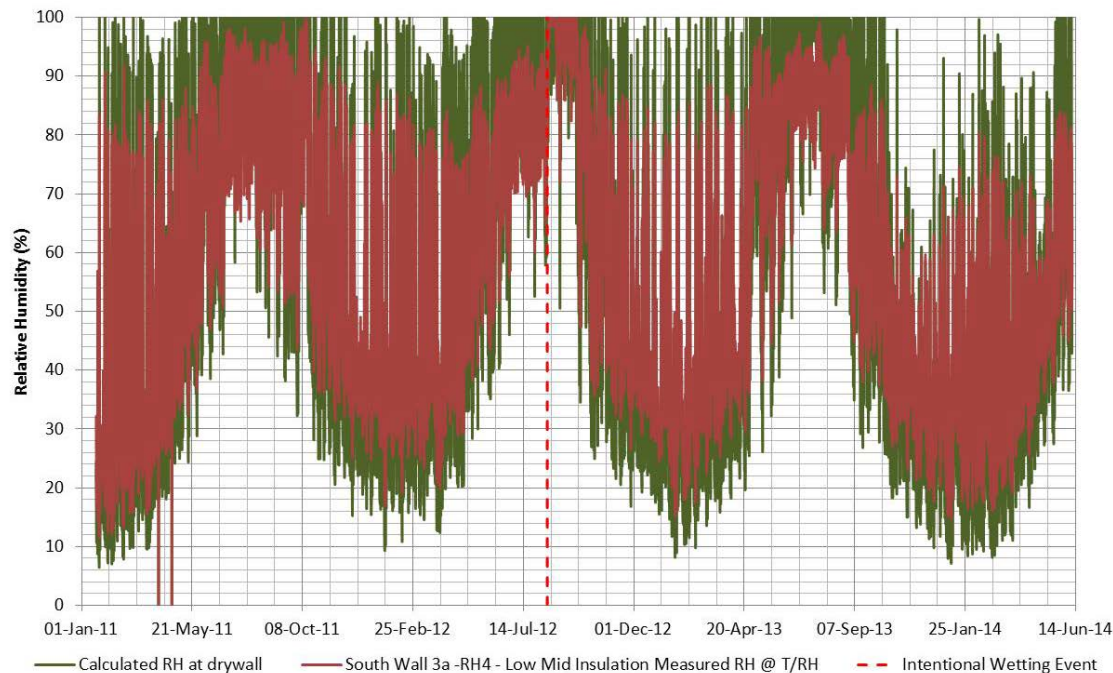
FIGURE 8: Calculated RH at the Exterior Surface of the Drywall Based on Measured RH at Mid-Depth of Stud Cavity

Figure 8 shows a comparison on the South orientation of the measured RH at the mid-depth of the cavity (red line) and the calculated RH at the exterior surface of the drywall (green line). This analysis shows that on the South orientation, there are many hours of calculated condensation at the exterior surface of the drywall/poly often without periods of lower RH in between. It can be assumed that the relative humidity will increase at the drywall/poly in each comparison wall. In the winter months, when the drywall is the warmer side of the enclosure, the calculated relative humidity at the drywall is lower than the relative humidity at the mid-depth as expected.

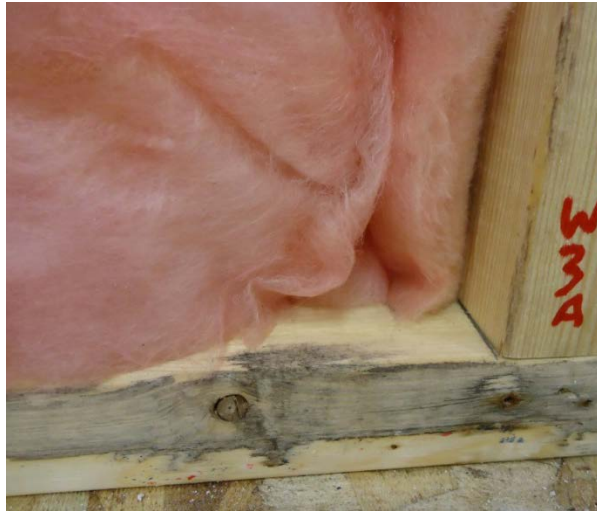
FIGURE 10: West Wall 3A Bottom Plate.
Note: Staining is visible on the interior surface of the bottom plate where water has drained down the poly and become trapped at the bottom between the taped edge of the poly and the wood. This was the worst observed staining of all poly walls. Some staining is also evident on the side of the vertical stud at the interior edge.

In August of 2013, the three comparison walls were opened on all four orientations to visually inspect the interior of the walls. Testing began in January of 2011, so the walls were opened during their third summer. All of the moisture related damage (i.e. staining, mold) was a result of only two and a half years of exposure. Most of the walls with poly (3A and 3B on all four orientations) had condensation present during the inspection. Nearly all of the 3A and 3B walls had some degree of staining on the bottom plate as a result of moisture accumulation from run down. The West walls had the greatest staining of all four orientations. North 3A and North 3B were the most pristine of all the poly walls as a result of having the least solar exposure and minimal inward solar drives. Wall 3C with continuous exterior insulation and latex paint vapor control on all orientations showed no evidence of moisture accumulation or staining. The following three photos show examples of the condensation and staining observed during the August 2013 investigation.

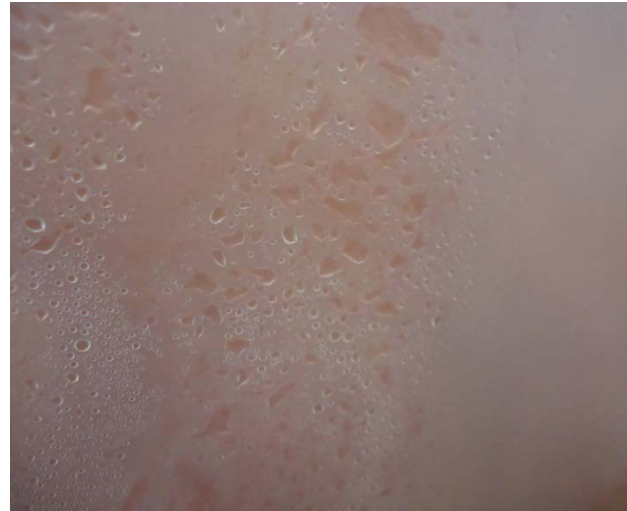
FIGURE 11: West Wall 3B Poly.
Note: There was sufficient condensation on the poly to accumulate into large, easily visible drops. When there is sufficient accumulation, it will drain to the bottom plate, and wet the insulation in the cavity. In some of the poly walls, there was only a little condensation, which had not yet formed large droplets.

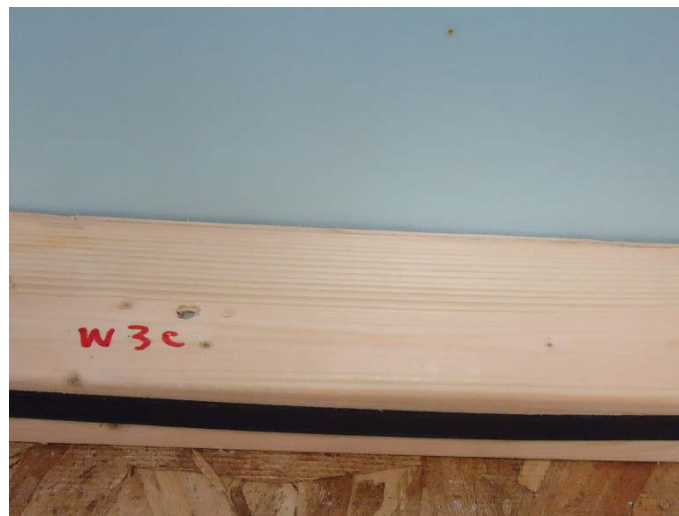
FIGURE 12: West Wall 3C Bottom Plate and XPS.
Note: There is no staining on the top or inside edge of the bottom plate, or on the surface of the XPS. There is no corrosion of the fastener in the bottom plate.
