Fire Hazards of Exterior Wall Assemblies Containing Combustible Components

Amanda Kimball¹

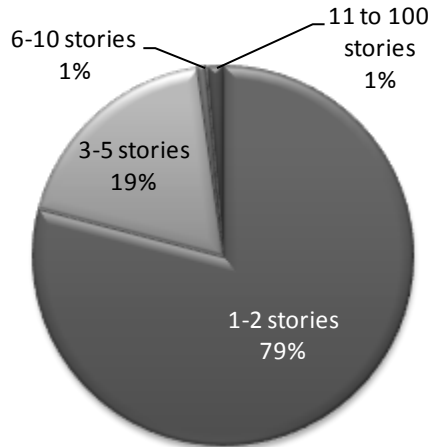
Exterior wall fires - all building types considered

Fig. 1 – Percentage of exterior wall fires by building height (White and Delichatsios 2014)

started on the exterior wall surface, 32% were where the item first ignited was exterior wall covering, and 26% were where the item contributing most to fire spread was an exterior wall. It should be noted that the specific construction of the exterior wall cannot be ascertained from the NFIRS data and this presents a more general view of fires involving exterior walls. Most exterior wall fires occur in low rise buildings, which is shown on Figure 1.

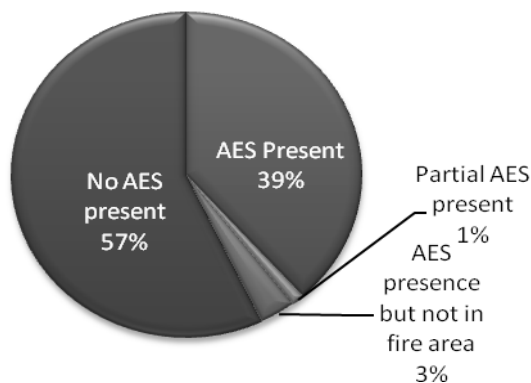
Exterior wall fires in buildings 6-10 stories

Fig. 2 – Percentage of exterior wall fires by presence of automatic extinguishing systems (AES) in buildings 6-10 stories (White and Delichatsios 2014)

The percentage of exterior wall fires occurring in buildings with installed sprinkler systems ranges from 15% to 39% of the building height groups considered (1-2 stories, 3-5 stories, 6-10 stories, and 11-100 stories). This indicates that while automatic sprinklers provide protection, there are still a significant number of fires occurring in protected buildings. The highest percentage of fires occurring in protected buildings 6-10 stories as shown in Figure 2.
