Thermal Bridging: Observed Impacts and Proposed Improvement for Common Conditions

Andrea Love¹, Charles Klee²

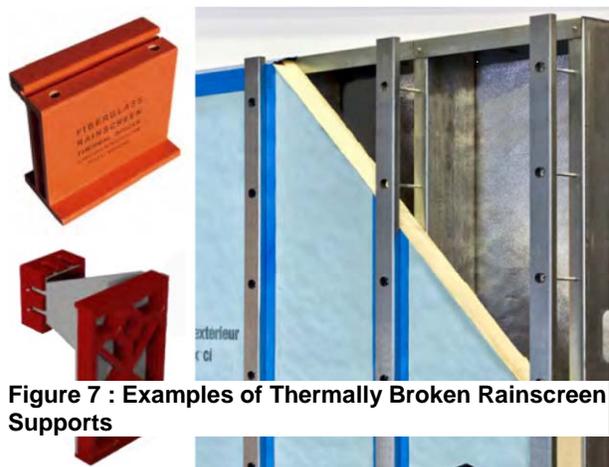
Figure 7 : Examples of Thermally Broken Rainscreen Supports

A number of thermally broken Z-girt and rainscreen support systems currently exist on the market. As part of the research project, the team explored three of the thermally-broken options available. The first removed the support through the insulation with horizontal and vertical tube supports on the exterior and allowed only the stainless steel bolts to penetrate the insulation. The second system investigated a fiber glass clip system. This has the benefit of being intermittent, similar to the previous clip, but also uses a material that is more than 200 times less conductive than steel. The third system investigated was a discontinuous steel bracket with isolator pads on both the warm and cold side of the insulation, in order to minimize heat flow through the brackets. All three of the tested systems performed well. In general the R-value of the assemblies was only reduced by 10-15% due to thermal bridging through their support systems so that they achieved a minimum of $R_{SI}-3.5$ ($R_{IP}-20$) with four inches of insulation.

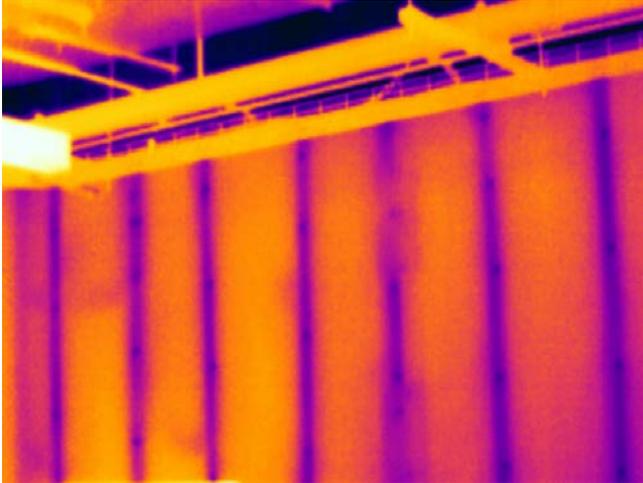
Figure 12 : Infrared image showing studs attached directly to exterior masonry wall

Spray applied insulation is once again gaining popularity, particularly because of its ability to fill unseen voids and provide an integral vapor barrier. In the northeast, it is a particularly popular technology for renovating existing, uninsulated masonry and cast in place concrete facades. Conventional details often call for metal studs to support interior gypsum board and these studs live in the same space as the insulation, creating discontinuities at 400 and 600 mm (16 and 24 in.) on center spacing. While the web of the steel studs is quite slender, they are highly effective heat transfer devices because of the conductivity of the material and the flanges, which provide significant contact area to collect and disperse heat.

Thermal images of the renovation of three separate existing buildings revealed dramatically different results. The first case, had applied 76 mm (3 in) of insulation, the second employed just 51 mm (2 in.) of insulation, and third used 88 mm (3.5 in.). While hand calculations of the thermal resistance would show the façade with the least insulation to be the weakest performer and the one with the most insulation to be the best, the thermal images revealed a different story. The 76 mm (3 in) of insulation included steel studs flush against the exterior construction, resulting in an R-value that was 55% less than the calculated R-value. The second building pulled the studs back by 25 mm (1 in.), allowing for half of the applied insulation to be

continuous which resulted in decreasing the R-value by only 15%. Consequently, that façade was observed to have a higher R-value than one with the studs penetration through to the exterior, despite having less insulation. The third façade took the studs back even farther, completely separating them from the insulation and as a result the simulated R-value was nearly identical to the measured values.
