EE4-2 BUILDING ENVELOPE FAILURE CASE STUDIES IN HIGH-RISE CONSTRUCTION

Pierre-Michel Busque, P.Eng.¹

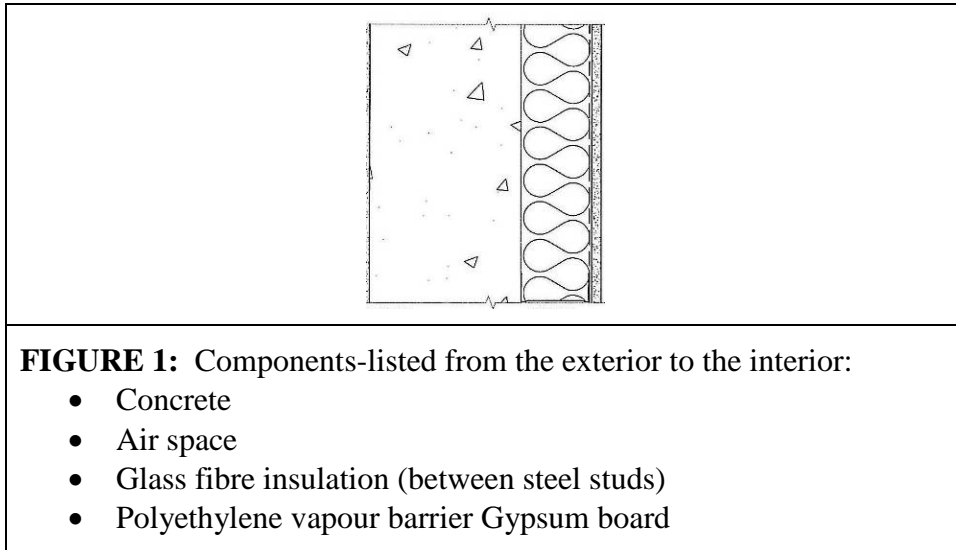
The traditional cast in place concrete wall assembly is shown below.

This building assembly contains planes of low vapour permeance on the interior side and on the exterior faces of the wall. As moisture is released from the concrete on the interior side of the wall, the polyethylene will impede the drying process of the wall due to its low vapour permeance and the steel studs and fiberglass insulation will be subjected to a humid environment for a substantial period of time. If the air temperature inside of the dwelling is below the dew point temperature of the air within the stud cavity, condensation will form on the polyethylene vapour barrier. When the concrete cools below the dew point of the air of the stud cavity, condensation will form on the concrete and on the steel studs.

The presence of two planes of low vapour permeances either side of a thermal resistance with a high vapour permeance and capacity to absorb moisture transform this assembly into an assembly that will accumulate moisture more readily than it will release it. For the purpose of this paper, this type of assembly will be referred to as moisture “Accumulator”. Building envelope assemblies that are conceived to easily dissipate moisture through the process of drainage, ventilation or diffusion will be referred to as “Dissipaters”.

In the opinion of the author, the traditional cast-in-place wall assembly can be improved by means such as installing Exterior Insulated Finish System (EIFS) on the exterior face of the concrete and leaving the wall cavity empty and not installing a polyethylene vapour barrier on the interior face of the steel studs. EIFS, properly detailed, would provide the following benefits:

Unfortunately, by the time a building envelope consultant is retained by the developer, development permits are frequently in place and the choice of exterior finishes for the building cannot be modified. In lieu of installing EIFS to the exterior wall, the author has experience good success for the last decade by utilizing closed cell polyurethane insulation on the interior side of the concrete walls between the studs. A polyethylene vapour retarder is not utilized in such cases.

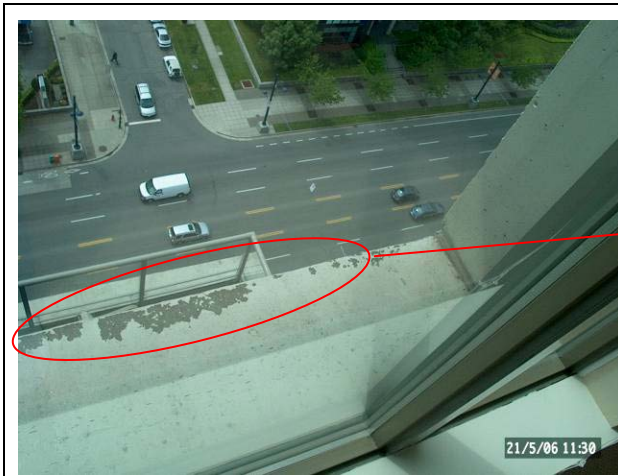
PHOTOGRAPH 2: View of the outward projection of a floor slab from the interior of the building. Note the spalling paint on the surface of the slab.

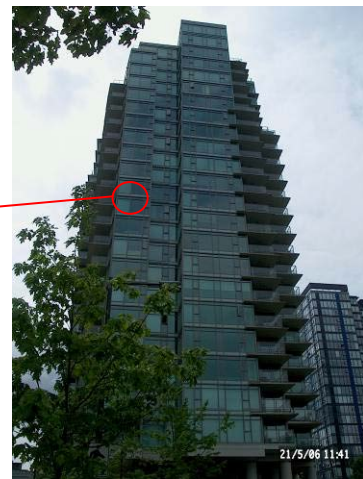
PHOTOGRAPH 3: Exterior view of the building.

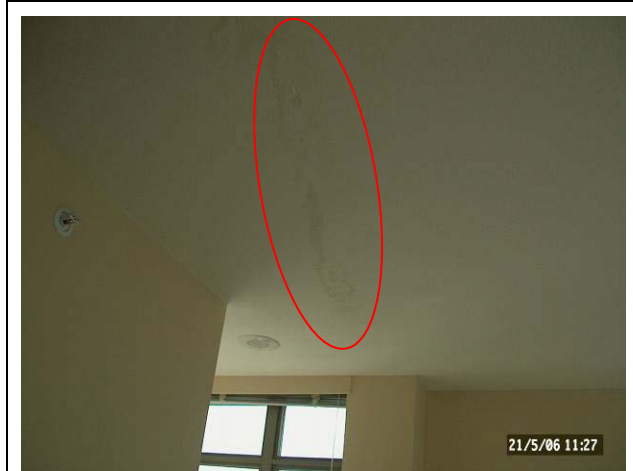
The Eyebrows of the one building reviewed by the author were sloped approximately 2% towards the exterior and coated with acrylic paint. A leak had developed at the ceiling of a unit approximately 10 feet inwards from the exterior wall. Multiple tests were performed on the building and no evidence of leakage was observed. Finally, water was directed over the eyebrow of the floor above where the leak was reported. A spray of water was allowed to continue for a period of approximately two hours. After two hours, a steady drip of water was noticed at the bedroom ceiling where the leak had been reported.

PHOTOGRAPH 4: The ellipse denotes a crack in the ceiling where water was dripping.

The author was surprised to observe that water was able to travel a distance of approximately 10 feet through a slab to finally escape at a crack in the concrete.

The Standard of Care required of a reasonable and prudent building envelope designer is to design a building envelope assembly that is tolerant to incidental moisture (and not leak). Based on several buildings, it is the opinion of the author, that a waterproofing membrane should be utilized on horizontal and near horizontal building surfaces. This said, it is also the experience of the Author that it is not always possible to convince a Developer that the extra cost involved in providing a waterproofing membrane in this location is worthwhile.

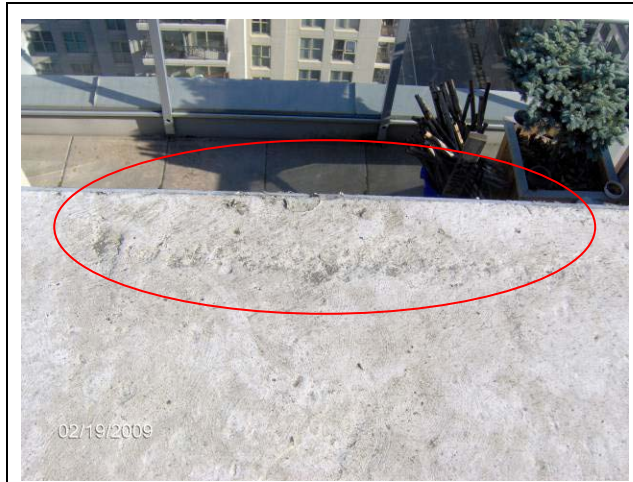
In a recently constructed building, silicone elastomeric paint had been utilized to waterproof the eyebrow projection. After approximately 3 years, the silicone paint was frayed and was delaminating from the concrete substrate. In the author's opinion, silicone paint is unlikely to provide a durable waterproofing membrane in (near) horizontal applications. This is due to the fact that unreinforced coatings are unlikely to effectively span cracks that develop during the service life of the concrete, even if the coating has a high elongation capacity. Where cracks develop in the concrete after the coating has been applied to the Eyebrow, the coatings will be stretched beyond its ability to bridge the crack. Unfortunately, Eyebrows are nearly never waterproofed with a waterproofing membrane and covered with flashings because of architectural considerations.

PHOTOGRAPH 5: The ellipse denotes an area where the silicone paint has delaminated from the concrete slab.

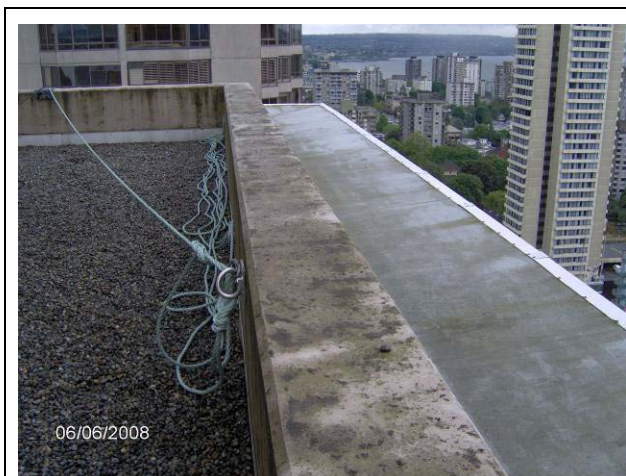
It is a preferred detail of the architectural community to design concrete walls that extend above the surface of the roof. These walls are referred to as parapet walls. Frequently, architects will require that the top of the concrete walls remain unprotected from the elements in order to create the aesthetic effect that they desire. This was an architectural feature favored by the late architect Arthur Erikson. At times, the resistance to installing a waterproofing membrane on top of a parapet wall can be obstinate. Convincing the architect that concrete cracks and that water can travel into the cracks down the parapet wall height to accumulate beneath the roofing and into the occupied space below is usually not difficult. Convincing the architect that he has to modify the appearance of the building usually is.

PHOTOGRAPH 6: The parapet wall of this building is unprotected by a waterproofing.

The Standard of Care required of a reasonable and prudent professional is to minimize the likelihood of building leakage. Leaving the top of a concrete parapet wall uncapped is not minimizing the likelihood of building leakage. Although regulations existed 20 years ago that required the top of parapet walls to be capped, the present building code are more performance-based. Thus the choice of whether or not to install capping on a parapet wall or not is left to the designers. Where the designer is ignorant of the risks of leakage, the parapet walls sometimes go uncovered.

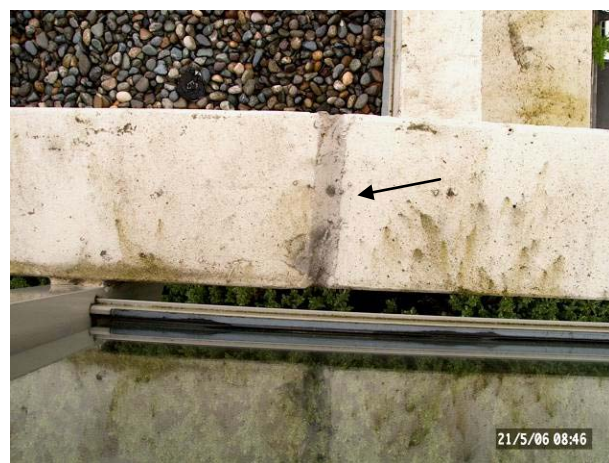
PHOTOGRAPH 7: The top of this parapet wall, on a building located approximately 10 blocks away from the building shown on Photograph 5. In this case, a joint in the parapet wall is waterproofed with sealant, thus increasing the likelihood of leakage.

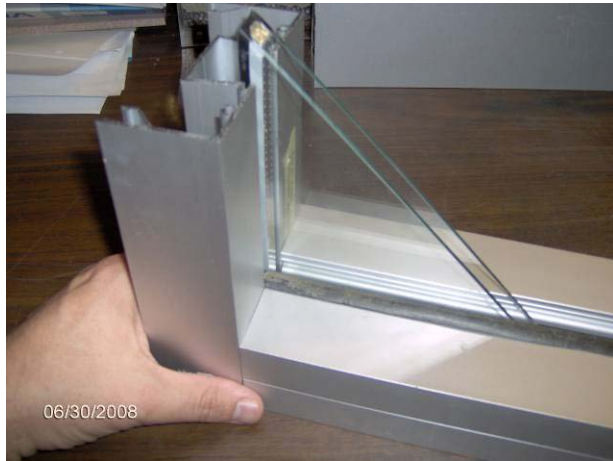
Storefront windows are aluminum framed windows usually reserved for use on the façade of retail establishments. These are often used in lieu of curtain wall systems partly because of lower product costs. The design of their frames is such that at the junction of the jamb with the sill, there is a hole that is formed in the glazing pocket.

PHOTOGRAPH 8: A storefront window frame with a sealed unit inside of the glazing pocket.

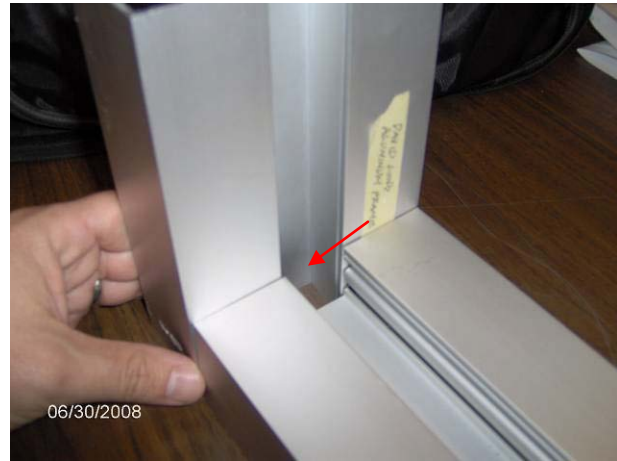
PHOTOGRAPH 9: With the sealed unit remove discontinuity of the glazing pocket at junction of the jamb and the sill shown by the red arrow.

Storefront windows rely on dry gaskets to secure the glass within the extrusion. Dry gaskets are more likely to allow water into the glazing rabbet of the window frame. Due to the discontinuity of the glazing pocket at the junction of the jamb and the sill, the water performance resistance of this type of glazing system is reliant on a sill membrane or flashing with back and end dams. If the sill flashing is imperfect or missing, leakage may result.

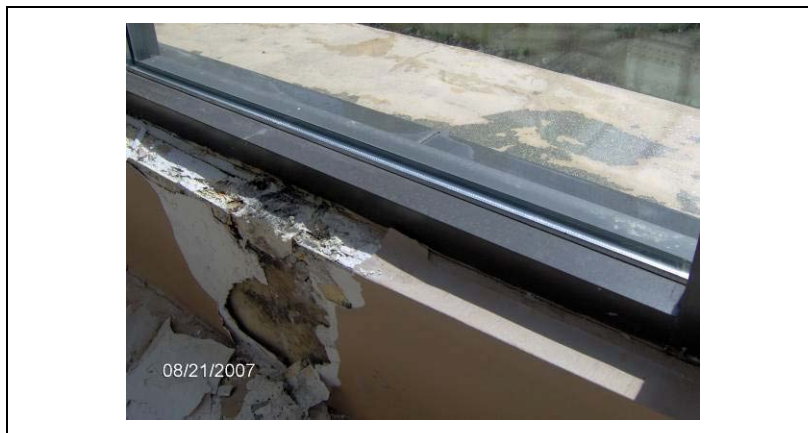
PHOTOGRAPH 10: Shows the consequence of utilizing a storefront window system in a location exposed to wind-driven rain without adequate sub-sill waterproofing. The sub-sill flashing in this photograph had a joint at the point of the leak.

The Standard of Care of a reasonable and prudent building envelope consultant would be to demonstrate that the storefront glazing system could provide comparable performance to that of another glazing system. It may be possible to do so, if the installation details are designed and constructed adequately.

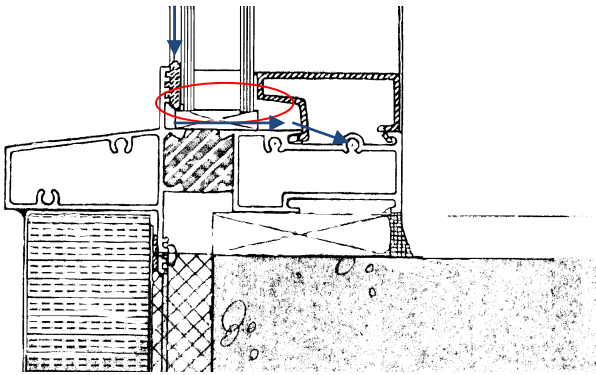
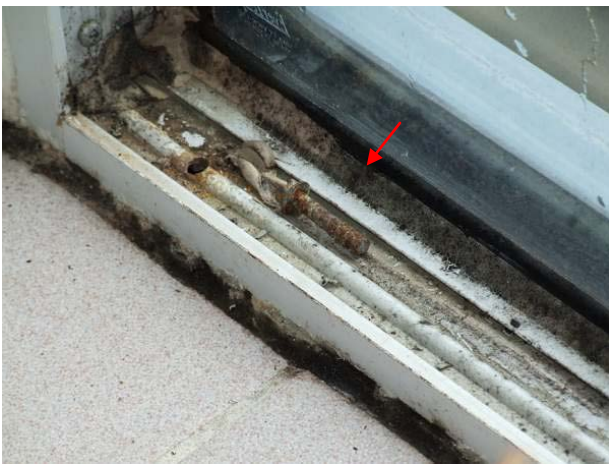
To achieve the desired level of performance, face sealed windows employ wet (or sticky) glazing tapes that join the window frame to the glass. In time, these tapes break down and water may penetrate into the glazing rabbet causing the sealed unit to fail.

<p>FIGURE 2: Face-Sealed Window. In a face-sealed window, the area denoted by the ellipse, is the glazing rabbet. The sealed unit sits on a setting block in the glazing rabbet. In a face-sealed window, this area is not drained to the exterior. Water penetration the exterior wet gasket will penetrate to the interior as shown by the blue arrows.</p>	<p>PHOTOGRAPH 11: The window shown on Figure 2 was utilized on a building and leaked. The windows were converted to a rainscreen water management approach by drilling weep holes through the extrusion and installing a fillet bead of sealant (heel bead) at the location marked by the red arrow.</p>

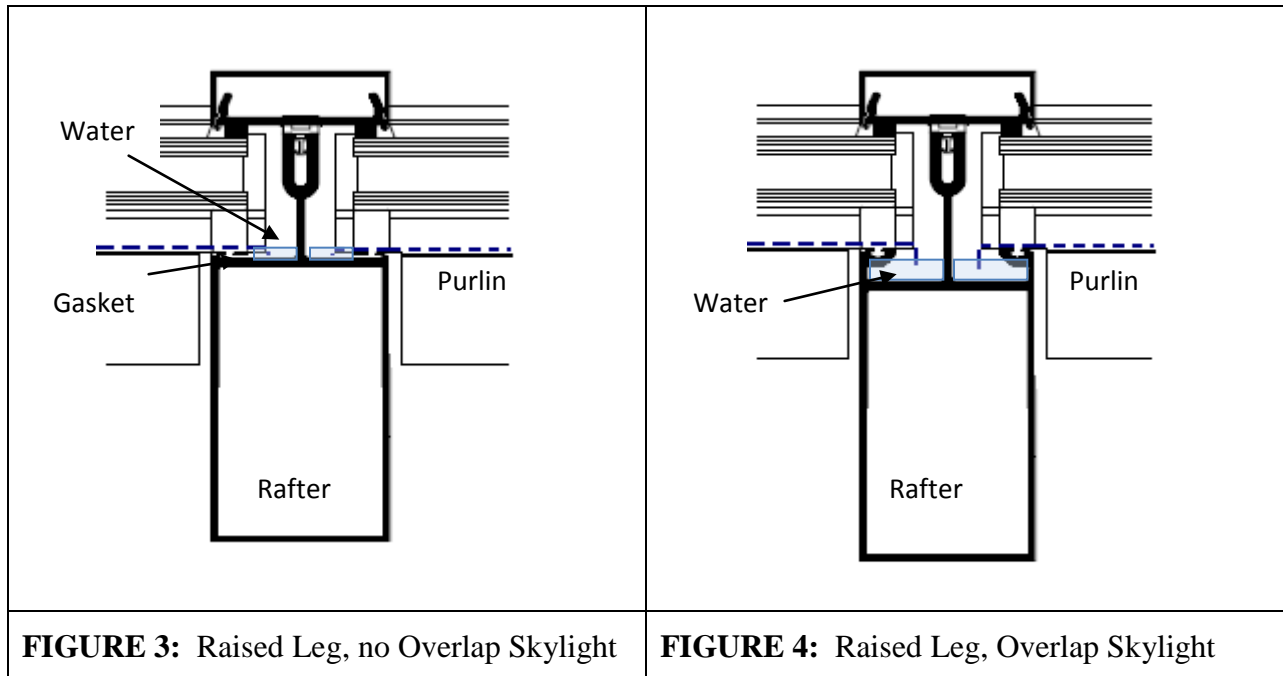
Skylights traditionally relied on a perfectly sealed exterior face in order to control water penetration. Over time, the design of skylights has evolved. An internal drainage system was incorporated to deal with moisture that could penetrate beyond the exterior seals of the skylight. Such a system is represented in Figure 3. The raised leg skylight features an internal drainage gutter at the level of the rafters and of the purlins. The dashed blue line represents the drainage path from the purlins of the skylight into the rafters. Unfortunately, because the drainage gutters of the purlin and of the rafter are at the same elevation, sealants and glazing tapes must be relied upon in order to ensure water tightness.

A vast improvement to the design of the skylight in Figure 4 is to raise the level of the bottom of the drainage gutter of the purlin. Thus the joint between the purlin and the rafter is not exposed to water for long periods of time.

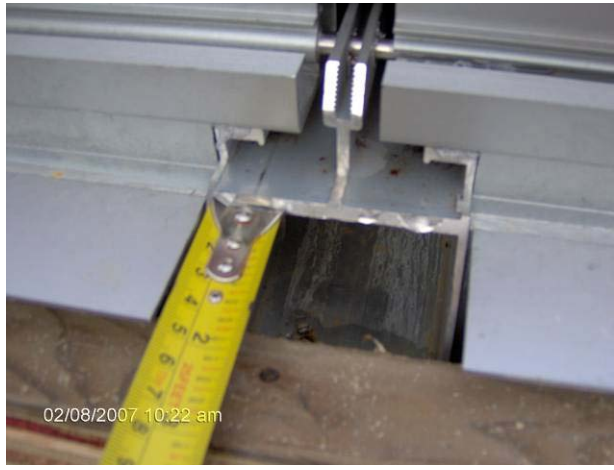
PHOTOGRAPH 12: Exterior view of a raised leg skylight with overlapped drainage gutters.

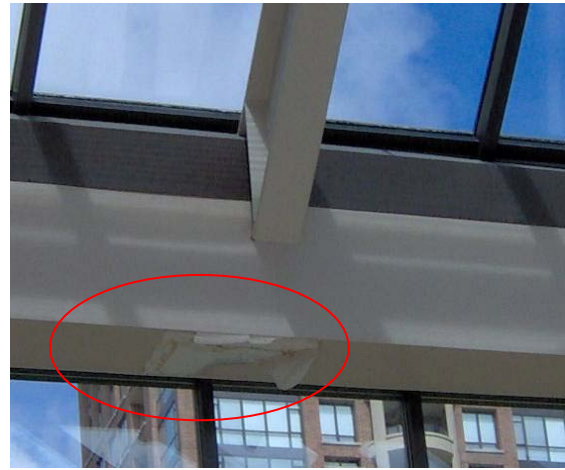
PHOTOGRAPH 13: Damage to the ceiling caused by the leaking of a very large skylight without the raised leg overlapped drainage gutters.

Building designer and Developers should select building components that are likely to perform with reasonable maintenance, for the expected service life of the building component. As skylights are also roofs of sort, it could be argued that the expected service life of a skylight should not be shorter than that of a roof. The skylight shown on Photograph 13 leaked profusely as soon as the sealants and glazing tapes employed failed, after approximately 5 years of service.
