Thermal Imaging Helps Locate Enclosure Air Leakage

By Dave Bohac, PE

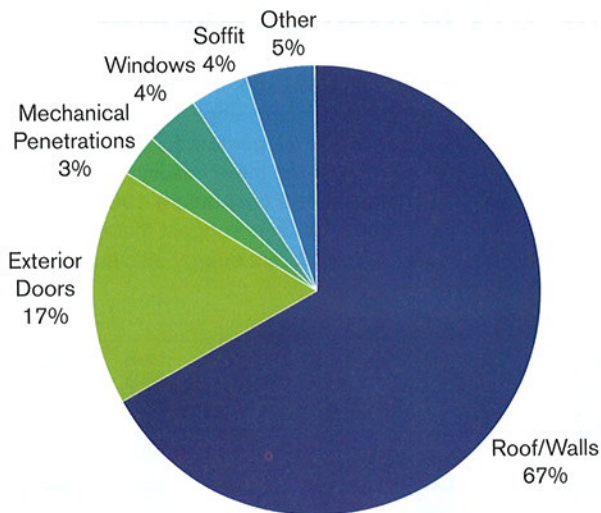
Figure 2: Distribution of leakage area by type of leak, according to a recent State of Minnesota-funded project.

Contractors also are air sealing existing building enclosures using the same investigation techniques. Recently, a State of Minnesota-funded project was conducted to expand the limited data on measured whole-building, air-leakage reductions from sealing. Another research goal was to discover and confirm methods for estimating any resulting energy savings. This project measured 26 C&I buildings and performed air sealing for eight of those buildings. Air sealing targeted larger gaps that were accessible, with little or no damage to surrounding materials. Over the 26 buildings, 67 percent of the area to be sealed occurred at accessible wall/roof joints; 17 percent at exterior door weatherstripping; and the remaining 16 percent spread fairly evenly between soffits, windows, mechanical penetrations and other locations (see "Figure 2," above). Only two of the buildings had less than 40 percent of the sealing for the roof/wall joint. This

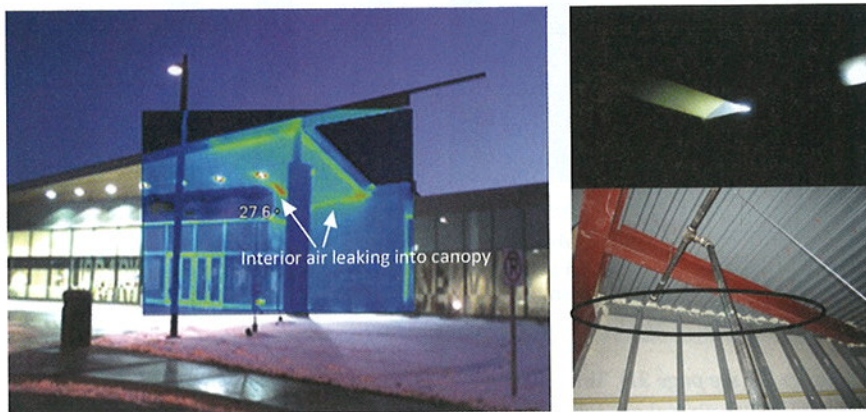
Figure 3: IR image of canopy air leakage (left), with gaps circled (right) between the wall and the corrugated roof deck.

An example of before-and-after thermal imaging from this project is shown

in "Figure 3" (see page 21). The initial IR image shows air leakage where walls meet the canopy. A visual inspection found air leakage in the gap between the flutes of the corrugated roof decking and

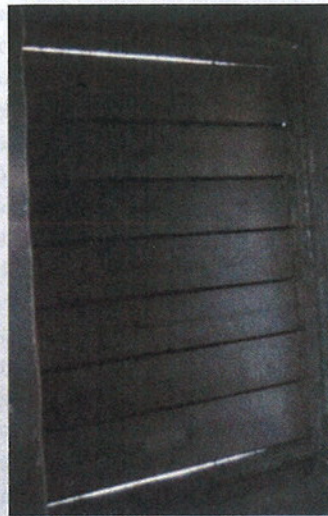
Gaps at the top and bottom of an outside air damper.

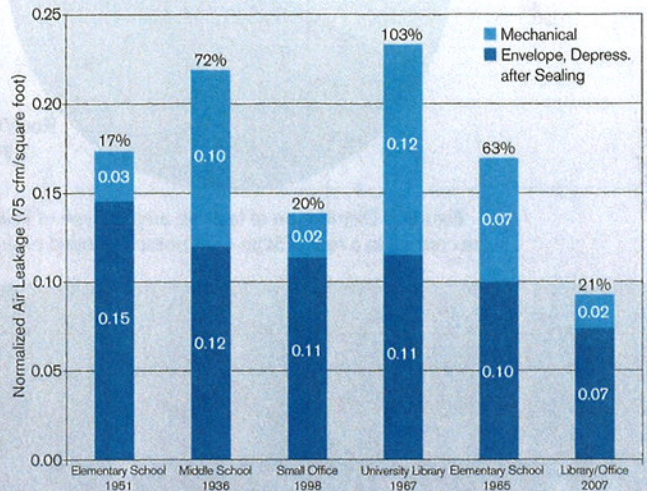
Figure 5: Whole-building leakage tests were conducted, with mechanical penetrations sealed (dark-blue bars) and unsealed. Light-blue bars show additional leakage due to the mechanical systems.

Whole-building, air-leakage tests are typically conducted with temporary seals on mechanical dampers or penetrations. For a recent project, researchers also conducted a single-point test with the seals removed. Findings showed mechanical-system leakage increased the enclosure leakage by 17 percent, to 103 percent (see "Figure 5").
