# Lab to Field: From Components to Verified High Performing Buildings

## ABSTRACT HEADING

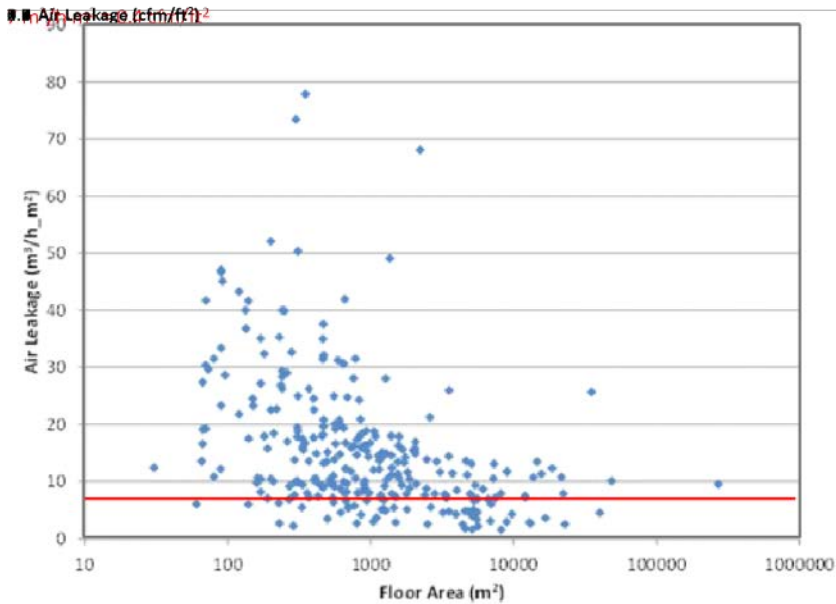
Figure 1. Measured air leakage rate at 0.3 in. of water as a function of floor area (Emmerich and Persily 2014).  
 Notes: (1) 0.4 cfm/ft² at 0.3 in. of water is one of the options for air barrier compliance under the 2015 IECC. (2) 1 m³/(h·m²) = 0.056 cfm/ft².

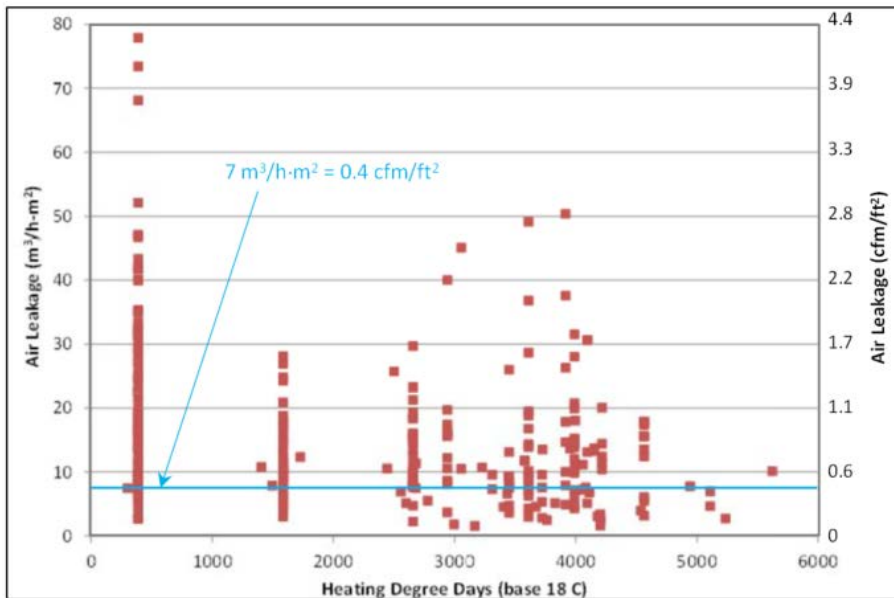
Figure 2. Measured air leakage rate at 0.3 in. of water as a function of heating degree days (Emmerich and Persily 2014).  
 Notes: (1) 0.4 cfm/ft² at 0.3 in. of water is one of the options for air barrier compliance under the 2015 IECC. (2) 1 m³/(h·m²) = 0.056 cfm/ft².

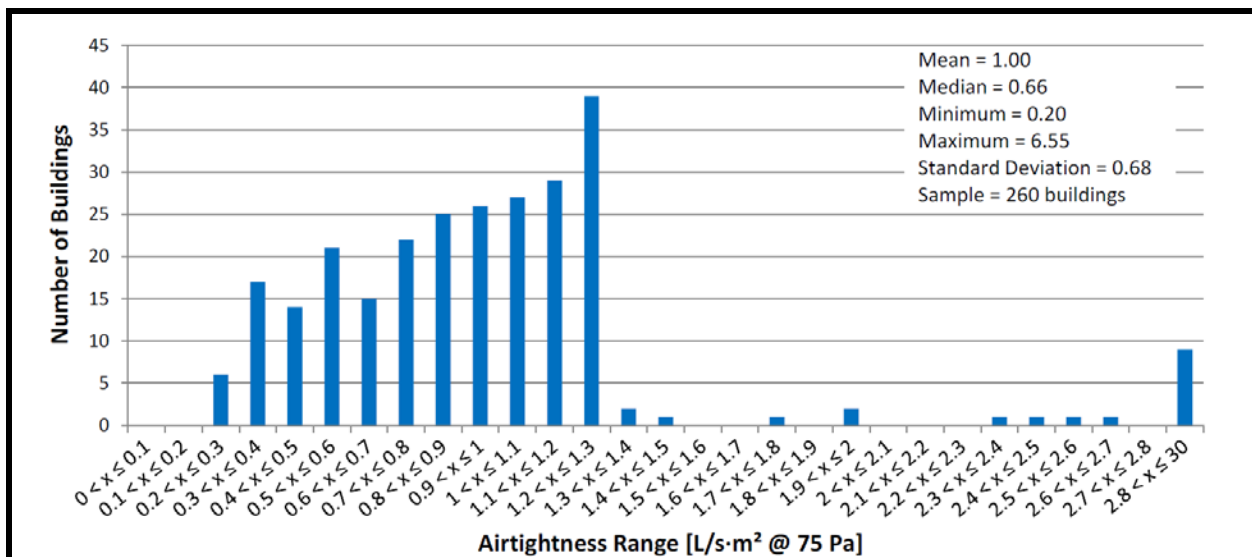
Figure 4. Measured air leakage rates at 0.3 in. of water (75 Pa) from buildings that were evaluated per the USACE Air Leakage Test Protocol (RDH Building Science 2015). Note that the USACE airtightness requirement is 0.25 cfm/ft<sup>2</sup> at 0.3 in. of water (1.25 L/s·m<sup>2</sup> at 75 Pa).

A few years after Washington State started mandating air leakage tests, the US Army Corp of Engineers (USACE) issued an Air Leakage Test Protocol for Building Envelopes (USACE 2012). According to this document, buildings that are tested per this protocol need to achieve an air leakage rate that is lower than 0.25 cfm/ft<sup>2</sup> at 0.3 in. of water. Zhivov et al. (2014) published information about 285 new and renovated buildings that were tested per the USACE protocol. The buildings included barracks; medical, training and childcare centers; offices; and miscellaneous facilities. The number of floors of these buildings varied between 1 and 8. Moreover, their floor areas ranged from 13,000 to 371,000 ft<sup>2</sup>. Zhivov et al. reported the air leakage rate from 122 of the buildings that complied with USACE's airtightness requirement; the authors stated that compliance was achieved with minimal increase in material cost. RDH Building Science (2015) summarized in Figure 4 some of the data that were collected by Zhivov et al. Figure 4 indicates that most of the buildings reached airtightness levels that spanned from 0.04 to 0.26 cfm/ft<sup>2</sup> at 0.3 in. of water (0.2 to 1.3 L/s/m<sup>2</sup> at 75 Pa).

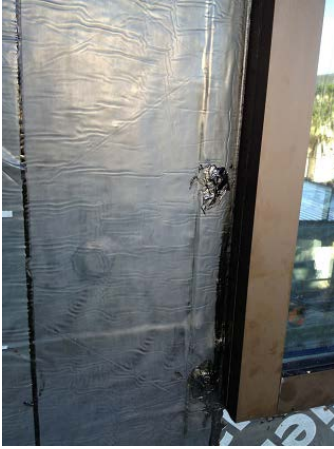
#### Method 2: Self-adhered

Self adhered membranes are plastic films with thick layers of butyl or asphalt adhesives which allow them to self adhere to a smooth substrate, overlap at seams, and, to some extent, self-heal when penetrated. Often referred to as “peal-and-stick” products, these are typically applied in full coverage.

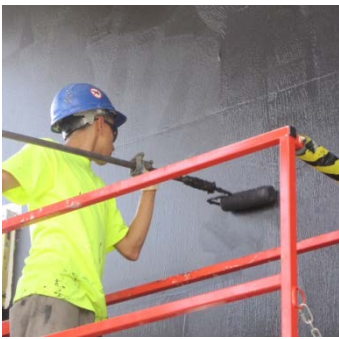
#### Method 3: Fluid applied

Fluid applied membranes are viscous, high solids content liquids which are applied at a given thickness to a prepared substrate and allowed to cure/dry into a flexible, solid material which is a barrier to water and air penetration. These are also typically applied to fully cover the substrate.

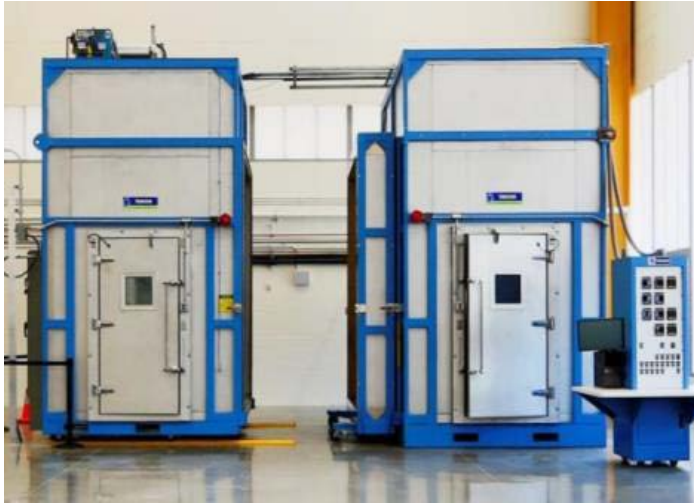
Figure 6. Environmental chamber that evaluates heat, air and moisture penetration.

Tests were conducted in the Heat, Air and Moisture (HAM) penetration chamber shown in Figure 6. The chamber is composed of an indoor room, an outdoor room and a test frame; all three components are thermally isolated from the lab space with R30 insulation, which facilitates controlling the temperature within the chamber. The indoor room and the test frames are movable so walls that are up to about 8'-0" wide by 10'-0" tall can be built outside the chamber. Table 1 lists the parameter ranges that the chamber is capable of regulating. Both the indoor and outdoor rooms have patch panels within them so sensors can be installed on either side of the test wall to monitor temperature and relative humidity at various locations without penetrating the air- and water-resistive barriers. ASTM and AAMA tests were executed through LabView codes that regulated the parameters listed in Table 1.

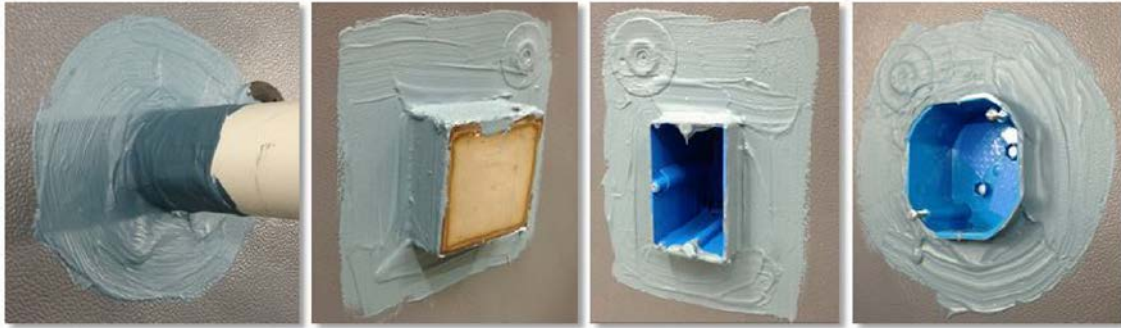
Figure 8. Gaps around penetrations that were sealed with liquid flashing.

Gaps around PVC pipes, electrical outlets and steel ducts were close to 1/4" wide, and joints between polyisocyanurate insulation boards were ~1/8" wide. All the joints and gaps were sealed with either the liquid applied board joint sealant or the flashing tape board joint sealant and as illustrated in Figures 8 through 10. A supporting material was not used underneath either board joint flashing method.

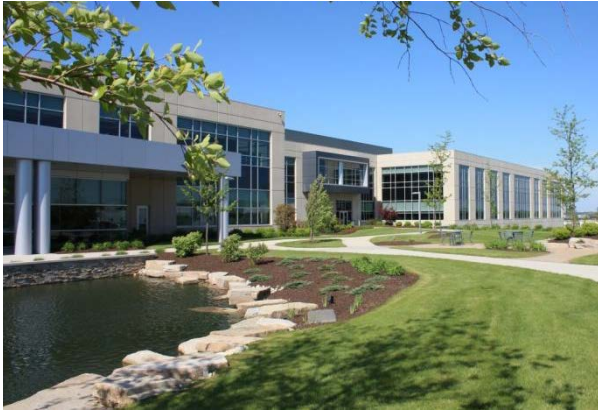
Figure 2A-1 Partial view of Corporate Headquarters

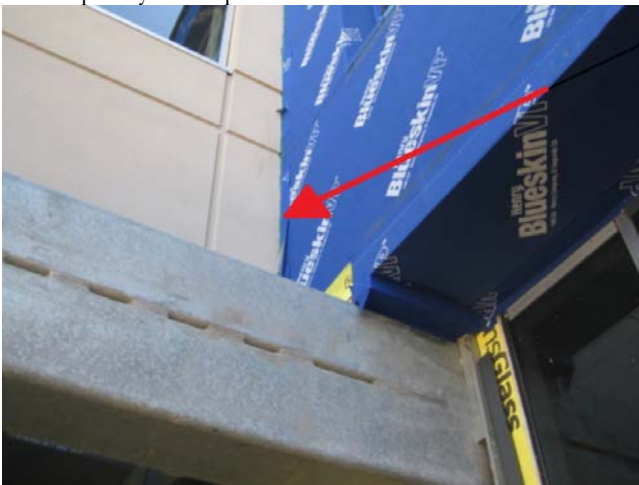
Figure 2A-4 View of junction between Blue Skin and precast concrete

(3) As with many air and water barriers, the transition to a different system was shown to be a weak point. In this case, the installers failed to follow manufacturer's recommendations for the transition from the AWB material to the adjacent precast [Figure 2A-4] The builder cut the AWB to just touch the precast panel and then proposed sealing the AWB to the precast with a "fillet" sealant shape [figure 2A-5, left]. This type of sealant joint would likely fail in an unacceptably short period.

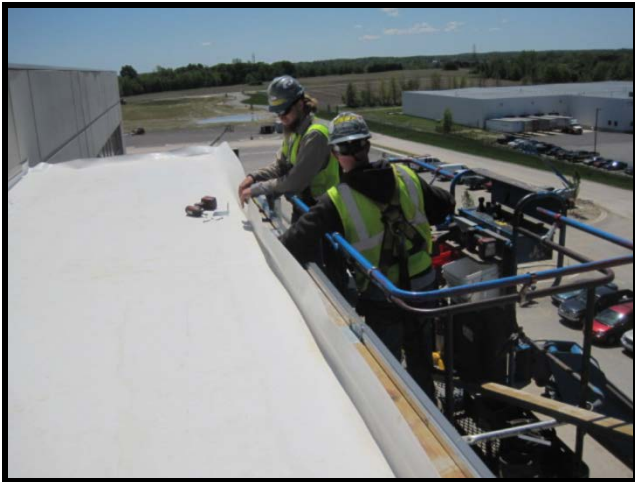
Figure 2A-5 Metal panel rainscreen meet a roof

In Figure 2A-5 a metal panel rainscreen system meets a fully adhered roof membrane. The AWB behind the metal panels is cut just to the top of the sheathing. Another section had to be stripped in, extended across the rough substrates, and married to the roofing membrane. This is a case where a self-adhered membrane is best suited compared to the other categories of AWB considered by the authors.

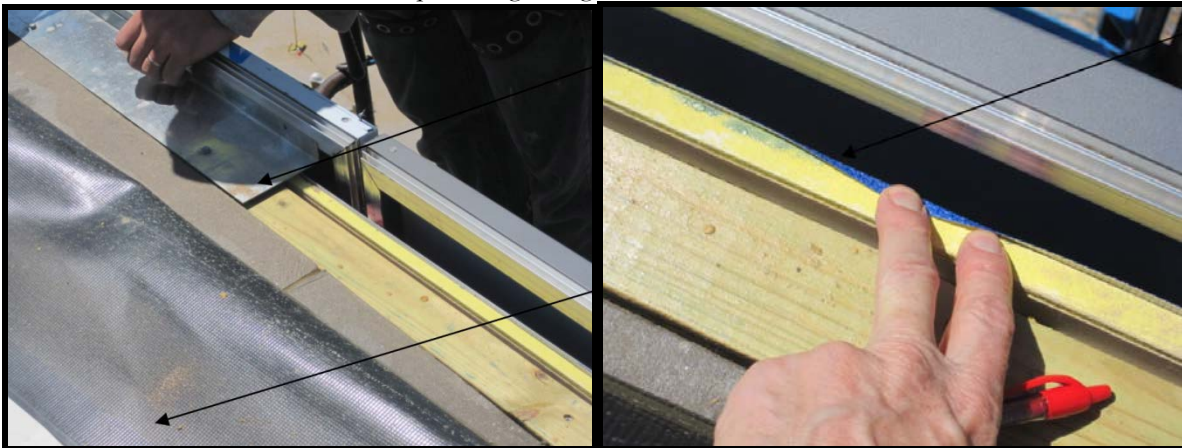
Figure 2A-7 Close up of roof-panel junction shows the irregular substrates that the self-adhered AWB must span to marry to the roof system

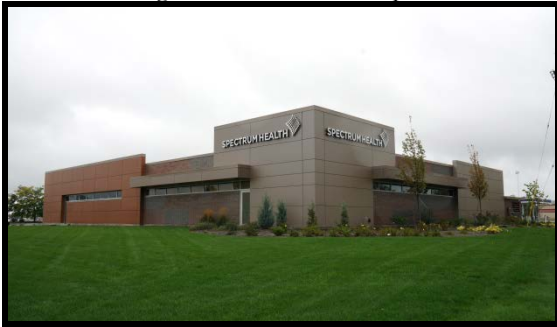
**Highlight:** A self-adhered AWB product had difficulties navigating the complex geometries of this building and had to be augmented with spray foam at beam penetrations and window offsets to accomplish a continuous air barrier. Also, there was difficulty properly flashing the AWB at a window to direct water from behind rain-screen panels out of the building. This area failed repeated water tests.

The AWB system consisted of a self-adhered sheet air barrier that did not require the use of a primer. The physical nature of the product was shown to be thicker and less malleable than other sheet products, which created difficult installation around complex geometry. In the case of this particular building, the structural steel penetrated the exterior sheathing and supported cantilevered canopies. The AWB product simply was unable to navigate the geometry, leaving larger portions of the sheathing exposed with no AWB [See Figure 2B-1].

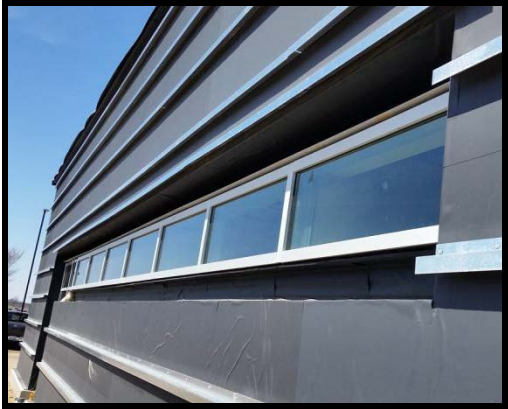
<p>Figure 2B-2: Distinct geometry limited the ability of the AWB to mate with the glazing systems</p>	<p>Figure 2B-3: Spray foam was used in place of the sheet applied AWB in areas where the product could not be applied.</p>

Similarly, the ribbon windows for the building were inset from the face of the AWB and tightly snug to various overhangs at the head conditions. Due to this, distinct head, sill, and jamb conditions did not compliment the AWB product that was selected for the project and continuity of the systems was not easily accomplished [See Figure 2B-2].

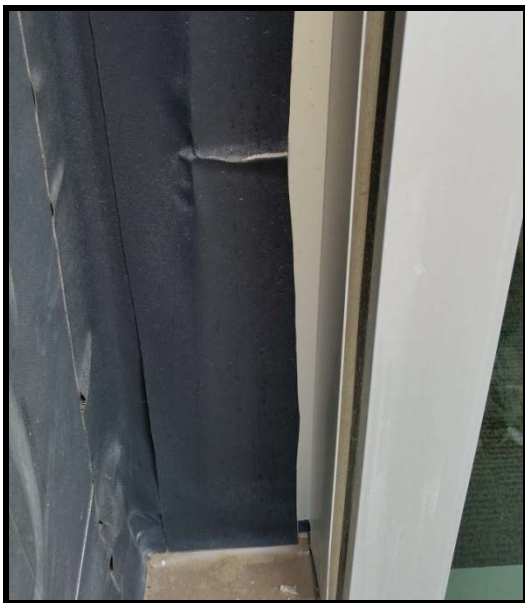
Figure 2B-4: To bridge the gap between systems, custom pieces of sheet metal had to be installed to provide a surface for the AWB to span the gap.

At window locations, each distinct window condition required a custom shop fabricated piece of sheet metal to provide a backing surface to bridge the gap between the AWB and the glazing system [See figure 2B-4]. This option was shown to be time consuming, labor intensive, and often ineffective in its attempts to complete the air and water barrier. It is worth noting that the construction schedule had to be reconfigured to account for this, which delayed cladding install.

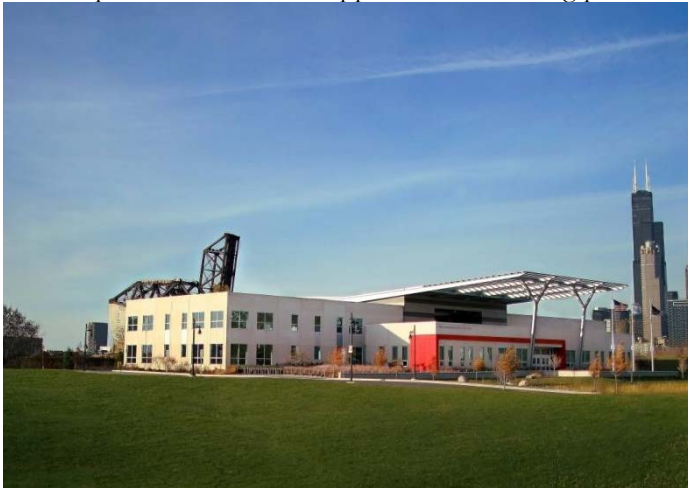
Figure 3A-1 View of the completed community recreation center.

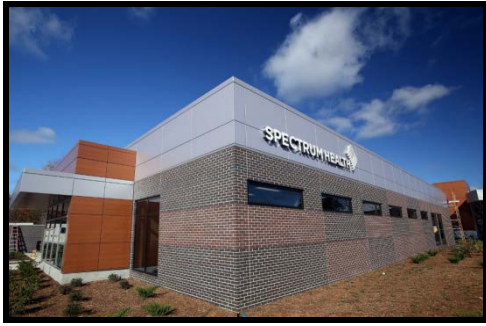
**Highlights:** A liquid applied, joint-treated polyisocyanurate insulation board system was the AWB and was applied directly to the steel studs. It was backed up with spray foam applied between the studs. While the project experienced minimal issues with the AWB itself, a field-improvised solution to close the cavity behind masonry at windows had to be used. The building performed well in whole-building blower door test.

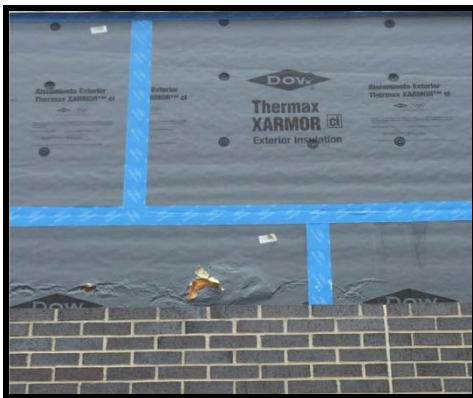
Figure 4A-1 AWB before metal panels are applied. Note the scarring of the surface from masons pressure washing of the brick.

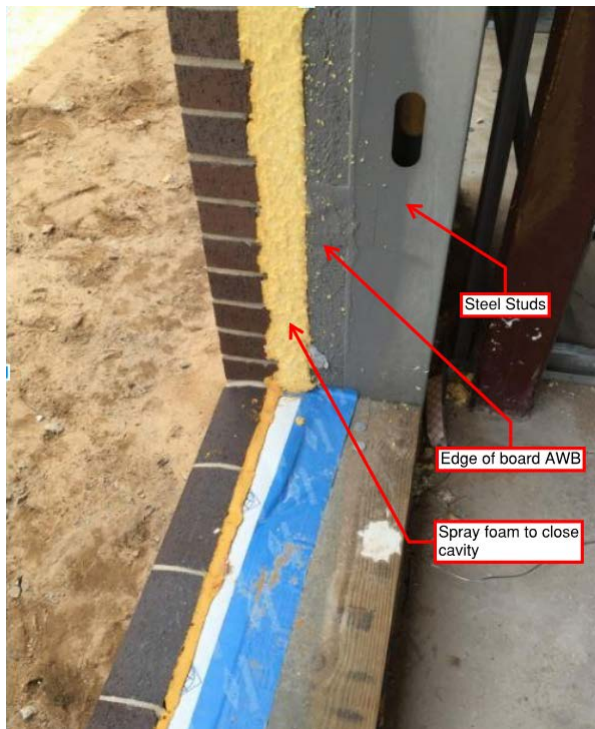
Figure 4A-3 View of window sill and jamb after placement of foam cavity-closer

Spray foam is applied in the cavity between the AWB Board and the brick at the window jamb. A tubular flexible rubber pipe insulation is used as a backer against which to place the foam. The primary seal (silicone caulk) is placed between the spray foam and the window mullion.

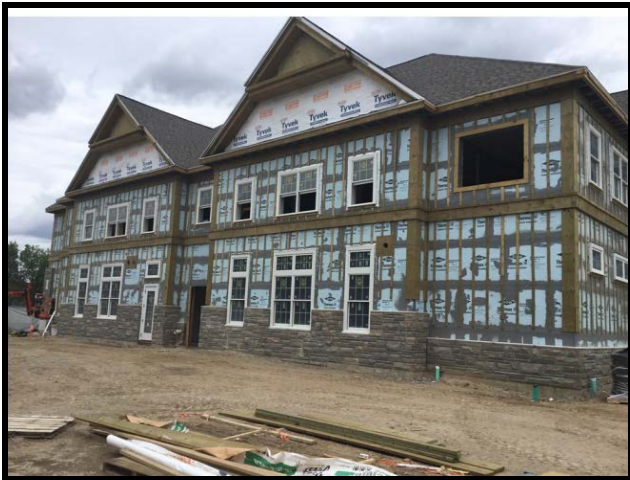
**Highlights:** The Contractor experienced problems with the tape-sealed joints of the polyisocyanurate insulation board AWB and switched to fluid-sealed joints. The windows were residential grade and came with a nailing flange. Thus, they avoided the Issue presented in the previous case study. There were some challenges in maintaining the integrity of the air barrier, particularly at the wall-to-attic interface. Because the ventilated attic relied on the gypsum board ceiling for the air barrier at the horizontal plane, contractors struggled to navigate the steel structure effectively so that the horizontal air barrier connected with the vertical air barrier.

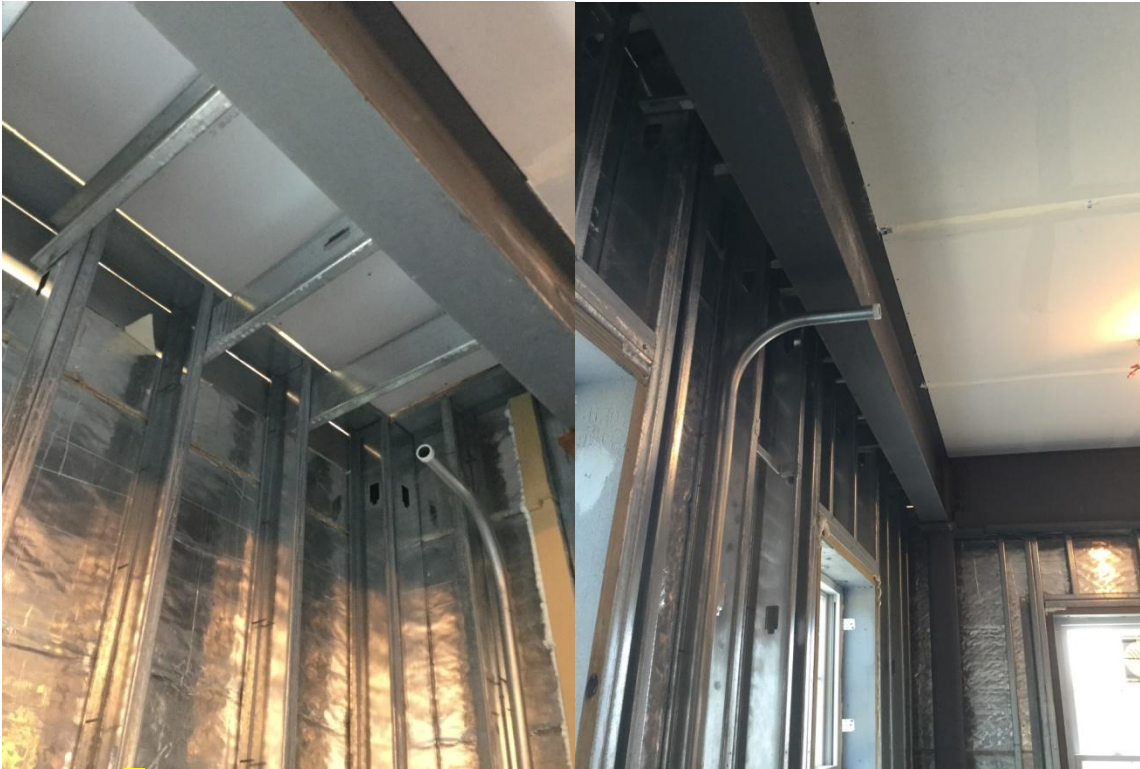
Figure 4B-X: Connection of vertical polyisocyanurate insulation to horizontal gypsum board in the attic. Note the various structural components interrupting the connection of the two materials.

Infrared scanning was performed during blower door testing which demonstrated the majority of the air leakage from the top plate of exterior walls into the framing cavity. This condition appears to be directly linked to challenges of connecting the air barrier at the wall to attic interface.

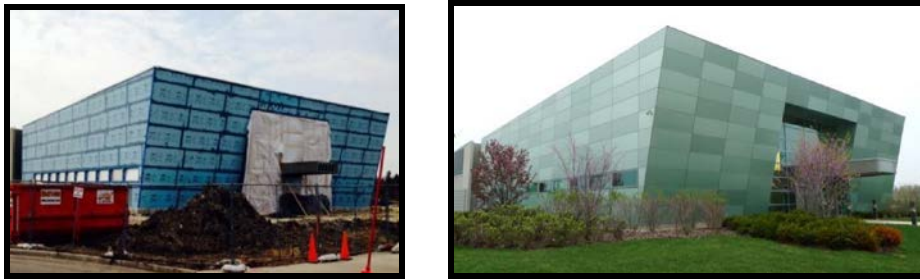
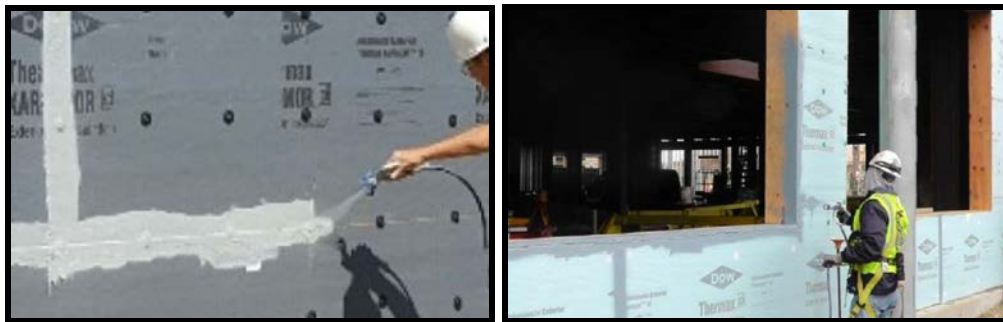
Figure 4. Liquid flashing sprayed over board joints and a window rough opening.

The Homeland Security Training Center (HTC) at the College of DuPage was constructed with a board joint sealing method using polyisocyanurate boards and liquid flashing joint sealant as the AWB for the opaque walls (Figure 4). The completed building has 40,000 ft<sup>2</sup> of floor area. The air leakage rate was tested via the blower door technique as outlined in ASTM E779-10.

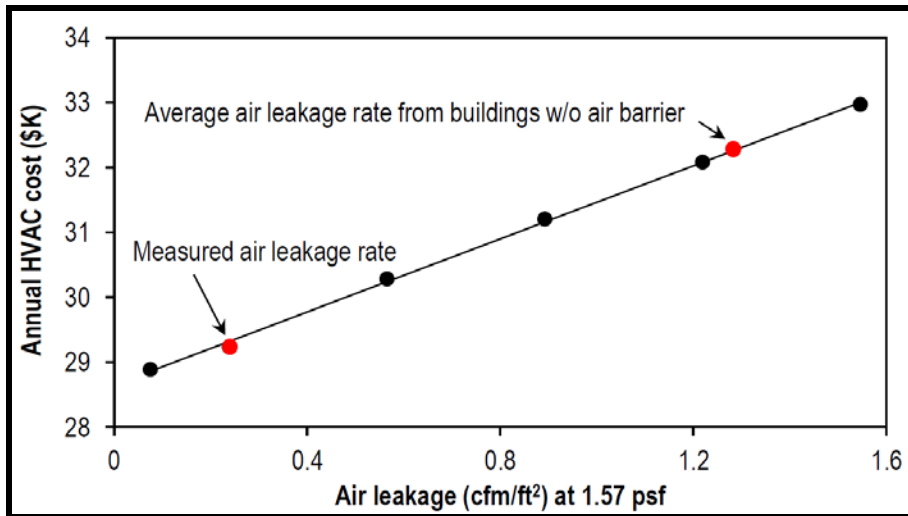
Figure 11. Simulation results of the annual HVAC energy cost for the Homeland Security Training Center as a function of air leakage rate through the above grade walls and roof.

A simulation model was created to estimate the energy savings due to the airtightness achieved at the HTC. The DOE's whole building energy simulation software EnergyPlus™ ver 8.3 (DOE 2016a) was used in this task. The building geometry was obtained from the architectural drawings that included the dimensions, floor plans, and construction material layouts. The HVAC system in the HTC consists of water cooled chilled water for cooling and boilers for heating. Internal loads, lighting, HVAC set point temperatures and efficiency, and their respective schedules were primarily based on information from the architectural drawings; assumptions that are commonly made for typical office buildings based on DOE prototype buildings (DOE 2016b) were used as inputs for missing information.
