# A Sustainable Repurposing of the Aging Facility

*This case study documents the complete repurposing of an existing, 1970's era, 9 story critical care patient tower in an urban hospital complex. A key element of the repurposing is the incorporation of a new thermal over-cladding that retained much of the existing building's exterior masonry envelope while maintaining internal critical hospital operations. The comprehensive approach used by this project to develop a high-performance enclosure for an aging structure began with developing strategies for hybrid thermal over-cladding and "recycling in-place" to achieve passive temperature regulation, air compartmentilization, and increased thermal mass. Over-cladding with a thermal high-performance envelope improved energy performance through improved insulation, moisture mitigation strategies, and resilient materials, in addition to providing an aesthetic improvement that successfully positioned the aging building as a viable part of the hospital's master plan for future decades.*

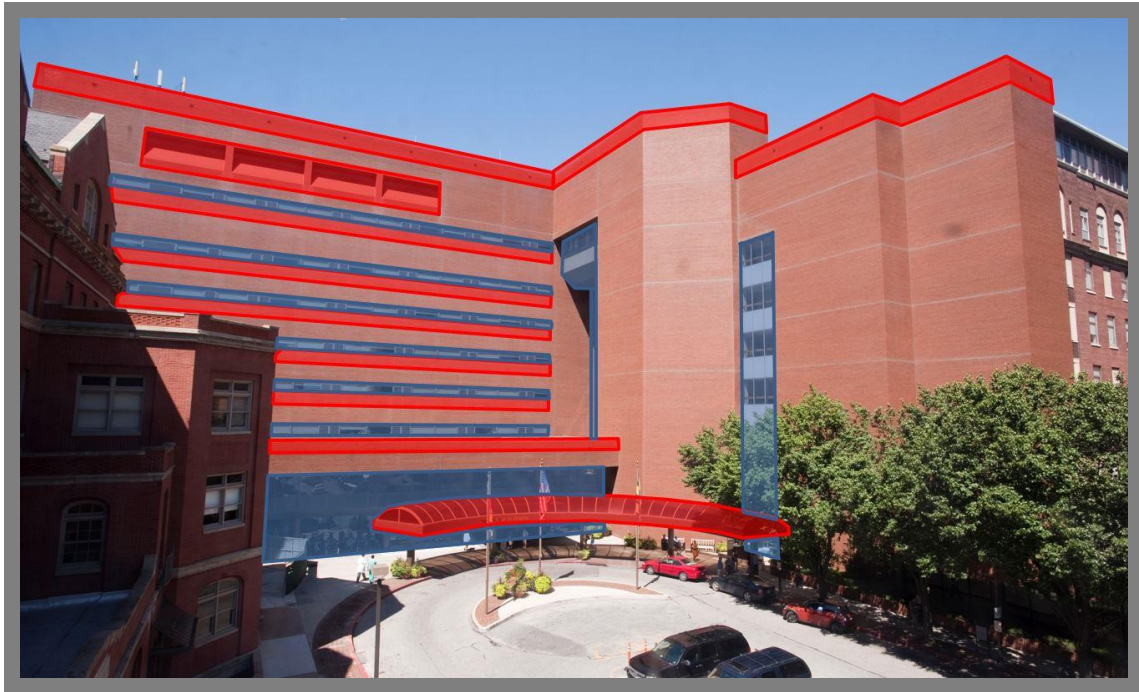
**Figure 16:** Location of masonry (red) and glazing (blue) demolition – east elevation

The portion of the existing masonry wall located from the existing window sill to the floor line was removed to aid in the reduction of the overall dead load of the building, allowed the installation of new steel structure to support the curtain wall system, and provided additional floor space for the patient rooms, see Figures 16 and 17.

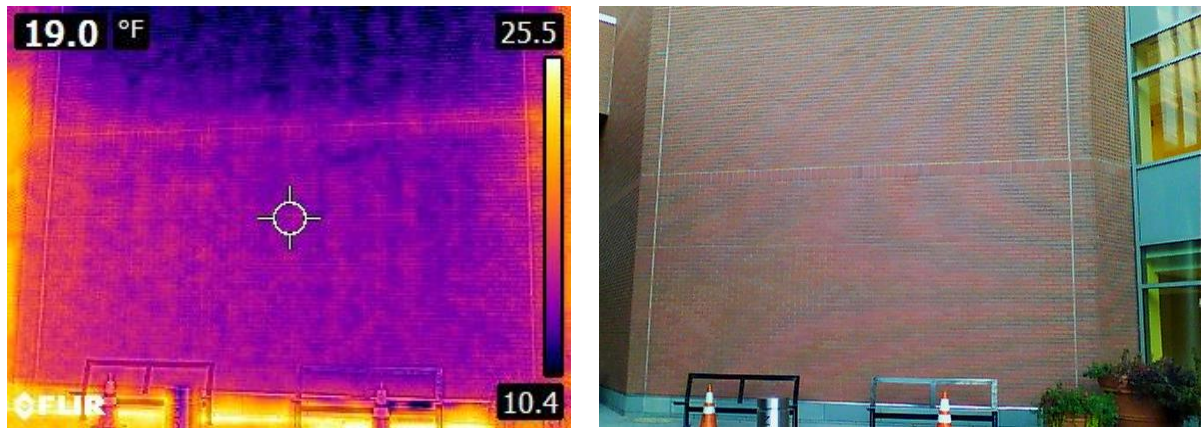
The insulated precast panels are performing well with very limited thermal conductance through the actual panel, see Figure 29. The cold-formed metal framing of the precast panels are held off from the concrete via spaced Nelson studs and these appear to be quite successful at limiting thermal conductance between framing and the concrete facing. There are limited locations where a structural connection is evident behind the panel as revealed by the thermal images.

**Figure 29a & b:** Thermal & Visible imaging photos of the thin-brick precast wall panel system
