## **Glazing Upgrade at Frank Lloyd Wright's Solomon R. Guggenheim Museum**

Angel Ayón<sup>1</sup> and William Rose<sup>2</sup>

The paper presents more than a dozen options considered to address the undesirable effects of seasonal condensation at Frank Lloyd Wright's Guggenheim Museum in New York. These options followed two main approaches, repair and replacement. The pros and cons of each approach will be presented, as well as the selected replacement option with an unprecedented custom-made thermally-broken steel frame system matching the exterior appearance of the original glazing. The energy models devised for the proposed replacement systems, using software by the Windows & Daylighting Group from Lawrence Berkeley National Laboratory, are presented. Innovative construction details prepared by the Architect and selected manufacturers to build the thermally broken systems are discussed, as well as the results of the comparative testing of such systems.

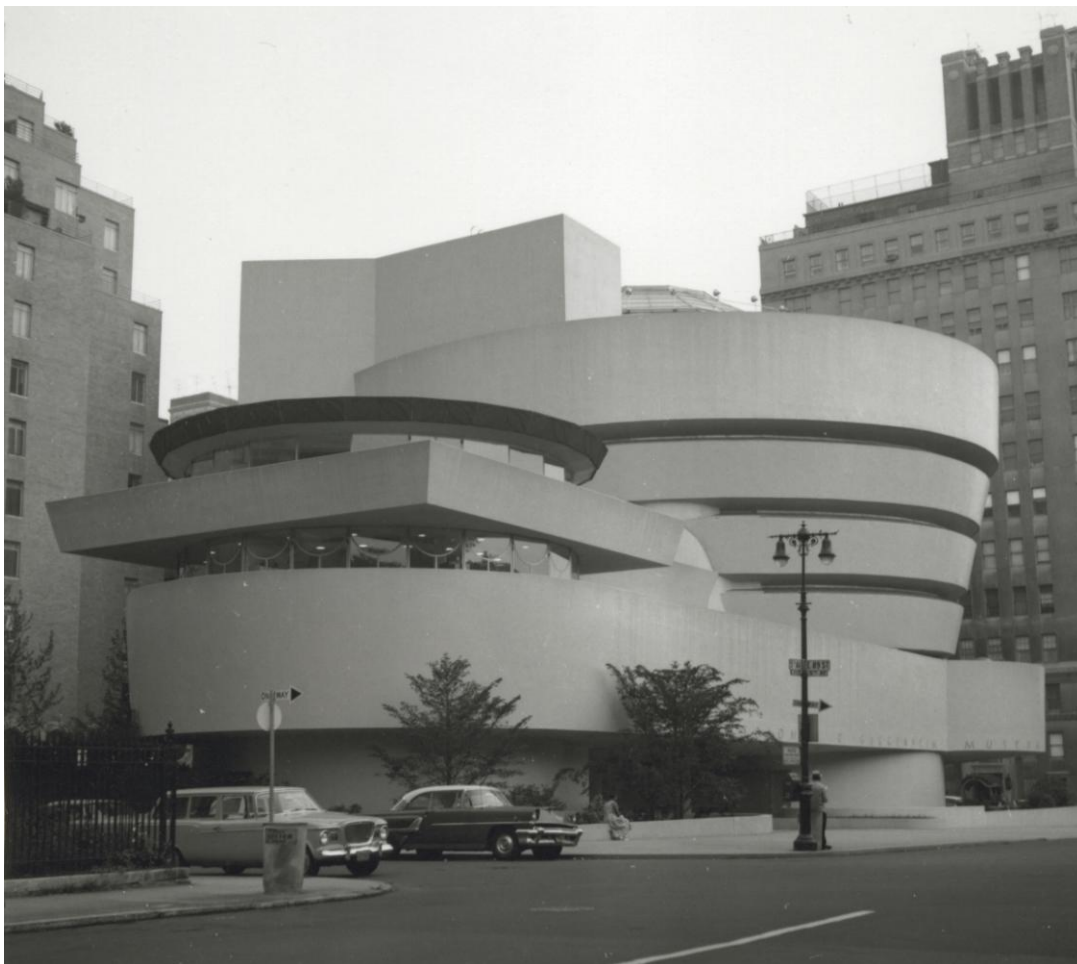
To fulfill this vision, Wright designed the Monitor as independent levels connected to the Rotunda ramps, with one end of the two upper floors enclosed by polygonal, floor-to-ceiling, glass walls leading to perimeter balconies (fig. 1).

**Fig. 1:** Solomon R. Guggenheim Museum, New York, NY  
(ca. 1959) © William B Shot, Solomon R Guggenheim Foundation.

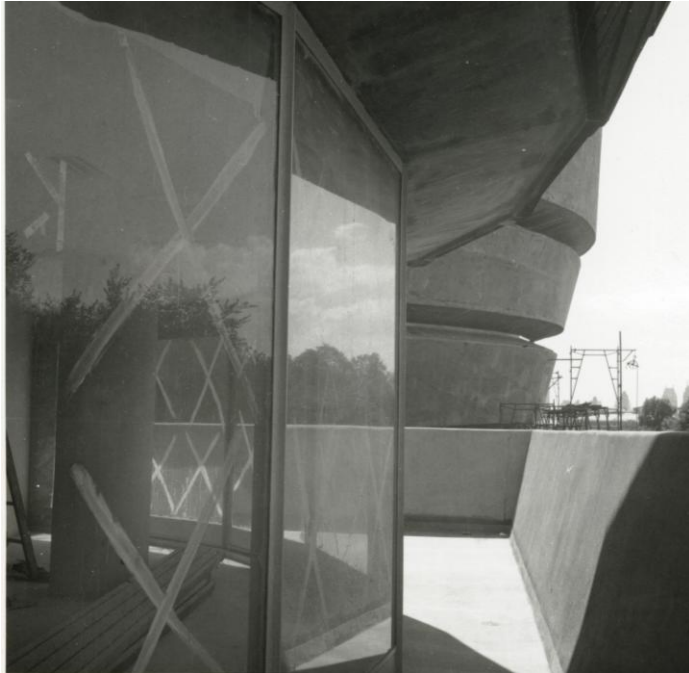
**Fig. 2:** Original single-glazed steel-frame glazed enclosure at the Guggenheim Museum.  
(ca. 1958) © William B Shot, Solomon R Guggenheim Foundation.

The original glass walls, manufactured by Henry Hope's & Sons in the UK, were a single-glazed, un-insulated, galvanized steel-frame system (fig. 2).

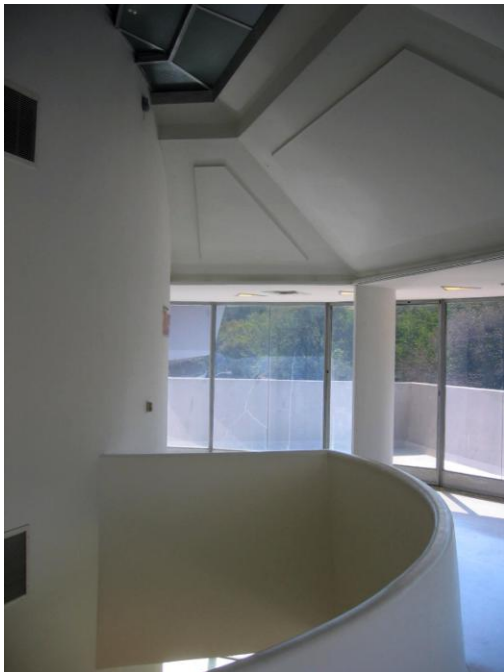
**Fig. 3:** Existing single-glazed steel-frame glazed enclosure at the Guggenheim Museum.  
(2005) © Angel Ayón, WASA/Studio A.

Unlike the Rotunda, the glass walls convey a sense of transparency and extroversion suitable to the non-exhibition spaces they were designed for—and to Wright’s vision of organic architecture, where a building embraces, rather than separates, the indoor and outdoor environments that it is meant to demarcate (fig. 3).

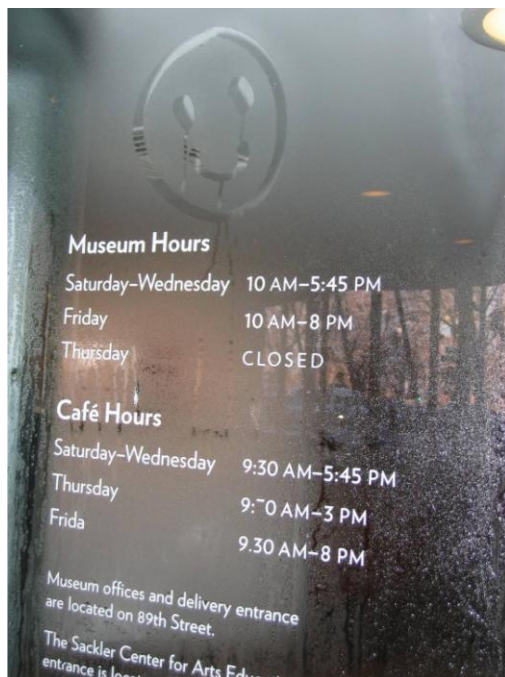
**Fig. 4:** Condensation at exterior glazed enclosure. (2005) © Angel Ayón, WASA/Studio A.

The original galvanized steel framing of the Guggenheim’s glass-walls were in good condition, showing no sign of deterioration and, by traditional preservation standards, would have been deemed as sound, original historic fabric to be retained. During the winter, however, water vapor from warm, humidified, indoor air condensed on the cold surfaces of the un-insulated glass panes, steel frames and mullions (fig. 4). To a lesser extent, similar condensation occurred during the summer, as the outdoor atmospheric water vapor condensed on the cold exterior glass surfaces of the Thannhauser galleries.

Such seasonal condensation compromised the stability of the indoor museum environment; impaired indoor-outdoor visibility; created wet spots posing a traffic hazard, and lowered the RH in some locations to levels unfit for exhibition display during cold seasons.

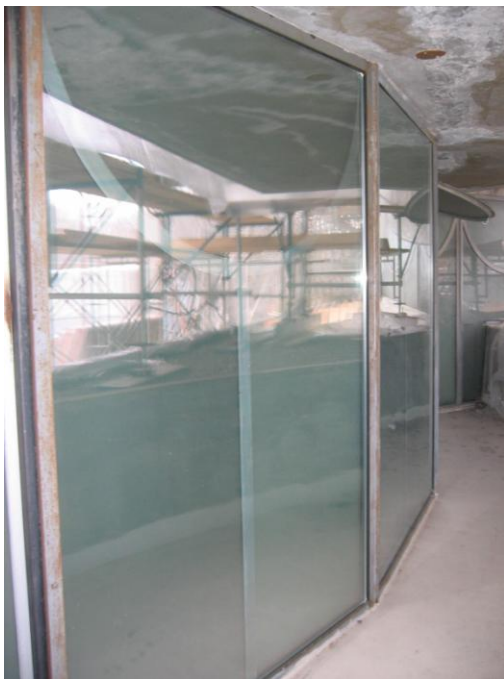
**Fig. 5:** New IG unit on steel- frame in front of original glazed enclosure.  
(2007) © Angel Ayón, WASA/Studio A.

At the 3<sup>rd</sup> floor Thannhauser, new IG units had been installed at selected locations, adjacent to the exterior face of the existing single-glazed enclosure. The steel frames encasing the new insulating glass increased the original sightlines, modified the exterior appearance of the glazed enclosure and overshadowed its distinctive semicircular transom pattern (fig. 5).

The insertion of insulated glass units in the aforementioned tests rendered positive results to reduce condensation on the glass surfaces, if not eliminating it completely. There was no observed condensation, but observations were occasional and intermittent. However, the shallow glazing pockets of the original steel frames provided insufficient space to install IG units according to current industry standards. The proximity of the IG units to the existing frames had the potential to compromise the integrity of their edge seals and void the fabricator's warranties.

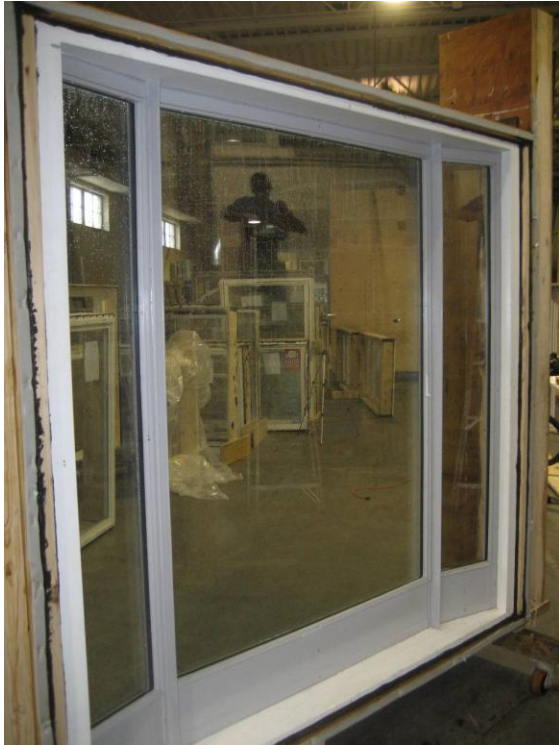
**Fig. 18:** View of typical mockup at testing laboratory.

The mockups were subject to a comparative testing at an independent testing agency. Water infiltration was tested according to ASTM E2268 – 04 Standard Test Method for Water Penetration of Exterior Windows, Skylights, and Doors by Rapid Pulsed Air Pressure Difference. Structural properties were tested per ASTM E 330 Standard Test Method for Structural

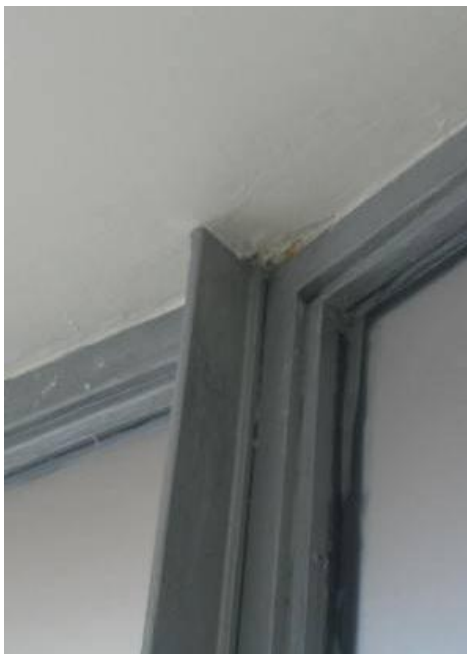
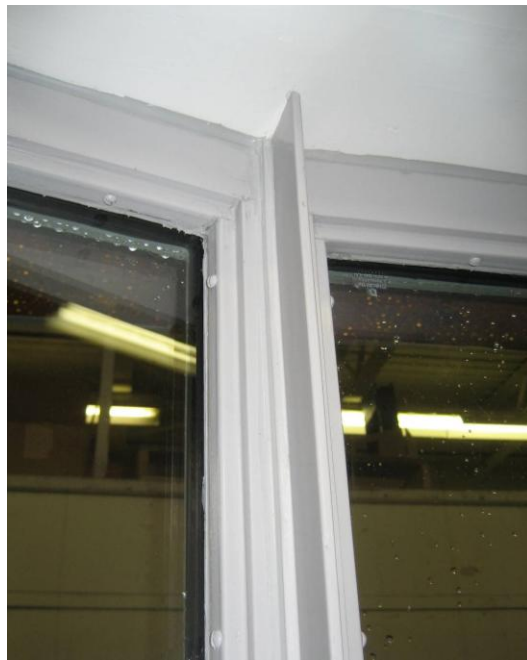
**Fig. 19 and 20:** Details of existing onsite frame detail (left) and at testing mockup (right).

Innovative construction details were proposed by selected manufacturers (fig. 16 and 17) to build the unprecedented system designed by WASA/Studio A and William B Rose & Associates. Two of these manufacturers were retained by the Guggenheim to construct equally-dimensioned mockups representative of the system proposed by each manufacturer. The mockups were designed to include configurations and details matching the existing conditions (fig. 18 to 20).

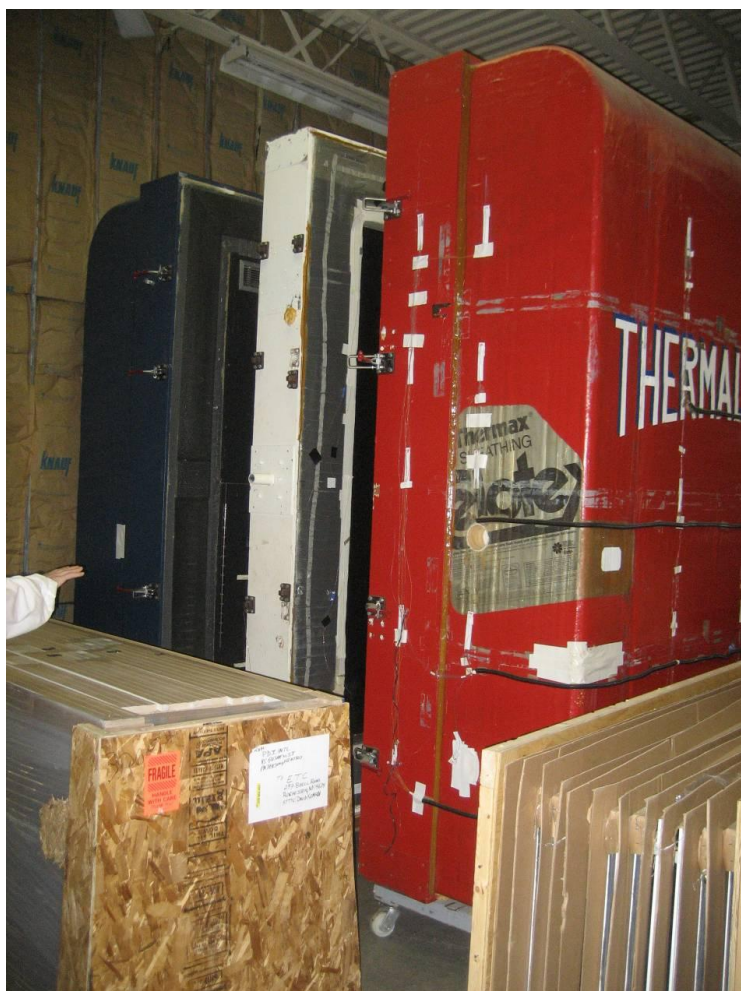
**Fig. 20:** Laboratory chamber where specimens were subjected to thermal testing.

Performance of Exterior Windows, Doors, Skylights and Curtain Walls by Uniform Static Air Pressure Difference. Thermal performance was tested according to AAMA 1503-98, Voluntary Test Method for Thermal Transmittance and Condensation Resistance of Windows, Doors and Glazed Wall Sections. The testing findings can be summarized as follows:
