# **Envelope Thermal Failures Due to Wind Washing in Two-Story Homes**

James B. Cummings and Charles R. Withers, Jr.

Florida Solar Energy Center

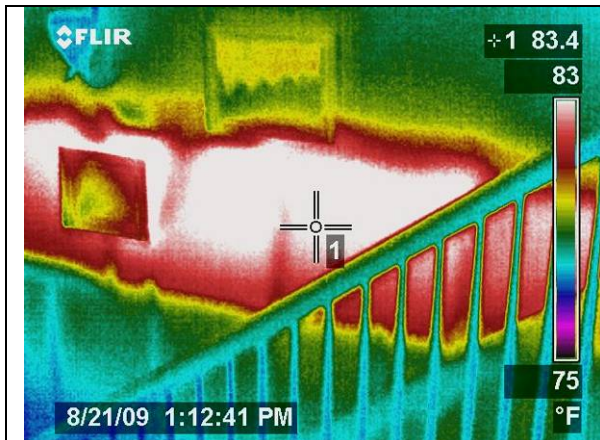
Figure 2 Infrared image at stairwell shows that floor space behind wall is very warm.  
(Image credit C. Withers)

During the cooling season, infrared scanning was typically done during early-to-mid afternoon when the sun had heated the attic substantially. During winter, scans were performed as early as practically possible while the attic was still cool. While effectiveness of thermography is limited by mild or cloudy weather, high mass construction, reflective roofing, or radiant barriers, it is very useful in a variety of conditions. Figures 2 and 3 provide a good illustration of a strong thermal signal resulting from wind washing when the outdoor temperature was about 90°F. In Figure 2, specifically, the thermal signature shows where hot air (from an attic space located above a one-story portion of the house) has been able to migrate throughout the interstitial floor cavity, between the first and second floors of the house. This pocket of hot attic air has been pushed into the inter-floor cavity where it delivers considerable heat, by means of conduction, convection, and radiation to the ceiling of the first floor, the floor of the second story, and a portion of the stairwell wall.

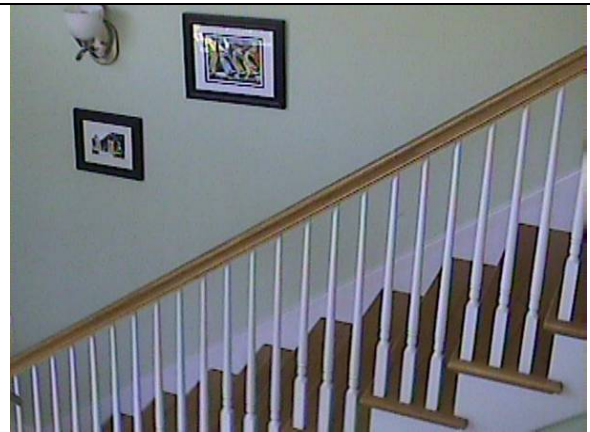
Figure 3 Visual image of stairwell. The location of the floor cavity can be referenced to the location of the pictures. (Withers)

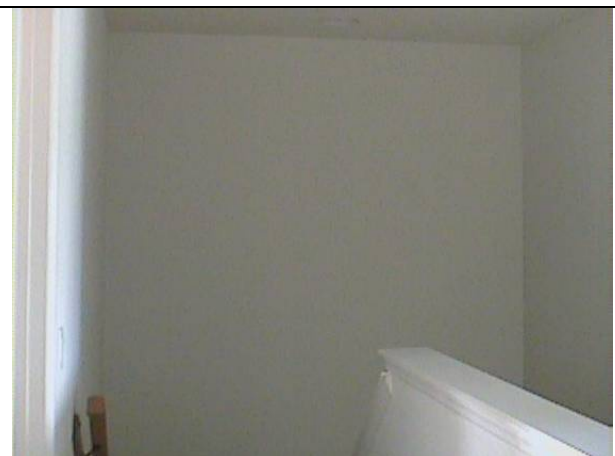
Figure 5 Photo of the stairwell wall matching the IR image of Figure 4. (Withers)

Figures 4 through 6 illustrate a second form of wind washing. In this instance, hot air from an attic space behind the stairwell wallboard migrates behind insulation batts and against the wallboard. This air flow can occur when insulation batts are not held tightly against the wallboard. Figure 6 shows that the batts have not been properly positioned to maintain contact with the wallboard. As the hot attic air comes into contact with the cool wallboard, it cools, becomes denser, and falls toward the attic floor, only to be replaced by additional hot attic air. This convective loop, driven by temperature differential and air density differentials, continues throughout the day and peaks during the hottest hours of the day. This particular form of wind washing (in this instance driven primarily by convective looping), where the insulation is not tightly held against the wallboard, was found to produce a significant energy flow effect in only one of the 32 field-tested homes.

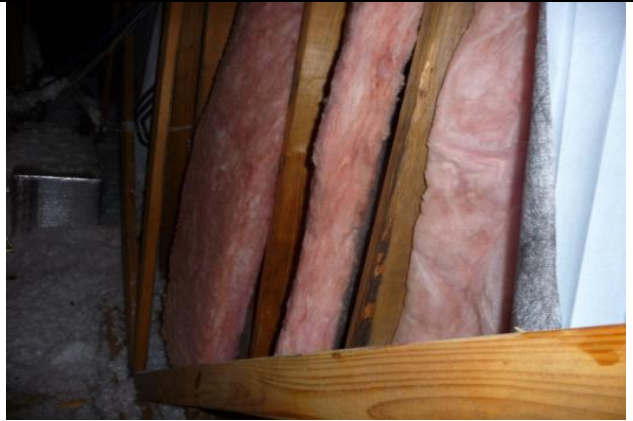
Figure 6 Insulation batts are not consistently in close contact with the wallboard, allowing considerable convective heat exchange between attic air and wallboard, as shown in Figure 4. (Withers)

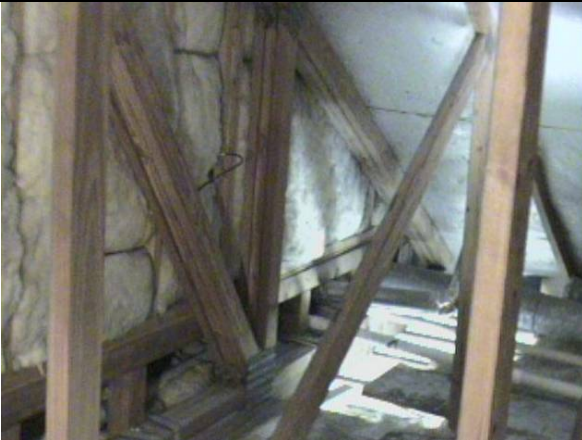
Figure 7 Photo of IR image above. The floor cavity at the bottom of the wall is open to garage attic. (Withers)

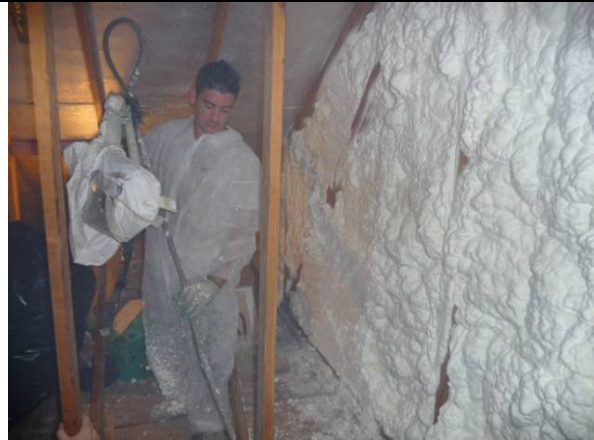
Figure 8 Technician finishes up kneewall and floor cavity insulation/air tightening. (Ian LaHiff)

All six central Florida homes were repaired in the same month (September 2009) and in all cases, open-cell foam was applied to seal openings of the between-stories floor cavities (Figures 7 and 8). In two homes, duct leak repairs were also separately implemented. The researchers

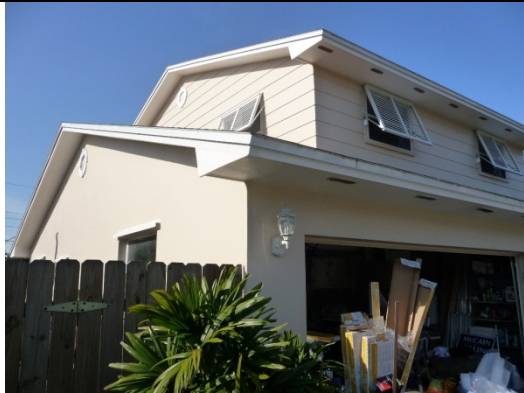
Figure 12 Shallow attic at front of house H11C. Oval vents allow air from outside into attic. No peak or off-peak vents were used.

Wind washing pathways into the floor cavity create the connectivity to outdoors through which duct leakage can flow. Consider house H11C (previously shown in Figures 12-15) which has more duct leakage on the return side than the supply side. Return leaks were drawing air from

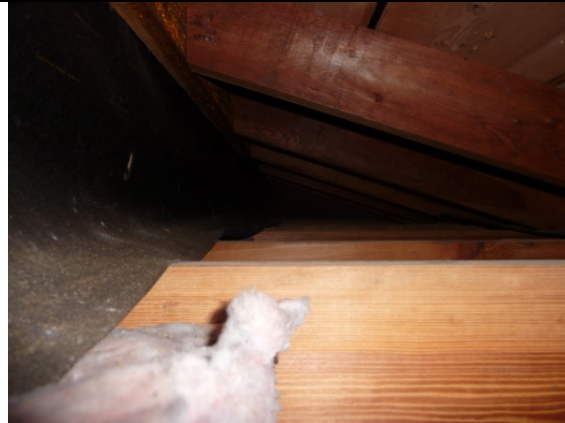
Figure 13 View inside shallow attic eave; vents are to the right and floor cavities are to the left. Attic ventilation air could flow from right to left, under the tar paper, over the batts, and into the floor cavities.

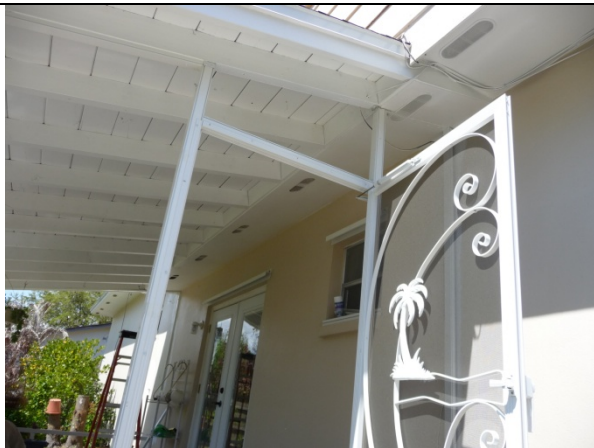
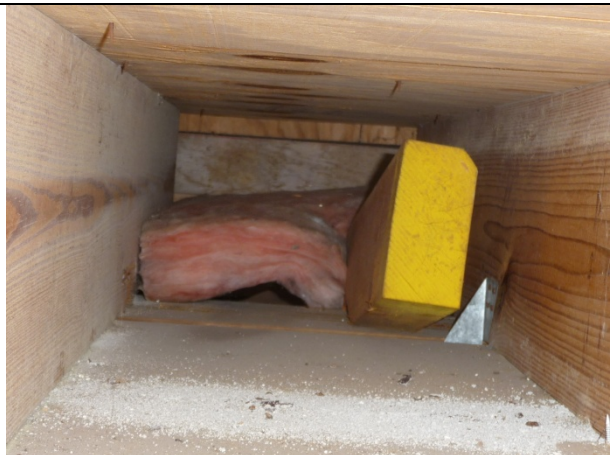
| Figure 14 Cantilever floor has eave vents underneath (elongated ovals) which open directly into the floor cavities, as shown in Figure 15. This means that the floor cavities are open to outdoors. | Figure 15 View inside one floor cavity which is open to one of the vents shown in Figure 14 (looking toward vented eave). Air from vent (below batt) bypasses the batt and flows into the floor cavity. |

In some cases, the attic space is small and the eave vents are in close proximity to the floor cavity (typically inaccessible to people), so the air is heated to a lesser degree (as in Figures 12 and 13). Figure 13 is an image obtained by moving into the attic space over the garage at the front of the house. The exterior of this area is seen in Figure 12. In other cases, there is no attic space at all, in which case the temperature of the entering air is similar to that outdoors (Figures 14 and 15). This can be seen in Figure 14, where the second story is cantilevered over the first floor, and the vents enter directly into the floor cavities without passing through an attic space.

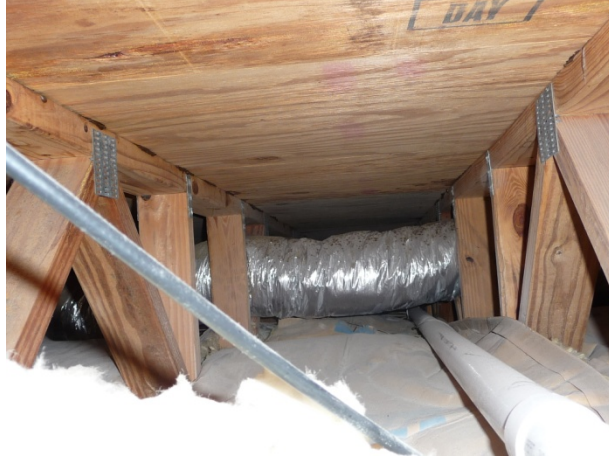
Figure 19 View inside floor cavity taken from opening to attic space. (Withers)

*Wind washing with no complimentary pathways.* The impact of wind washing is considerably lessened when there are no complementary pathways. In this circumstance, the attic air does not readily enter the floor cavity because the through-flow is restricted by the air barriers at the far side of the interstitial floor cavity. In the absence of ready through-flow, thermal buoyancy becomes a significant driver. The air in the attic is hotter and the air in the floor cavity is cooler. Therefore, air in the attic is less dense and the air in the floor cavity is more dense. Because of differences in air density, the cooler floor cavity air flows from outward into the attic, and the lighter attic air replaces the displaced floor cavity air. The rate of this air exchange between attic and floor cavity depends upon the height of the floor cavity opening and the temperature differential between the attic air (at the attic floor level) and the floor cavity air. Figures 19 and 20 show the floor cavity-to-attic interface and thermal stratification within the floor cavity of a home with no complimentary pathways.
