## **Frost Damage of Roof Tiles in Relatively Warm Areas in Japan: Influence of Surface Finish on Water Penetration**

### **ABSTRACT**

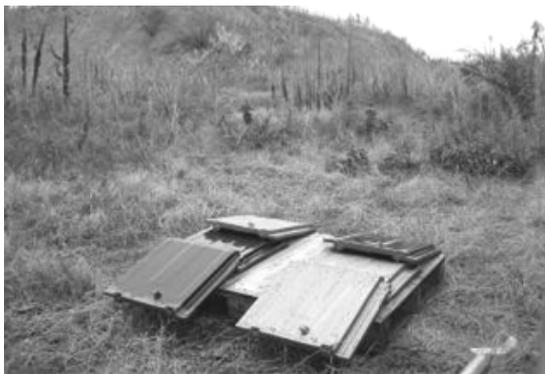
To examine the water absorption characteristics of tiles, two simple experiments were performed; one in an outdoor environment and the other in a laboratory. In the outdoor experiment, four roof tiles were arranged so as to simulate an inclined roof and were exposed to outdoor conditions as shown in Figure 1. The weather was cloudy with intermittent rain. Figure 2 shows a section of the tile cut after exposure. The area that absorbed water is clearly distinguished, and the water content distribution is not uniform even in a single tile under actual climatic conditions.

FIGURE 1: Test specimens placed outdoors      FIGURE 2: Sections of the specimen

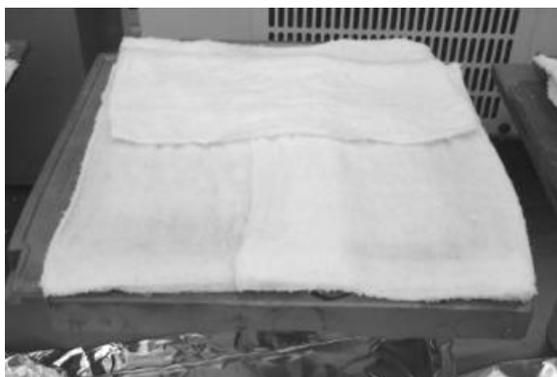
In the laboratory experiment, water was supplied to the specimen by placing a fully wet towel on the surface so that the water could be supplied without excessive pressure as shown in Figure 3. A section of the specimen obtained 9 h after the start of the experiment is shown in Figure 4. Non-uniform water distribution was also observed.

FIGURE 3: Wet towel placed on the surface      FIGURE 4: Sections of the specimen after 9 h

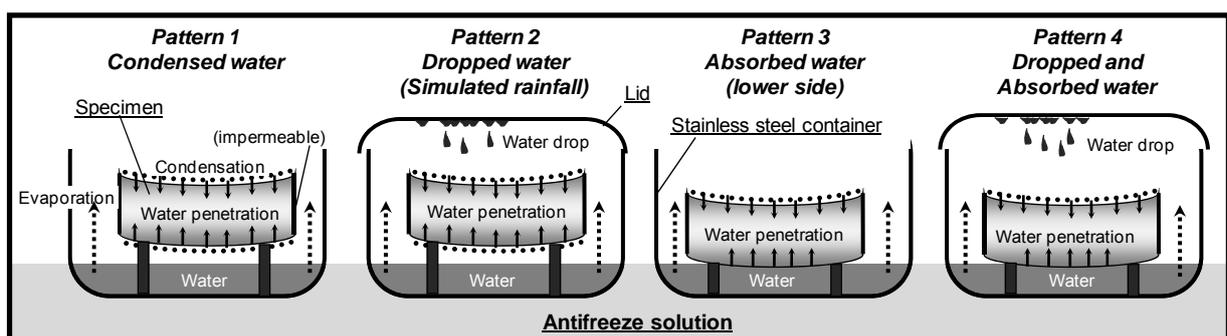
To investigate the influence of water absorption on tile deterioration under actual climatic conditions, a new freezing–thawing test was designed and conducted. The four types of water supplies shown in Figure 5 were used in this experiment. Each type is named as Pattern 1, 2, 3 and 4, respectively.

In Pattern 1, only surface condensation occurs. The water drops condensed on the upper surface of the specimen in Patterns 2 and 4. In Patterns 3 and 4, the lower surface of the specimen is immersed approximately 5 mm below the water surface. The amount of water supplied successively increases from Patterns 1 to 4.

FIGURE 5: Four types of water supplies

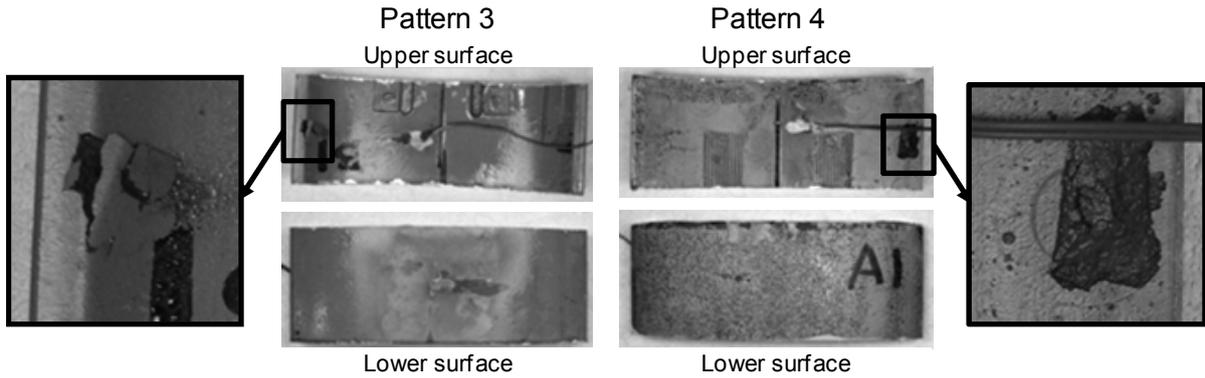
Figure 6 shows the appearance of the specimens in Patterns 3 and 4 after 56 cycles. Fine flaking appeared and increased to cover the entire lower surface as the cycles continued. Furthermore, spallings occurred near the ends of the upper surface, although the upper surface was not immersed in water throughout the experiment.

FIGURE 6: Appearance of specimens in Patterns 3 and 4 after 56 cycles

In Patterns 1 and 2, no apparent damage was found in the specimens after 56 cycles. After 90 cycles, damage similar to that in Pattern 4 was found in Pattern 2, where many fine flakes (approximately 1mm in size) appeared on the lower surface.

These results show that if droplets continuously fall on the specimens, even small droplets can penetrate the main body through the surface finish and can cause spalling similar to that found under actual conditions.

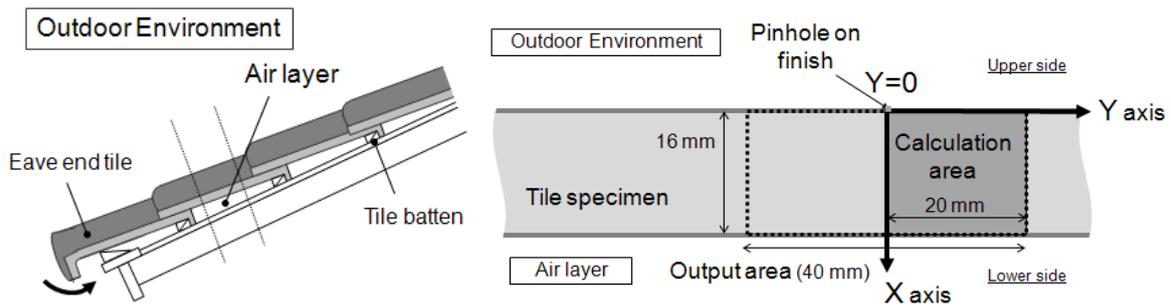
Figure 7 shows the section of a typical roof installed with roof tiles and the calculation model. An eave end tile is placed on the roof end, and other tiles are hung on the tile battens partially overlapping the lowermost tile. Generally, the undersurface of a roof tile is exposed to an air layer. Thus, both surfaces of the tile are assumed to be exposed to outdoor air in this calculation.

FIGURE 7: Section of a typical roof with roof tiles and the calculation model

A part of a tile with a surface finish on both sides is analyzed. The upper side contains a pinhole whose width is set at 0.1 mm (1/400 of the output area). The water resistance of the pinhole area is assumed to be extremely small than that of the surface finish. The calculation area and the output area are shown in Figure 7. The heat and moisture transfer properties of the tile body and surface finish are shown in Table 1.

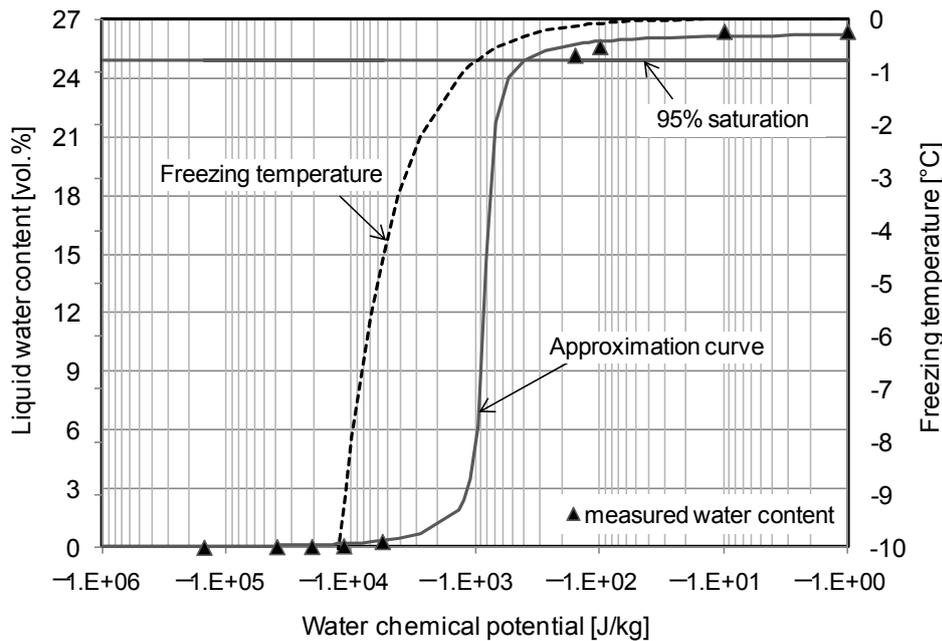
Figure 8 shows the absorption isotherm of the tile body. The moisture condition is expressed by the water chemical potential instead of the relative humidity. The freezing temperature calculated by Equation (3) is also plotted. It can be observed that when the tile is nearly saturated (approximately 95% saturation), it can freeze at a temperature slightly below 0°C.

FIGURE 8: Absorption isotherm and freezing temperature

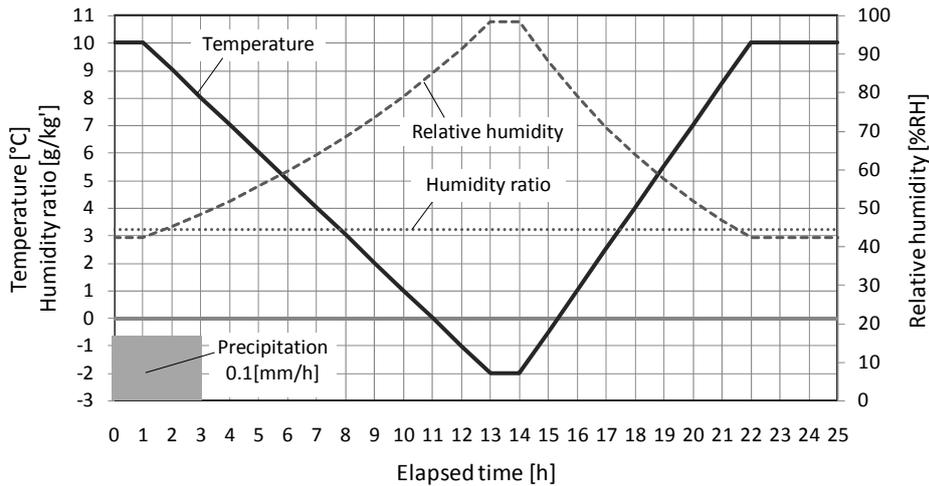
The environmental conditions were determined considering the colder conditions of a warm area in Japan, in which the minimum outdoor air temperature is below 0 °C. In this calculation, a situation is modeled in which the outdoor temperature decreases linearly to  $-2.0$  °C after a small amount of precipitation. Solar radiation is not considered since the weather is assumed rainy or cloudy through the periods. In order to simplify the analysis, night-sky radiation is not also considered, because the amount of radiation depends on the slope and the emissivity of the roof. The determined temperature, humidity, and precipitation are shown in Figure 9.

FIGURE 9: Environmental conditions

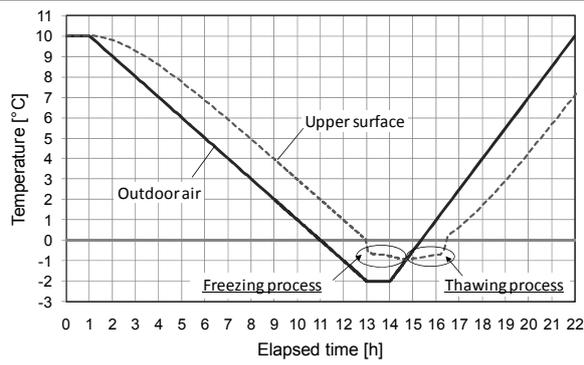
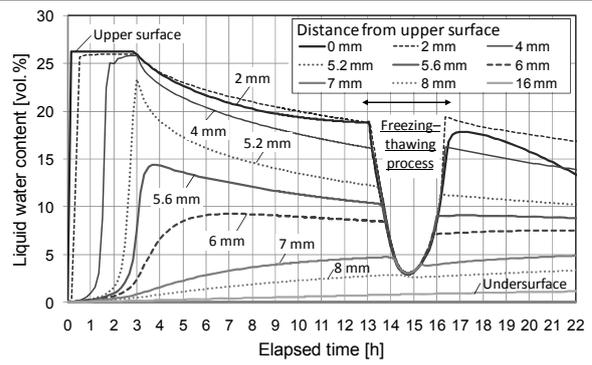
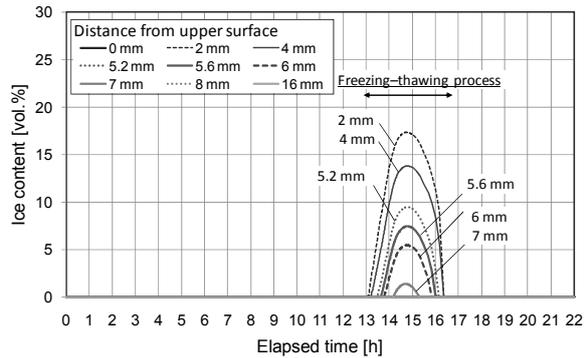
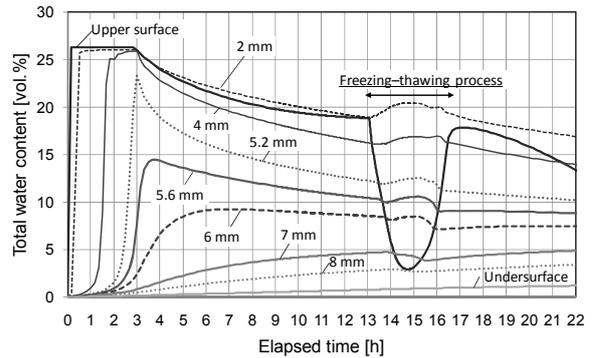
The time profiles of temperature, liquid water, ice and total moisture contents in Pattern a-1 are shown in Figure 10. Total moisture content is the sum of the liquid water and ice contents. These are the results for the position  $Y = 0$  (along X-axis). Because the tile thickness is relatively low (16 mm), the temperature of the inside and undersurface of the tile is almost the same as that of the upper surface. In both the freezing and thawing processes, the temperature changes gradually compared with those without phase changes.

The liquid water content increases from the upper surface to the inside in about 3 h because of rain penetration. When the temperature reaches the freezing point, freezing occurs in the high water content zone. In Pattern a-1, freezing occurs up to a depth of 7 mm in the upper surface.

Although volume expansion of water due to freezing is not considered in this calculation, the total moisture content slightly increases in the freezing zone. This is because the liquid water content decreases during the freezing process, which causes a decrease in the water chemical potential, and unfrozen water flows into the freezing zone from a neighboring unfrozen zone. In the zone closest to the pinhole ("Upper surface" in Figure 10), freezing does not occur because of decrease in water content due to an outflow to the freezing area and evaporation.

FIGURE 10: Time profile for Pattern a-1

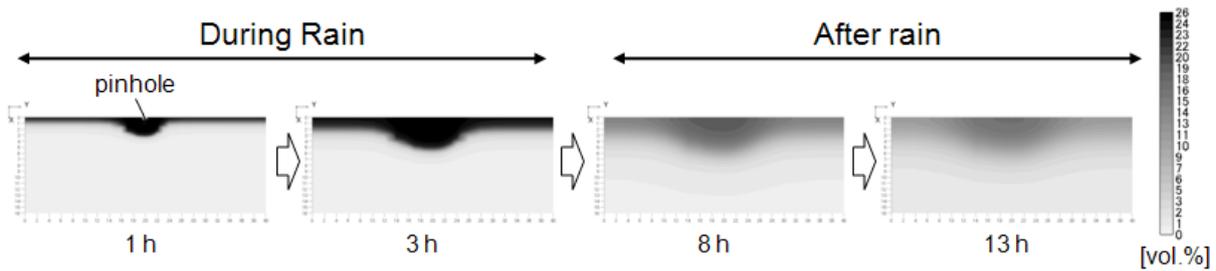
Figures 11 and 12 show the change in liquid water content distribution 1, 3, 8, and 13 h after the start of Pattern a-1 and Pattern a-2 calculations, respectively. The high water content zone spreads to approximately 3 mm depth and 8 mm width around the pinhole after 1 h of rain. When 3 h elapse, the area expands up to 6 mm depth and 12 mm width. During the rain, the area with high water content can be clearly distinguished.

FIGURE 11: Change in moisture distribution in Pattern a-1 (before freezing)

After the rain stops, liquid water around the pinhole moves inside the tile body, which remains dry, and evaporates through the surface finish, especially, the pinhole. Because moisture diffuses faster in Pattern a-2, the high water content area becomes indistinguishable.

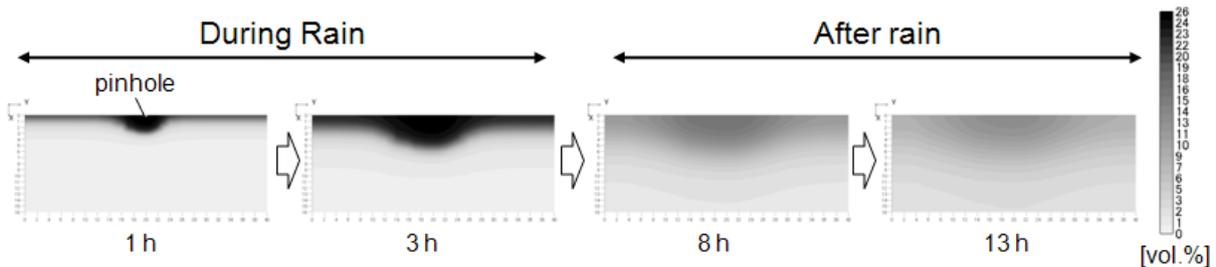
FIGURE 12: Change in moisture distribution in Pattern a-2 (before freezing)

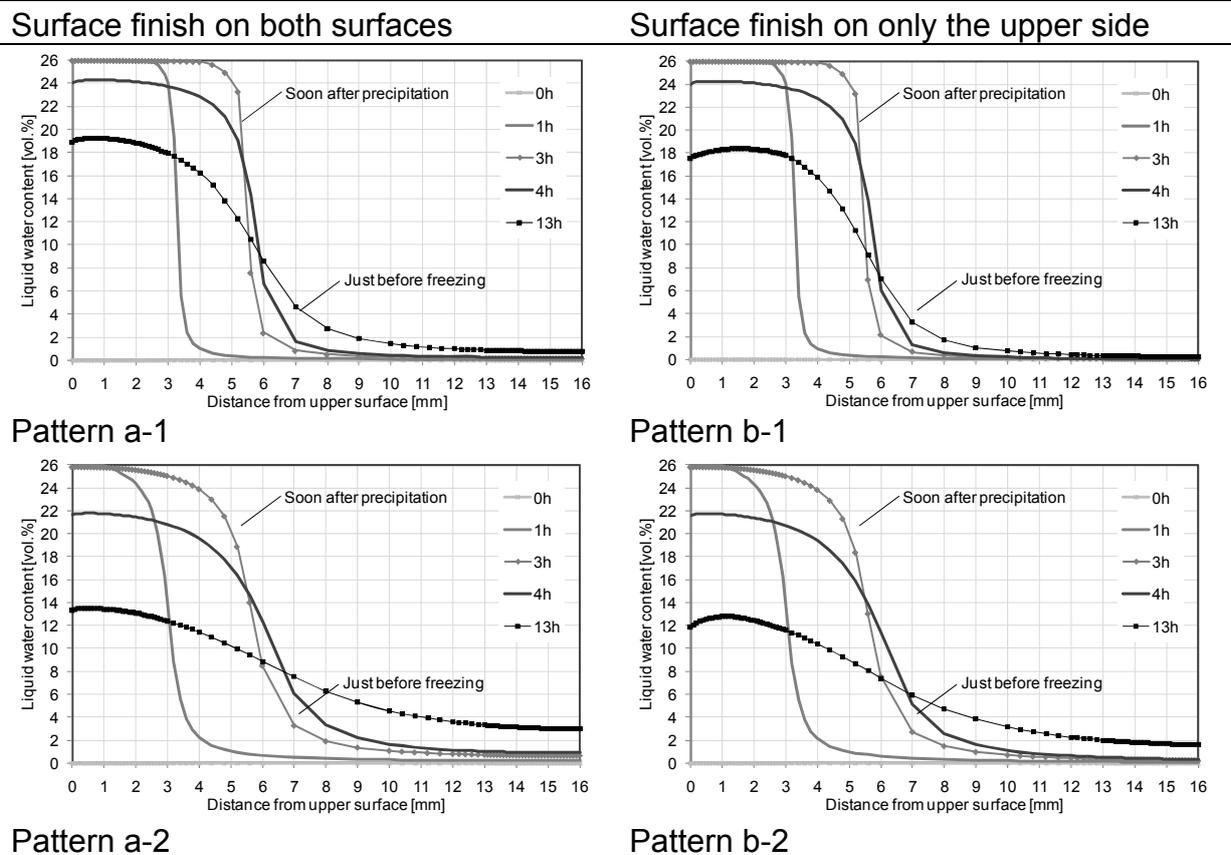
Figure 13 shows the liquid water content distribution before freezing at the position  $Y = 0$  (along X-axis) in all calculation patterns. When the moisture permeability is smaller (Patterns a-1 and b-1), the difference in distributions is not influenced by the surface finish position. When moisture moves faster (Patterns a-2 and b-2), water penetrates to a larger distance from the upper surface through the pinhole. Because the undersurface is unfinished in Pattern b-2, moisture inside the tile can easily evaporate from the undersurface; therefore, the water content near the undersurface is lower than that in Pattern a-2.

FIGURE 13: Liquid water content distribution before freezing ( $Y = 0$ )

As shown in Figure 13, the water content distribution becomes more uniform in Patterns a-2 and b-2 because the moisture transfers faster than in Patterns a-1 and b-1. The maximum ice content does not increase significantly, but the freezing range may be expanded.

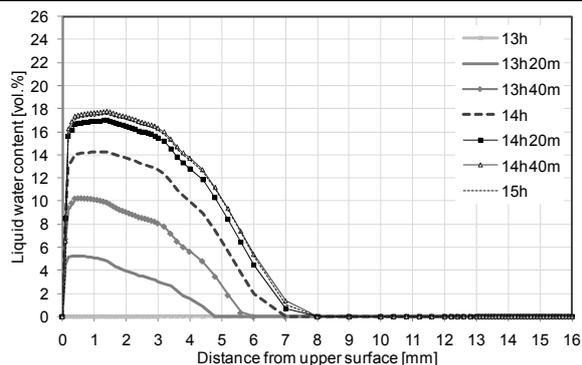
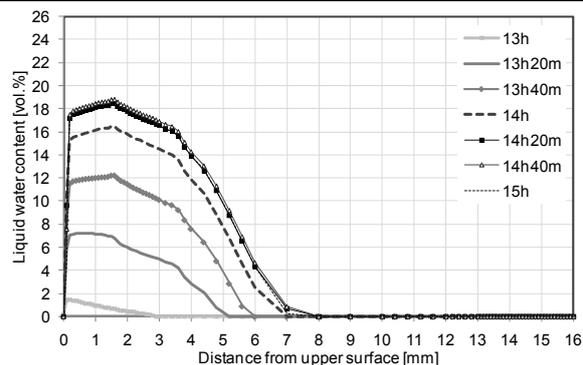
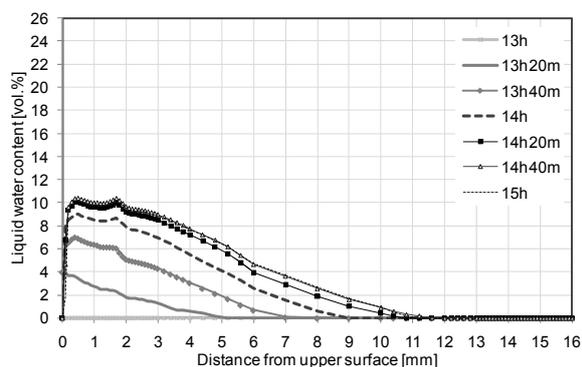
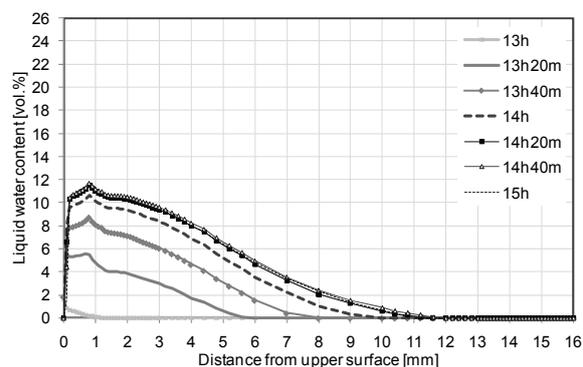
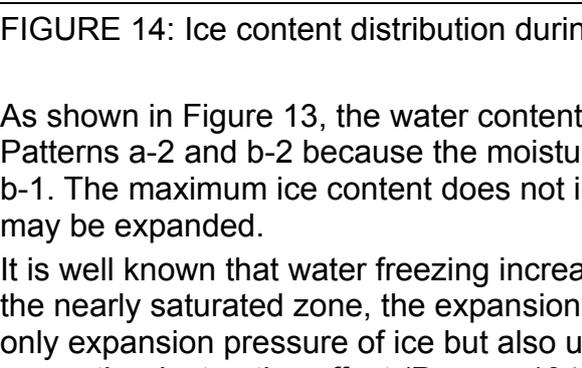
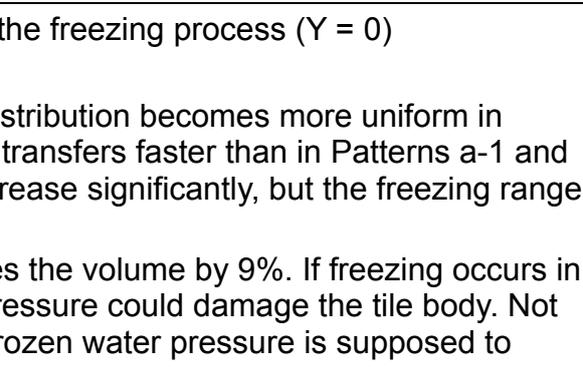
Figure 14 shows the ice content distribution during the freezing process. When the temperature and the water chemical potential (corresponding to the liquid water content) satisfy the freezing condition defined by Equation (3), ice formation starts at the zone. Latent heat is generated in the freezing zone; thus, the temperature increases slightly. Furthermore, as described before, because unfrozen water flows into the freezing zone from a neighboring unfrozen zone and the water content increases, ice grows with time. The amount of ice formation is determined according to the heat and moisture transfer balance.

FIGURE 14: Ice content distribution during the freezing process ( $Y = 0$ )
