## Introduction.

The seminar presents typical challenges and solutions associated with sloped glazing and skylights. The seminar presents a history of development of sloped glazing, different classifications, including the one developed by the author on basis of the air barrier location, types of internal and external drainage of sloped glazing, structural challenges typical sources of failures, applicable construction testing procedures, code compliance, maintenance access to the sloped glazing, safety standards, challenges involved in obsolete code interpretation as related to the modern glazing, analyses of frequently misunderstood details, examples of correct details, and energy ramifications of sloped glazing. Case examples will include typical cases of leakage, condensation and icing, thermal simulations of skylight, as well as a structural collapse of a monumental sloped glazing. Many designers and builders treat sloped glazing as it were a tilted curtain wall. However, this proved to be one of the most challenging assemblies, seldom fully understood by their own manufacturers, fabricators, and installers, as well as building enclosure consultants. This may be well illustra

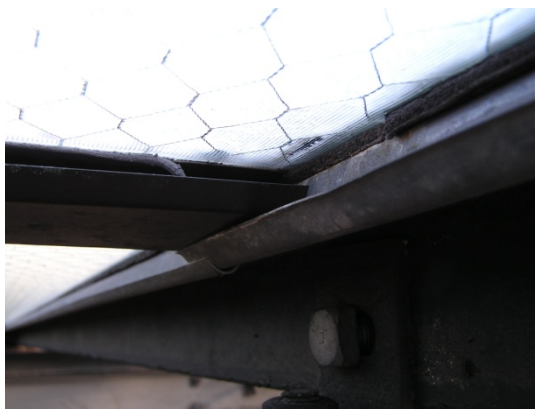
Figure 3 Condensate drainage in 1916 skylight in Cleveland Museum of Art, Cleveland, OH.

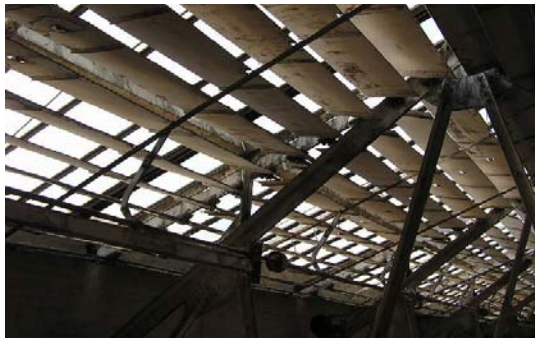
Figure 4 Operable internal louvers in 1916 skylight.

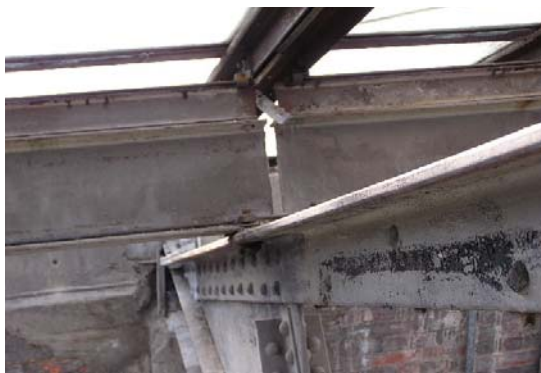
Figure 5 Movement joint with split rafter in the 1916 skylight.

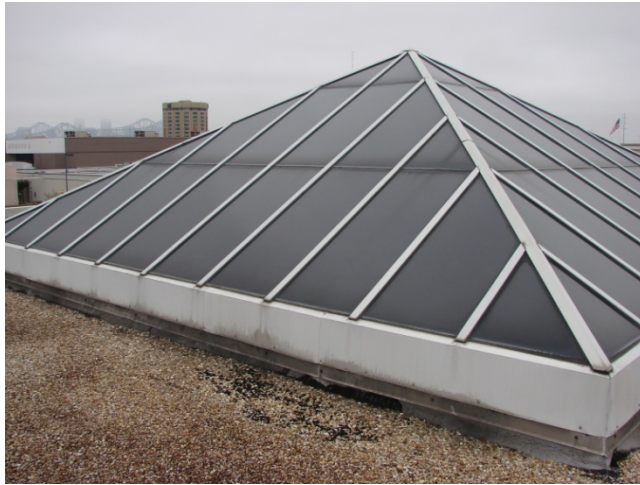
Figure 6 One of typical pyramid-shaped skylights built from 1950's in Gretna, LA.

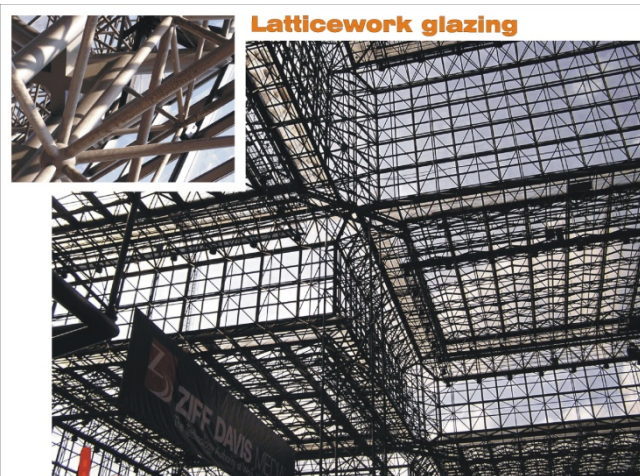
Figure 7 Sloped glazing on a latticework in Jacob K. Javits Convention Center in New York City in 1980's.

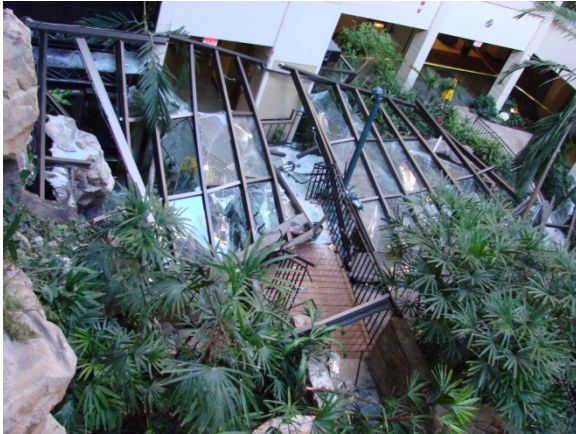
Figure 10 Sloped glazing built in 1980's investigated after collapse. 2008 Performance

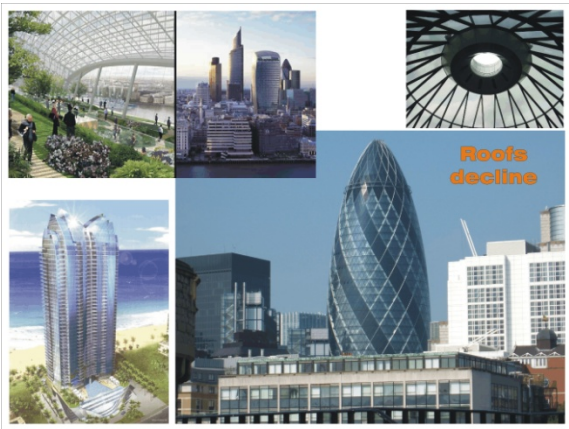
Figure 11 Sloped glazing in lieu of roofs.

The architectural Deconstructivism merged curtain walls with sloped glazing and substituted roofs with sloped glazing, as illustrated by numerous recent building examples (Figure 11). Large skylight-roof area ratios drain energy for air conditioning, and subject conversely larger spaces to the above-mentioned elevated functional failures' risk.

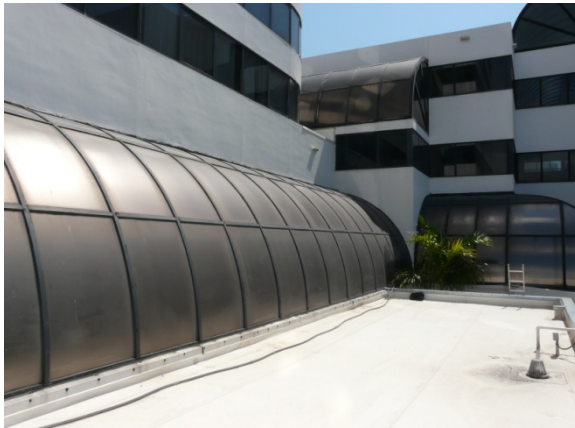
Figure 18 Popular (bad) example of the eave discharge below the sill flashing and roofing, causing the leak in the food court below. West Palm Beach, FL.

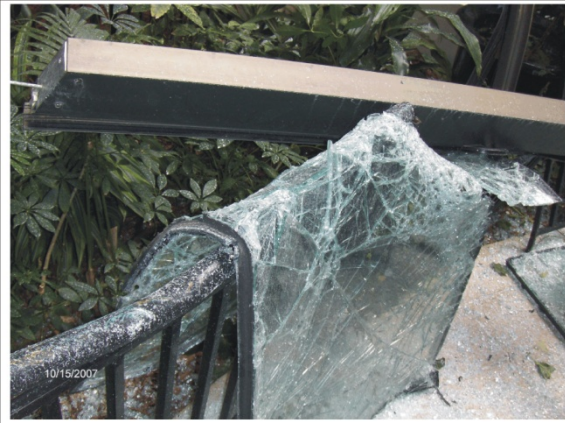
Figure 20 Collapse of the sloped glazing due to thrust inadequately resisted by anchor points.

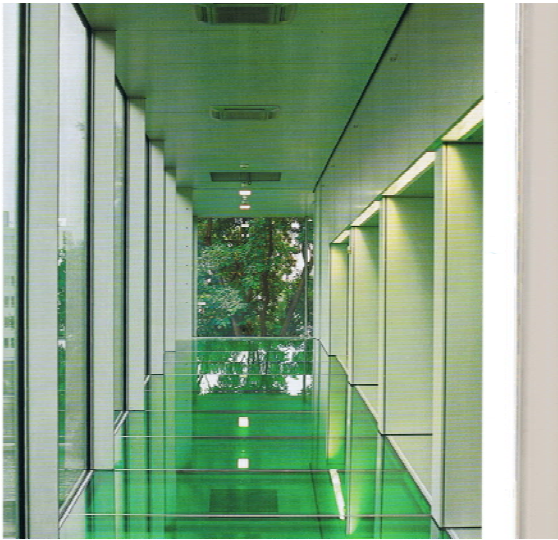
Figure 23 Exterior glass floor is considered a skylight.

portable cranes and aerial platforms, which should be able to access the adjacent spaces. The code extends the definition of skylights onto overhead glazing; therefore, embracing the glazed exterior floors (Figure 23). Large glass sizes used nowadays may overstrain the perimeter attachment in the unlikely event all glass layers are broken (e.g. discharge of a firearm) due to the significant weight which may be combined with live loads, such as snow

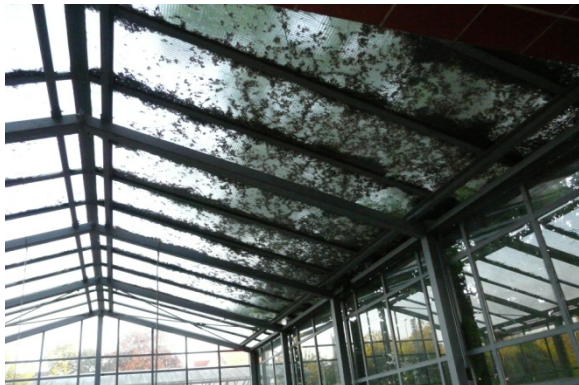
Figure 27 Collection of dirt. Berlin, 2008

Valleys, gutters, and insufficient slope contribute to the sedimentation associated with insufficient air and water velocity for particle removal at the surface (Figure 27). The modern hydrophilic "self cleaning" glass is often specified as a remedy. However, such a glass type needs a sufficient slope to allow for rain washing.

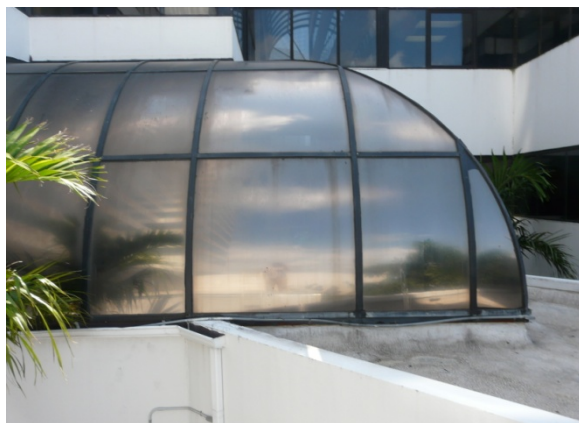
Figure 28 Corrosion and exterior condensation on pyrolytic coating. West Palm beach, FL 2011.

The overhead glazing is the best source of daylight. However, excessive size may result in significant solar heat gain, resulting in thermal discomfort and large energy bills. The most typical shading systems consist of interior fabric shades, stretched in a form of a tent below the glazing. The overhead glazing is typically coated with spectrally-selective and reflective coatings (Figure 28). The glass is also tinted in mass,
