A CASE STUDY FOR WATERPROOFING BELOW-GRADE WALLS SHORED WITH CONTINUOUS SOIL MIX TECHNOLOGY USING A BENTONITE WATERPROOFING SYSTEM

BEST3 Conference – Atlanta, Georgia

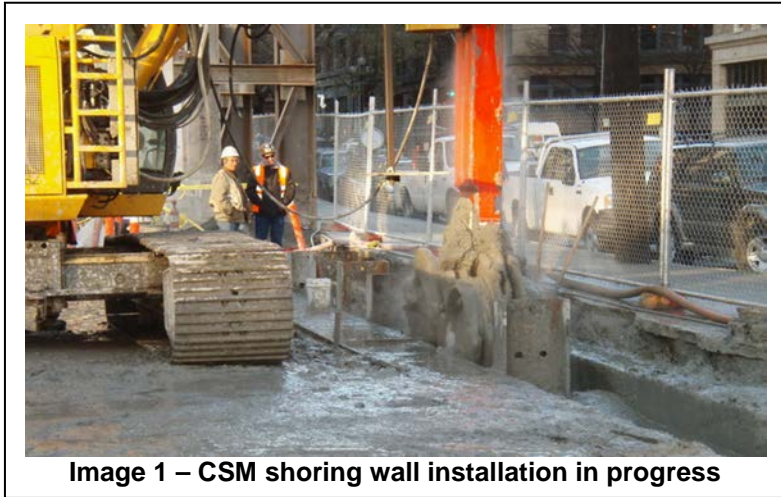
The final system selected was a cutter soil mix (CSM) shoring system. The CSM shoring wall is a modified soldier pile system that makes use of overlapping soil-cement panels to construct a strong and relatively watertight wall. CSM technology mixes the soil in situ with a cement and bentonite slurry, creating a solid and cohesive block. For this type of shoring wall, two sets of vertically mounted cutting wheels rotate on a horizontal axis creating a rectangular soil-cement panel. The mixing is performed using mixing paddles attached to the augers that are slowly driven into the ground. Refer to Photo No. 1 for a

view of the soil mix wall installation process. As the auger is rotated, the cement slurry is added through the hollow stem of the auger shaft. The mixing paddles are located above the auger to blend the soil and slurry. The slurry also helps break up the soil and lubricate the equipment as well as helping bring spoils in the mixture to the surface. A

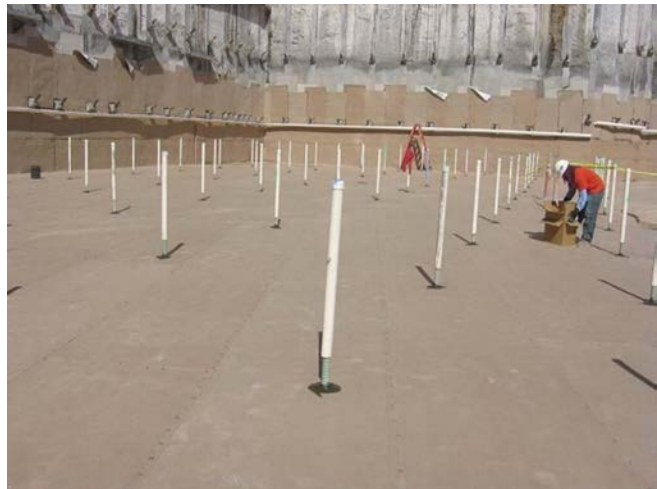
The waterproofing system was required to extend under the mat slab and all sump and elevator pits and to be tied into the wall panels in order to provide a continuous watertight assembly. Refer to Image 2 for an overall view of the bentonite membrane over the “rat” slab and tie-down anchor penetrations. A two layer rat slab was utilized with a single layer of bentonite membrane sandwiched between the slabs

Image 2 – Bentonite waterproofing membrane installed over rat slab and sealed around tie-down penetrations

after drilling of the tension piles through the bottom slab was completed. The top slab was used to provide a smooth and dry surface for the installation of the waterproofing membrane with the top layer providing a protection layer for the membrane as well as a solid working surface for equipment staging and the placement of the steel reinforcing for the 5 foot thick mat slab. The top layer of the rat slab as well as the mat slab were provided with sodium bentonite based waterstops installed at each cold joint as a secondary line of defense against water infiltration at the joints.

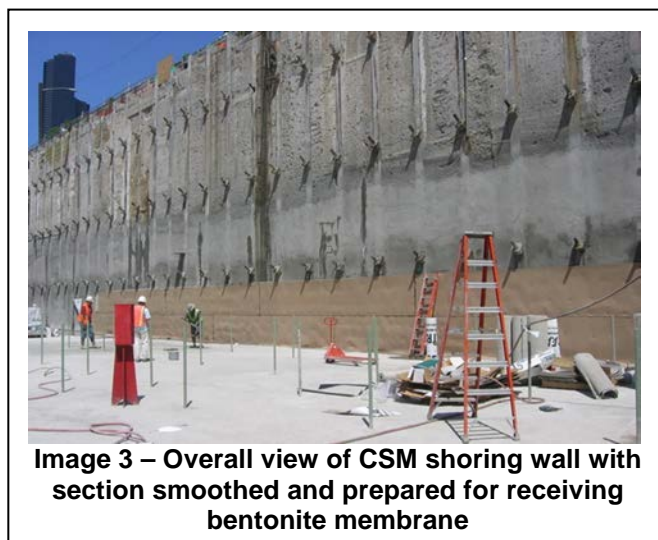
In order for the bentonite to perform effectively the membrane must be in intimate contact with the shoring wall. The shoring wall substrate was required to be prepared either with a layer of shotcrete that was troweled smooth or by filling any voids or large areas of rock pockets with

grout. Any fins, ridges or other protrusions at the shoring wall were ground down to level and smooth. Refer to Image 3 for a general view of the CSM wall with a section smoothed and ready to receive the bentonite waterproofing.

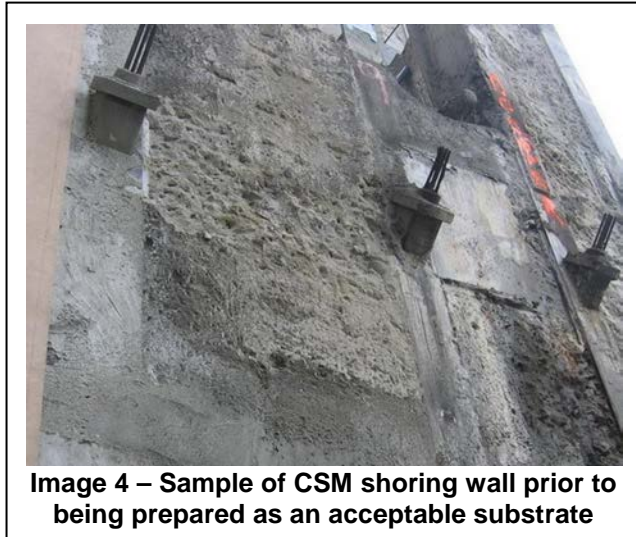
The CSM shoring walls, although intended to be flat and relatively smooth, were often wavy and had voids. Refer to Image 4 for view of voids and inconsistencies in the face of the CSM wall. It was determined that the waviness of the walls would not be an issue but that the bentonite needed be installed in direct contact with the substrate and any voids larger than 2- inches would require smoothing. A similar CSM shoring wall was reviewed and it was determined that approximately 10% of the surface of the shoring wall would likely require smoothing. This allowed for the shotcrete structural concrete to be applied directly against the membrane to confine the bentonite.

Image 4 – Sample of CSM shoring wall prior to being prepared as an acceptable substrate

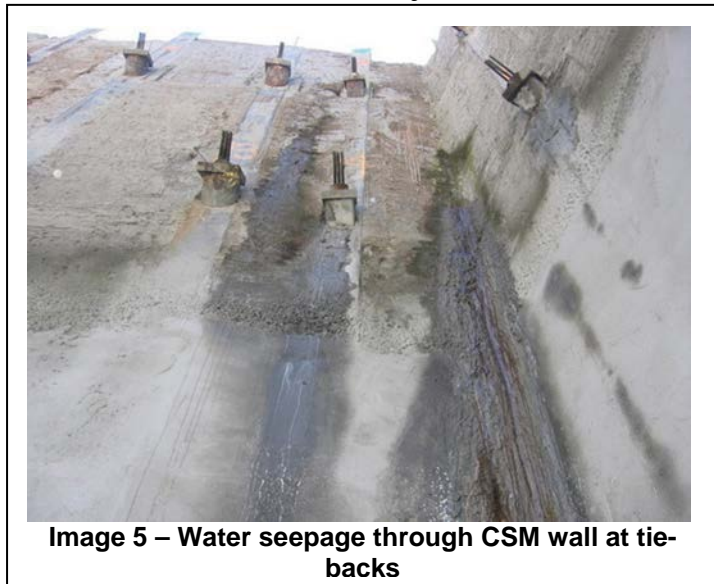
As was expected, the CSM wall did not provide a completely watertight cut-off wall. Water seepage from the perimeter water table was common at joints in the CSM and especially at the tie-back anchors. Refer to Image 5 for typical seepage down CSM wall. In order to maintain a clean and safe work area as well as keeping the bentonite products from significant hydration and damage, this water needed to be controlled as much as possible. A temporary system of gutters was installed at the upper levels of tie-backs to prevent the majority of the water from dripping down the walls and onto the slab. These gutters were not able to capture

Image 5 – Water seepage through CSM wall at tie-backs

all the water and other methods of addressing the water were needed. This included vacuuming ponding water from work areas and heat drying the concrete substrate at the

perimeter walls prior to installation of the waterstop at the horizontal cold joints at floor slabs and shotcrete foundation walls.
