LEARNING FROM EXTERIOR WALL PROBLEMS

Joseph P. Solinski

ABSTRACT¹

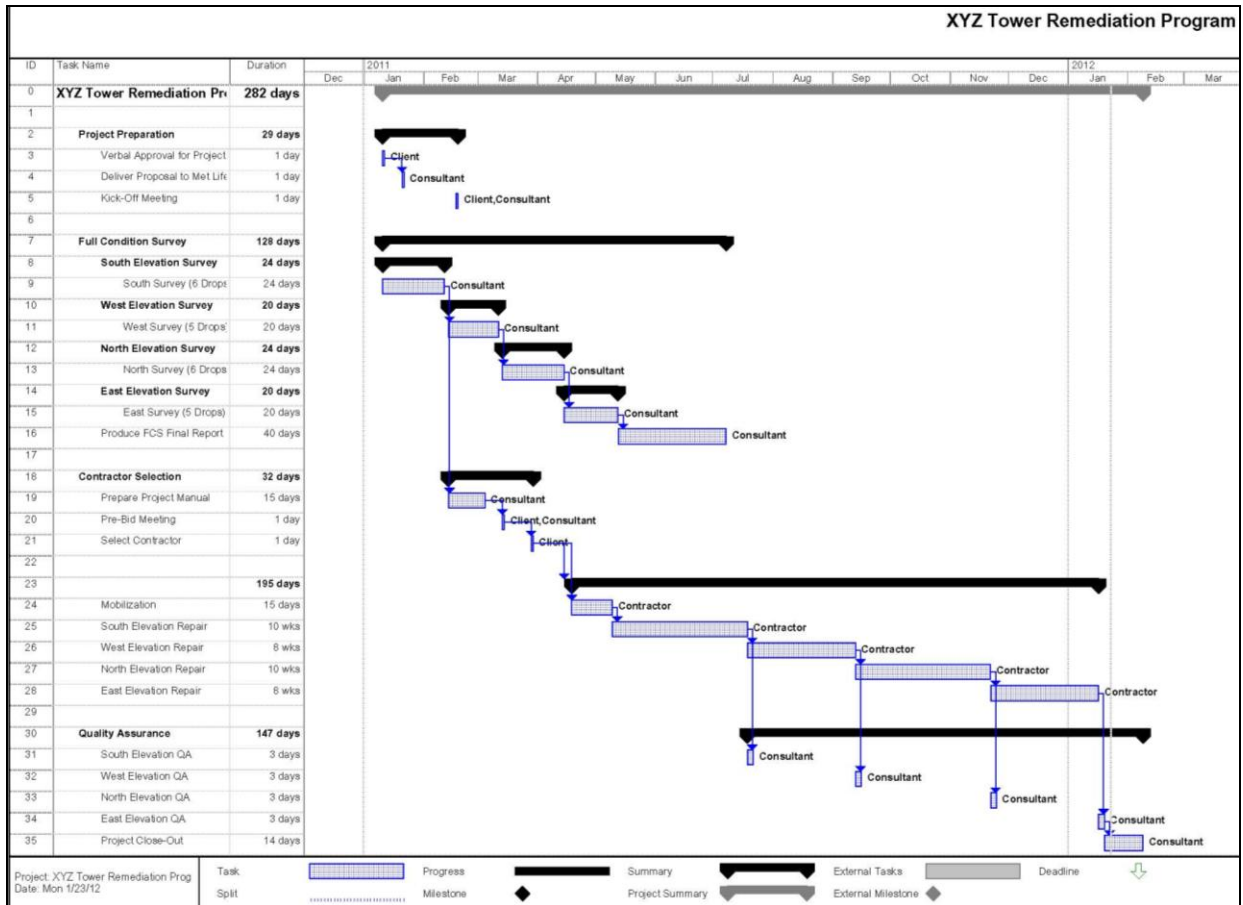
Figure 1: Example Gantt Chart of an Exterior Wall Survey and Remediation Program.

From a materials expectation, building facades are constructed to last a minimum of 20 years before some type of maintenance is required; however, many building facades require major renovation much sooner. Unfortunately, the industry practice is that most buildings are constructed with only a one-to-two year installation warranty specified. As a building is constructed, the project Gantt Chart (Figure 1) controls the jobsite schedule.

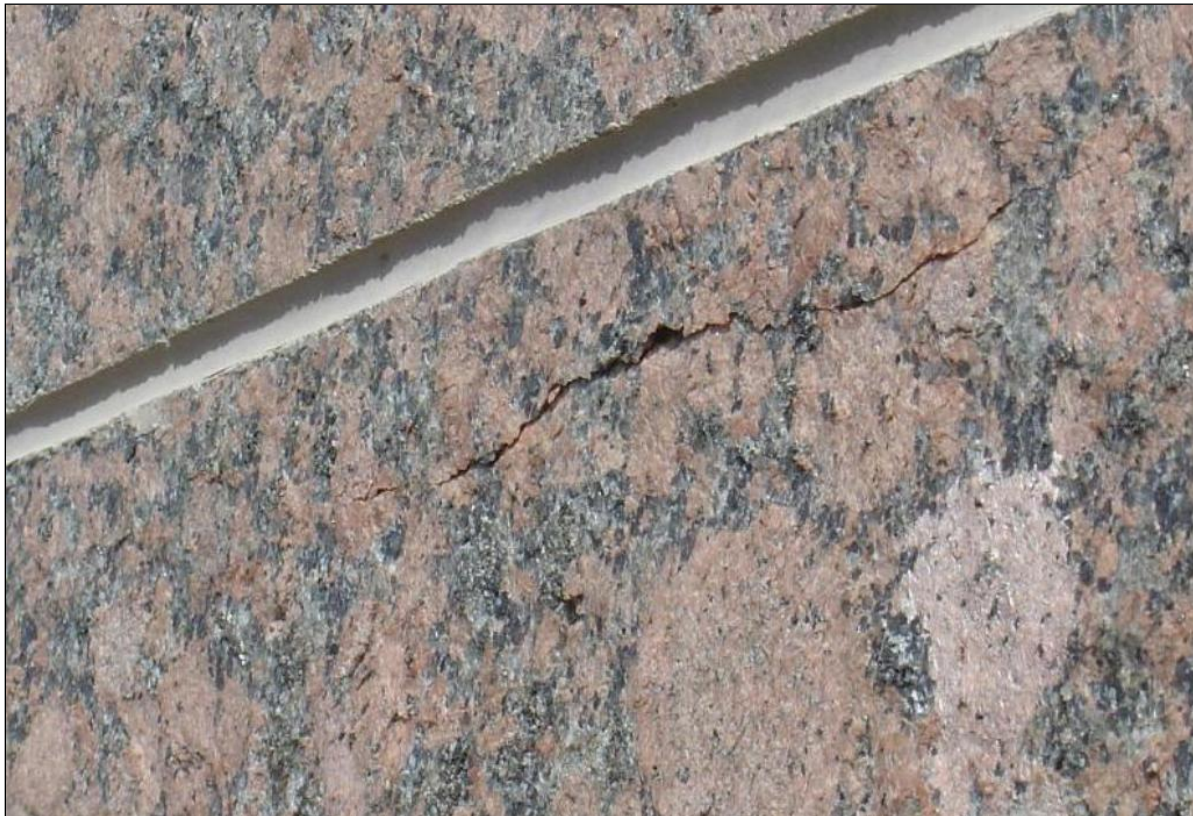
Figure 2: Cracks in Veneer cannot only allow water penetration, but can be a sign of structural instability in the cladding.

situations, it is not until organic growth (mold) develops or stone panels, brick veneer, or chunks of precast fall from the building that it is deemed necessary to make an evaluation of the problem and proceed with a scheduled maintenance program. (Figure 2) If the needed repairs go too long without a proper remedy, the repair costs can dramatically increase from an anticipated maintenance budget to an exponential version of the budget, becoming a tremendous burden to the property owner, management, and tenants.

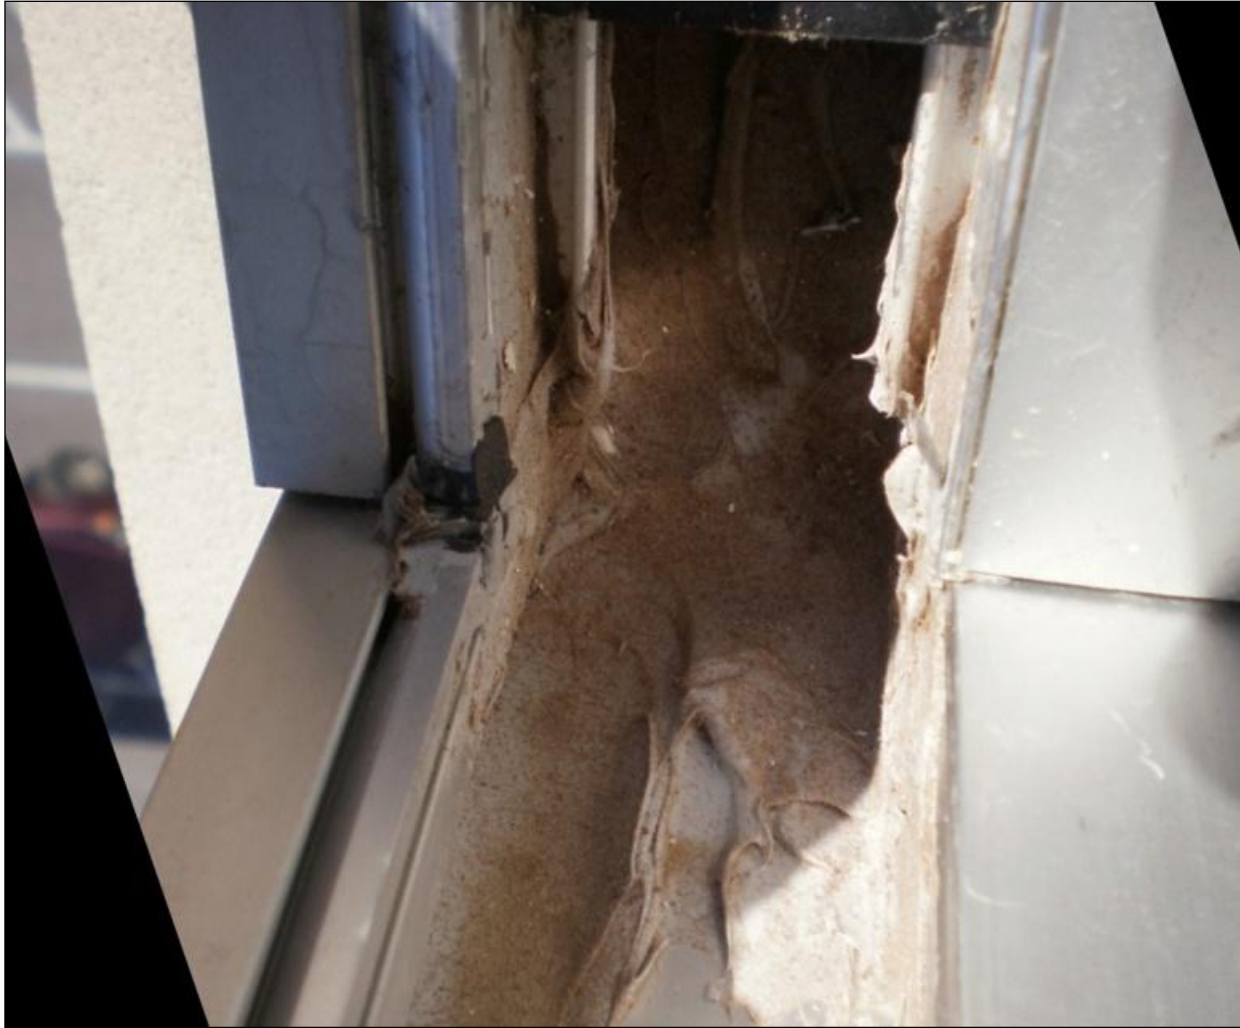
Figure 4: This is a typical end dam condition at a horizontal-to-vertical window mullion intersection. Checking window end dams by blocking the weep holes and filling the horizontal with prior to glass installation will save the Building Owner from future problems and costs.

On window systems in general, if the seals on the internal drainage system are not installed correctly in the shop or field, the installation will yield poor results and possibly allow water penetration. Components such as end dams and horizontal water diverters, which are located the internal glass pocket/gutter of the horizontal-to-vertical window mullion intersection, are frequently the culprit of water penetration issues on newly installed systems. Checking the integrity of these internal seals prior to glass installation will save the Building Owner from future problems and costs. Checking the end dams can be performed by simply blocking the weep holes with tape or putty and filling the horizontal with water. After a specified period of time (5 to 15 minutes), if water remains in the horizontal, the test was a success. If water appears on the interior space, then the seal is not effective. (Figure 4)

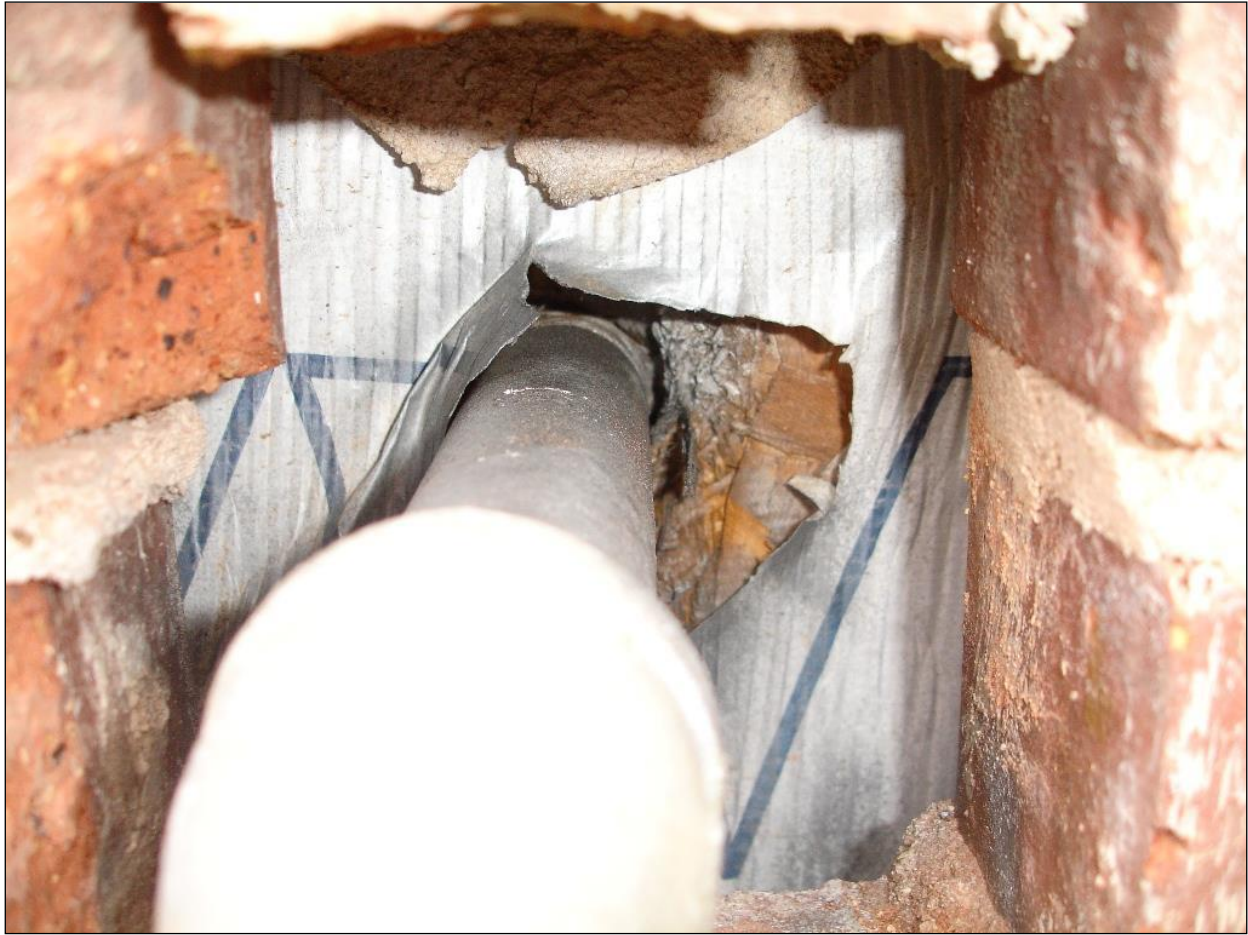
Figure 5: Hidden breaches and installation defects in the water-resistive barrier can allow water into the wall cavity and building interior.

Brick veneer systems can have issues with insufficient weep slots or holes or when excessive mortar has blocked the weep system. Excessive water can enter the wall cavity behind the brick if the head joints are not completely filled from front to back for the entire width of the brick masonry unit. After water enters the wall cavity, the system relies solely on the water-resistive barrier (WRB) to stop further penetration. Many times this WRB is ineffectively installed, breached with unsealed penetrations, or damaged during construction. These hidden holes in the WRB will allow water directly into the interior space and are very difficult to trace. (Figure 5)

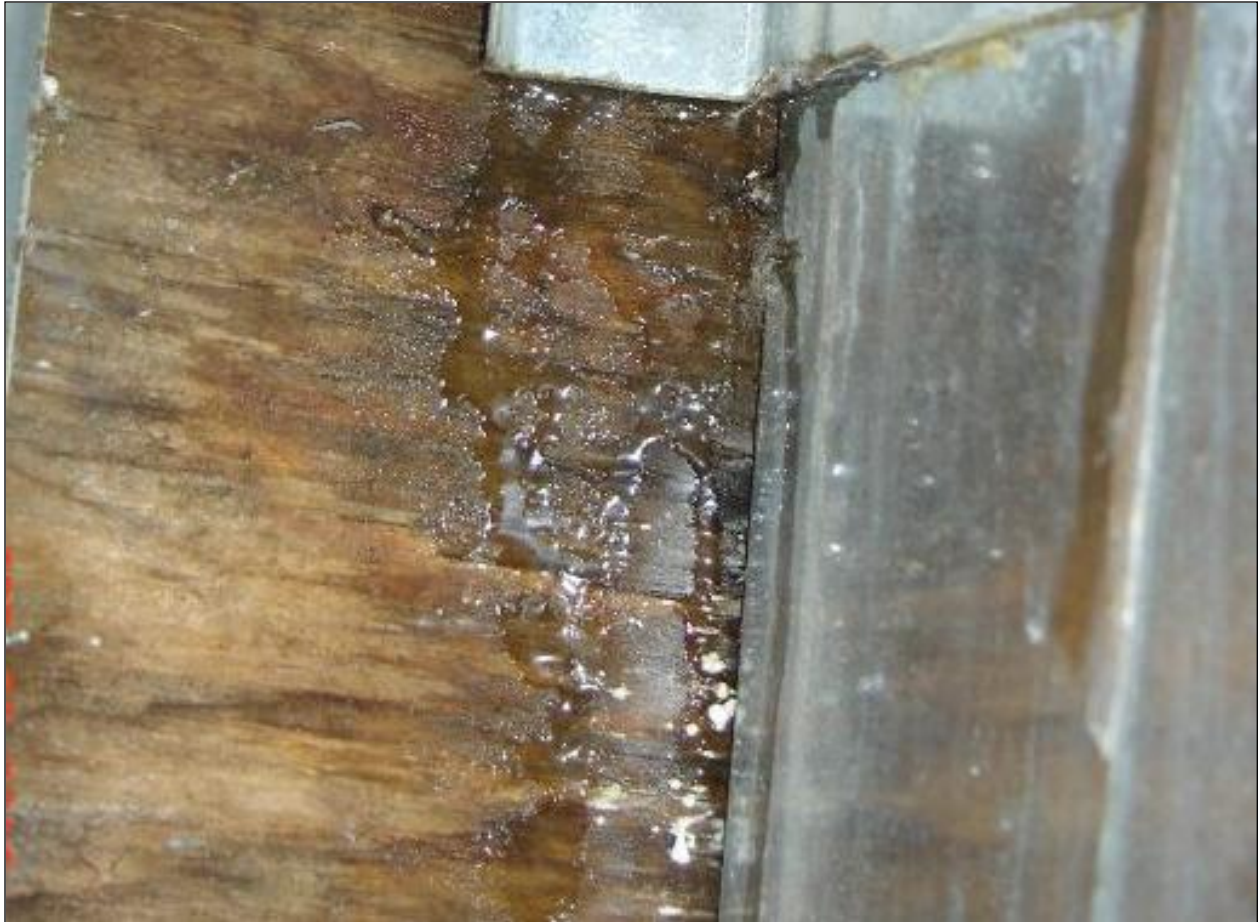
Figure 7: Water penetration in the wall cavity can go unnoticed if not evident from the interior of the building. This can eventually lead to hidden organic growth.

After a building has been completed and occupied with tenants, issues may develop over time. Sometimes an issue is not apparent because it has not visually manifested itself to a tenant or owner, but it could still be lurking in the wall cavity. Issues such as organic growth or even corrosion can be hidden for years before they are even noticed. (Figure 8) When cladding problems begin to reveal themselves in existing buildings, the exteriors should be surveyed to determine the cause of the exterior wall deficiencies, including such issues as water penetration, sealant failure, glass breakage, and/or other wall system failures.

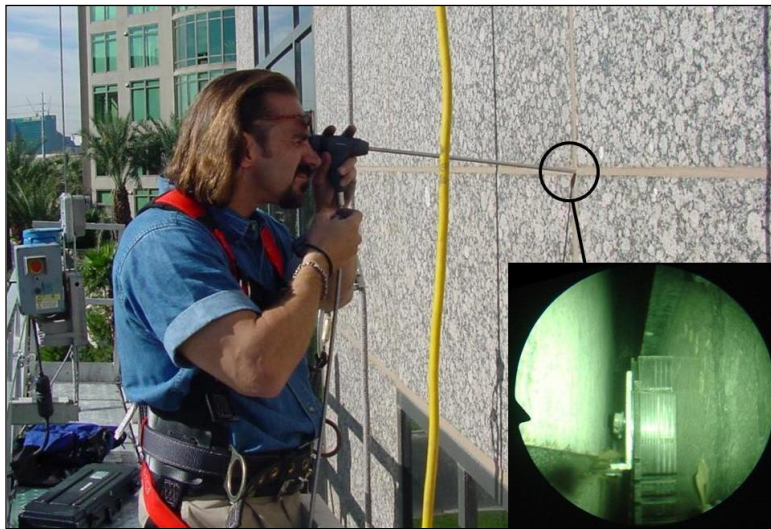
Figure 8: The borescope is an essential tool for reviewing conditions in the interior cavity of an exterior wall without destructive means.

Another essential tool for an EWC is a borescope. Initially, the borescope was used mainly in the medical field, but has gradually benefited the automotive and exterior wall industries, among others. A borescope typically uses a light source to illuminate the wall cavity and a viewing lens to make observations and take photographs. Today there are many types of scopes that are designed for tight locations that make it indispensable in the building enclosure field. A small viewing port is needed when using a scope. Often access can be made by cutting a small hole in the sealant, but it may require drilling a small hole (approximately 3/8" diameter) into the wall cladding. This provides a cost-effective means to literally see what is behind the wall surface in lieu of removing stones or panels to see behind the wall. Although this technique is very helpful, it can be limited based upon the type of obstructions within the wall cavity, like mortar or even insulation. These interior wall cavity elements can render the borescope useless, and other avenues may need to be employed. (Figure 8)

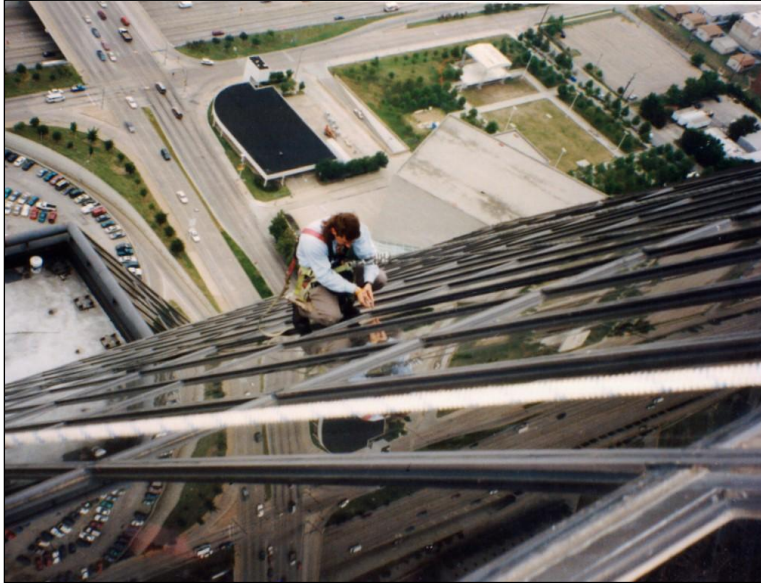
Figure 9: Independent quality control and installation verification ensures the installation is in compliance with the contract documents throughout the construction/renovation phase. This not only benefits the Building Owner and Property Manager, but enhances the durability of the renovation for the installation contractors warranty period.

Quality control measures such as periodic water testing, sealant adhesion sampling and installation verification are typically performed by a consultant to ensure the installation is in compliance with the contract documents throughout the renovation program. This provides assurance not only for the owner, but also benefits the remediation contractor in limiting his exposure to warranty repairs. (Figure 9)
