Building Enclosure Commissioning of a Student Athletic Facility

Paul E. Totten, PE, LEED AP BD+C

Andrew Smith, LEED AP

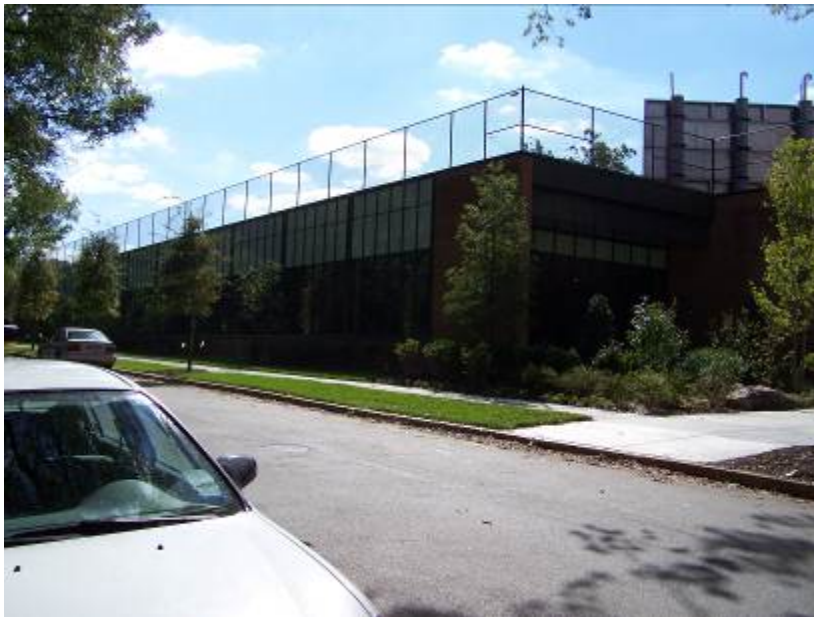
Photo 1

Overall view of completed Student Athletic Center.

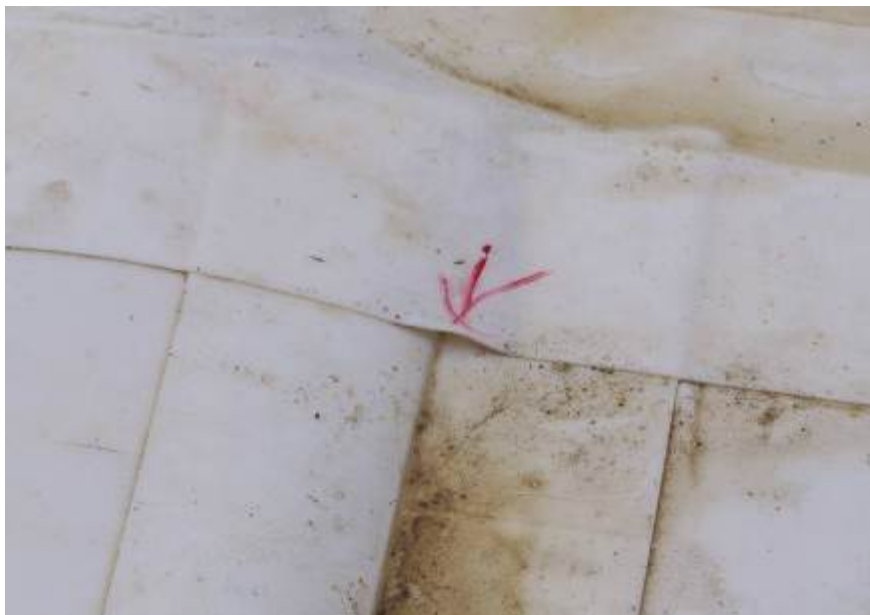
Photo 3

waterproofing membrane that can lead to tunneling, tape seams that were not fully adhered, and inside and outside corner details, especially at recesses for the columns that were not originally detailed correctly and provided tenting of the membrane instead of allowing it to lie flat and damage caused by placement of steel reinforcing. See Photos 3 through 4.

Tunnelling and fishmouths at membrane T-joints. These locations were repaired prior to casting concrete.

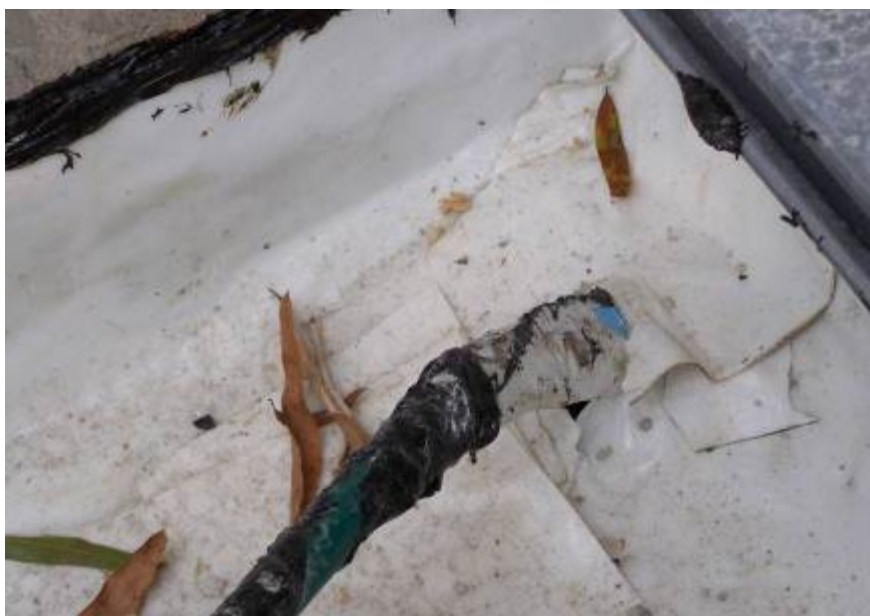
Photo 4

Improper detailing around a wire penetration through the waterproofing membrane. The detailing tape is loose and not installed continuously around the penetration. A proper boot was eventually installed at the base of this penetration.

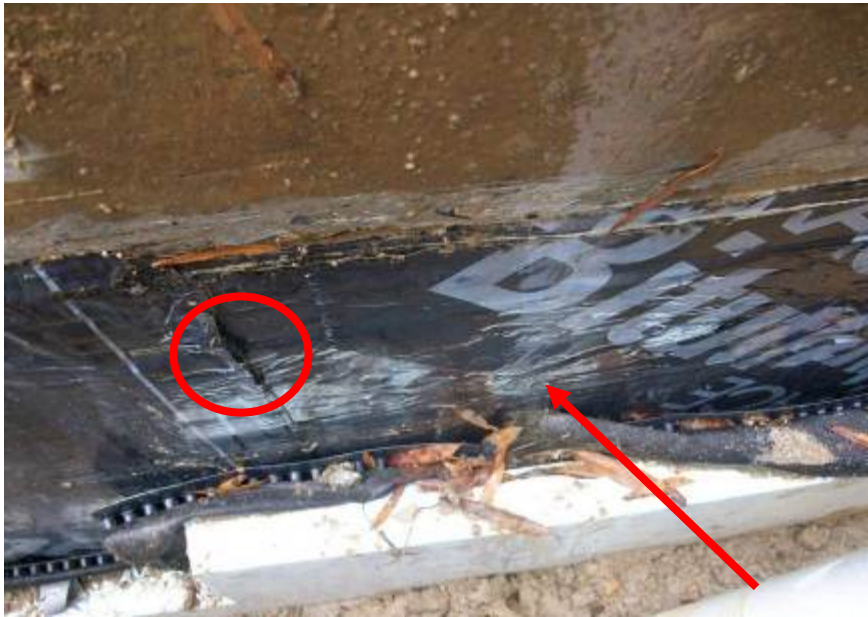
Photo 5

membrane was not rolled into place and use of end of day termination mastic that was not allowed to fully cure prior to installing the second sheet. See Photos 5 and 6. The deficiencies were corrected by the contractor and reviewed by the commissioning agent to verify compliance.

We observed several water-filled bubbles on the north elevation during construction. Note the unprotected top membrane edge and unadhered lap joint (circled).

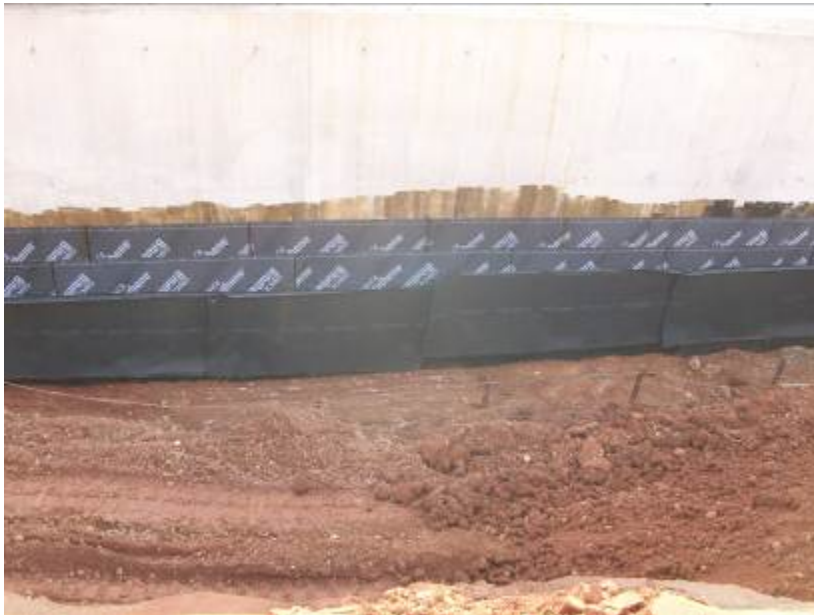
Photo 6

At vertical walls, a self-adhered sheet membrane was applied in two-layers, with seams at the upper layer detailed with liquid membrane and staggered vertically and horizontally from the first (inner) layer of waterproofing. The waterproofing was then covered over with drainage and protection board adhered in place and tied to foundation drains, and then covered with insulation. Deficiencies found by the commissioning agent included fishmouths where the sheet applied

Installation of the waterproofing and drainage/protection board along vertical walls.

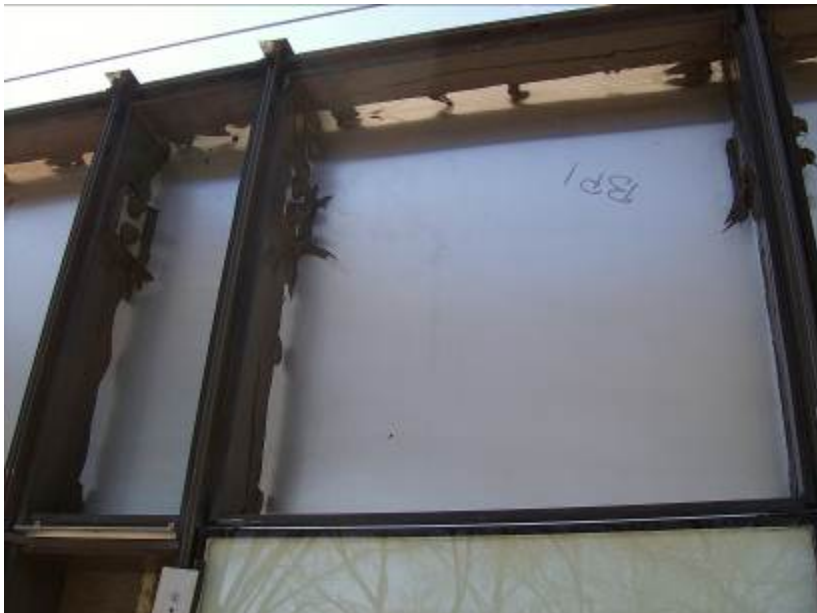
See Photo 7 for a view of this air sealing work in progress.

Air seals at shadow box back pan underway during construction.

- Installation of the metal back pan, with sealant applied between the back pan and frame at the perimeter.
- Installation of backer rod for perimeter edge seals temporarily tacked in place with sealant.
- Installation of fillet seals and perimeter seals at the shadow box to cover all curtain wall and shadow box frame joinery and the interface between the curtain wall and the shadow box.
- Temporary protection against weather to allow the seals to initially cure.
- Installation of the shadow box insulation system.
- Installation of the shadow box front pan which was also sealed in place.
- Installation of the glazing.

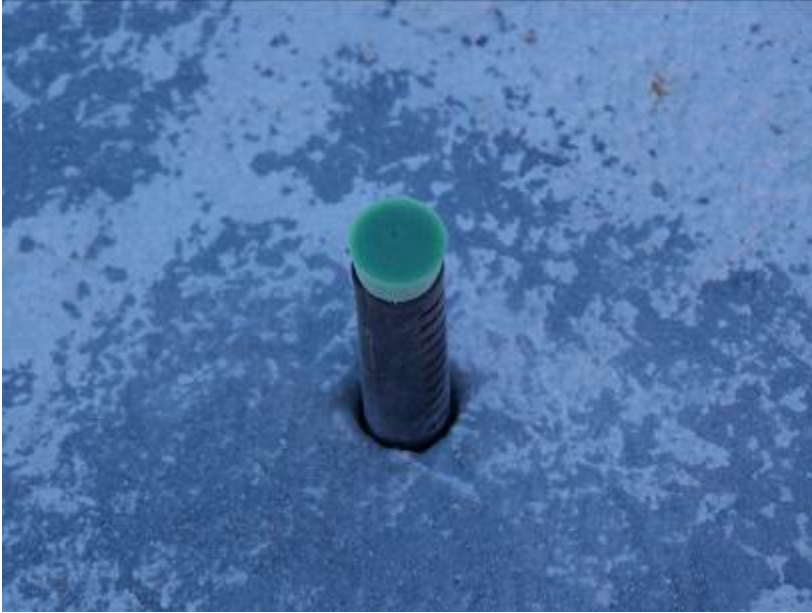
See Photo 8 for a view of functional performance testing completed prior to placing the hot-applied roofing.

Installation of sleeve for interstitial RH probe used as part of functional performance testing prior to installing hot-applied waterproofing.
