Energy Savings by Retrofitting Multi-Unit Residential Buildings: Case Studies

Marianne F. Touchie¹, Kim D. Pressnail², Ekaterina S. Tzekova³

ABSTRACT

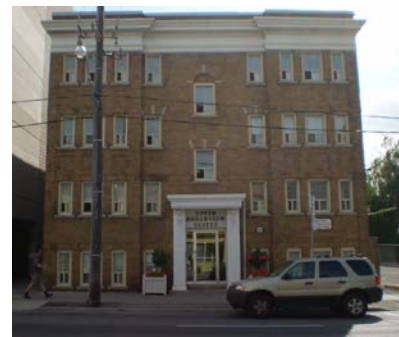
FIGURE 3: Building 1

Constructed in the 1930's, Building 1 shown in Figure 3 is the oldest building in the case study series and with 32 units, it is also the smallest. Since minimal work had been done since the date of the original building construction, there was great potential for the owners to increase the value of their investment as well as to improve the comfort of their tenants.

- replacement of the original, air-leaky, single-glazed windows with new insulated glazing units with a low-e coating;
- replacement of the boiler controls and steam traps;

- installation of attic insulation of which there was none (increase the thermal resistance to approximately RSI 7.8 m²K/W (R-44 hr-ft²·°F/BTU));
- replacement of the original 25 L/flush (6.6 gal/flush) toilets with 6 L/flush (1.6 gal/flush) toilets;
- replacement of all faucets and showerheads with low-flow shower heads (7.5 Lpm, 2 gpm) and low-flow aerators;
- replacement of the common area lighting (each 192W F40-T12 fluorescent bulb was replaced by two 13W compact fluorescents).

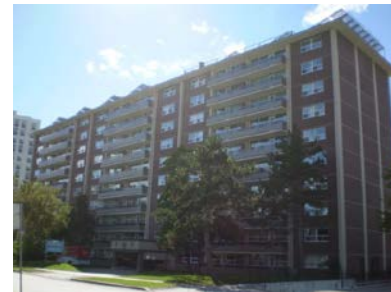
FIGURE 5: Building 2

The most recent retrofit project in this case study series was completed in 2010. It is a 10-storey, 128-unit apartment building constructed in 1970, shown in Figure 5. Similar to the owners of Building 1, this owner also saw the potential for increasing the value of his investment by reducing operating expenses.

- Replacement of the balcony doors and the original single-glazed window units. Windows were replaced with higher performance argon-filled, double-glazed units with a low-e coating and an area-weighted USI value of 2.3 W/m²K (U-0.4 BTU/hr·ft²·°F) (Prohaska 2011).
- Replacement of the original roof, which had no insulation. The owner took this opportunity to include about 75 mm (3 in.) of polyisocyanurate rigid insulating board improving the thermal resistance of the assembly by approximately RSI-3.8 m²K/W (R-21 hr·ft²·°F/BTU).

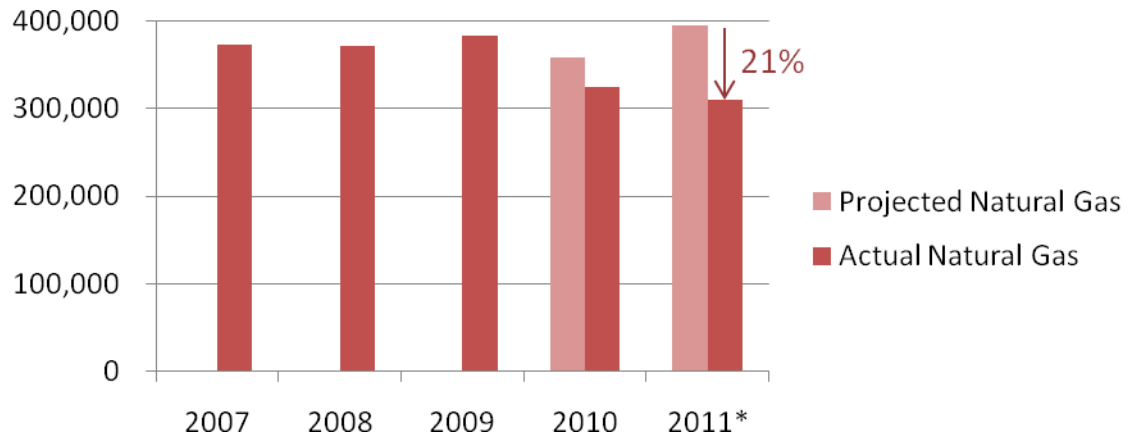
FIGURE 6: Building 2 Natural Gas Use

**Data estimated from July 2011 to December 2011 is based on usage from July 2010 to December 2010*

At the project outset, the estimated annual reduction in natural gas use was 28%. This was based on an estimate from the building owner of the effect of window and balcony door retrofits he had seen on other buildings as well as a RETScreen analysis of the SHW system energy production by the project engineer. Actual natural gas use from the first year of operation shows a savings of 21% from the pre-retrofit baseline, as shown in Figure 6. The owner is currently working with the SHW system installer to improve the performance of this equipment. In addition to reducing energy costs, the retrofit measures also contributed to an estimated annual reduction in greenhouse gas emissions of about 160 Tonnes (176 Tons) of CO₂e.

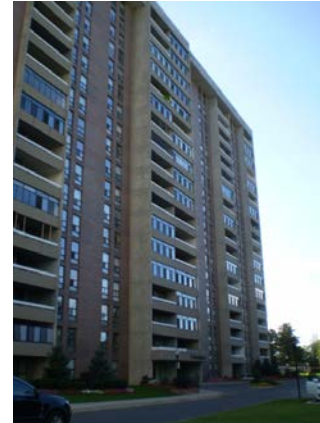
FIGURE 7: Building 3

Constructed in 1974, Building 3 is a 210-unit condominium building, shown in Figure 7, which is located in Brampton, Ontario. Prompted by excessive energy bills and the need to reduce operating costs, the building manager began looking into retrofit strategies. Priorities

- Replacement of two 45% efficient DHW boilers (1.05M and 0.77M BTU) with two 1.5M BTU 88% efficient boilers. The new boilers were purposely oversized so that when a new Air Handling Unit (AHU) was installed later that year, the DHW was used to pre-heat incoming air through a heat exchanger thereby eliminating the need for a separate AHU burner.
- Replacement of the five existing 55% efficient 1.5M BTU space heating boilers with two 85% efficient 2.0M BTU boilers.
- Replacement of the AHU motors with variable frequency drives to reduce electricity cost and connection of the DHW supply to the AHU.
- Replacement of the 13L/flush (3.4 gal/flush) toilets with 6L/flush (1.6 gal/flush) toilets.
- Replacement of the chiller (following a provincial directive that prohibited the use of R11 gas) with a higher efficiency model.

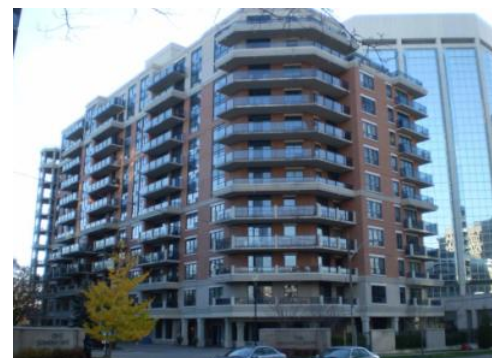
FIGURE 9: Building 4

First occupied in 2001, Building 4 is a 12 storey condominium building. Shown in Figure 9, it has 116 suites and it is the newest building in the case study series. The Chair of the condominium board began the energy retrofit process by investigating the possibility of a solar energy installation for the building. He discovered that there were many cost-effective demand reduction measures that could be undertaken to reduce utility costs before considering the installation of a solar energy system. By examination of the current operating conditions at Building 4 and extensive research and consultation with energy management firms, the condominium board put together a three-year

- Replacement of T12 parking garage lighting with T8 lighting and electronic ballasts;
- Linking parking garage exhaust fan control to CO monitors to ensure fresh air is supplied only when needed;
- Replacement of one of two atmospheric DHW boilers with a high-efficiency condensing boiler and new controls;
- Installation of a variable frequency drive (VFD) on the make-up air unit (MAU);
- Replacement of one of four atmospheric fan coil boilers with a high efficiency condensing boiler providing half the total capacity and new controls;
- Replacement of one of two atmospheric domestic prime boilers (for heating the common areas, pool and slab) with a high efficiency condensing boiler and new controls.

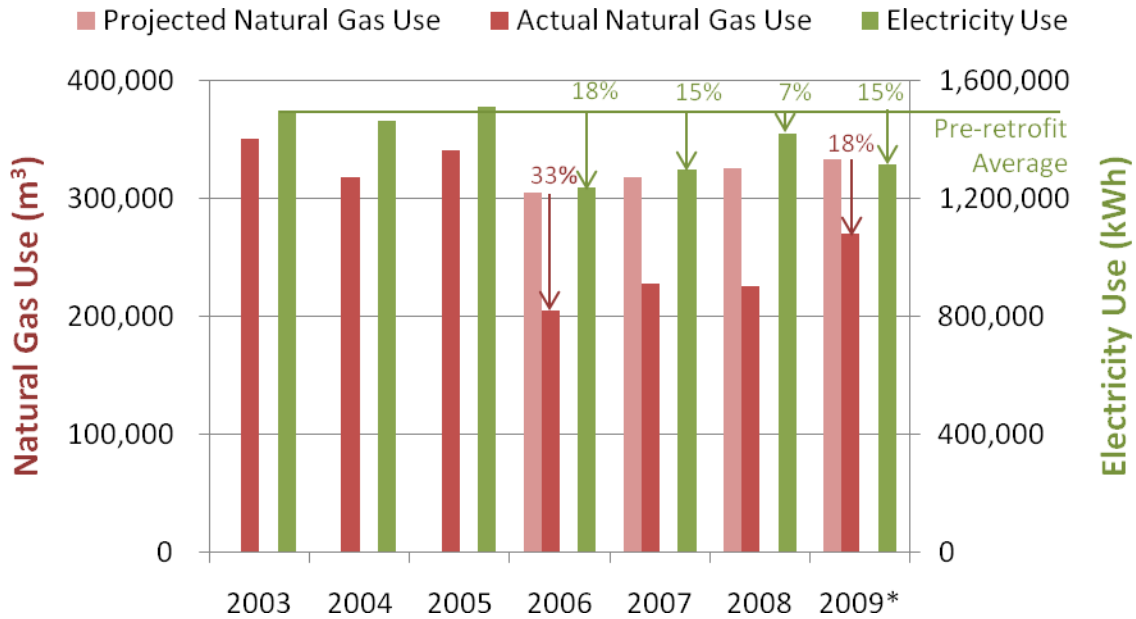
FIGURE 10: Building 4 Energy Use

**Estimate of December 2009 use based on 2008 usage and 2009 heating degree days*

Figure 10 shows the natural gas and electricity consumption for three baseline years (2003-2005) and four years of performance (2006-2009).
