THERMAL PERFORMANCE OF FAÇADES

2012 AIA UPJOHN GRANT
RESEARCH INITIATIVE

Final Report | November 2014

PAYETTE

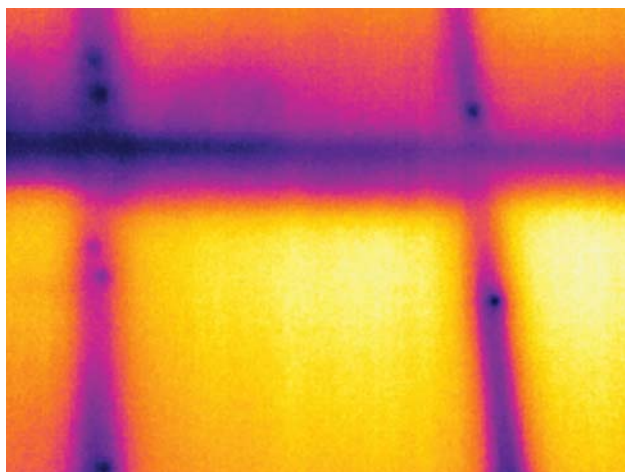
Infrared Image of Z-girt supports at a Rainscreen

In our thermal images of rainscreen façades, we observed a decrease in thermal performance that ranged from 20% to 60% less than the design intended performance, with the majority around a 45-55% decrease. The systems we selected for study all had between two to three inches of insulation. We looked at a rainscreen with horizontal Z-girts, vertical Z-girts, and a clip-based system. Not surprisingly, the continuous Z-girts, whether horizontal or vertical, performed similarly. In both orientations, Z-girts demonstrated an R.7.7 reduction in the assembly's R-value or roughly a 45-55% reduction in performance depending on the insulation thickness.

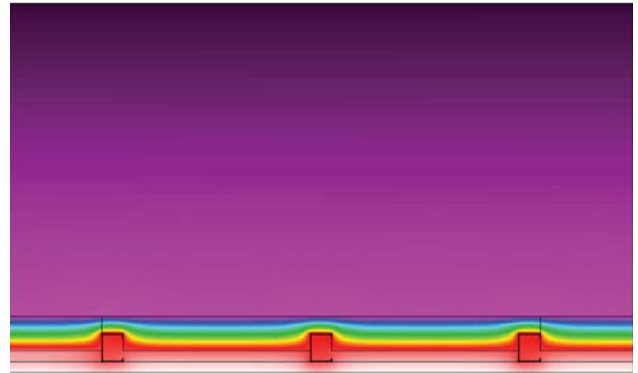
*Studs pulled 1" back from existing wall
16% of baseline calculated R-value*

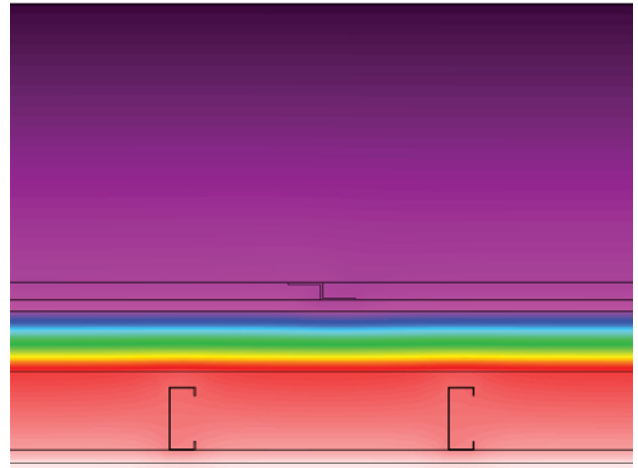
*Studs separated from insulation
2% of baseline calculated R-value*

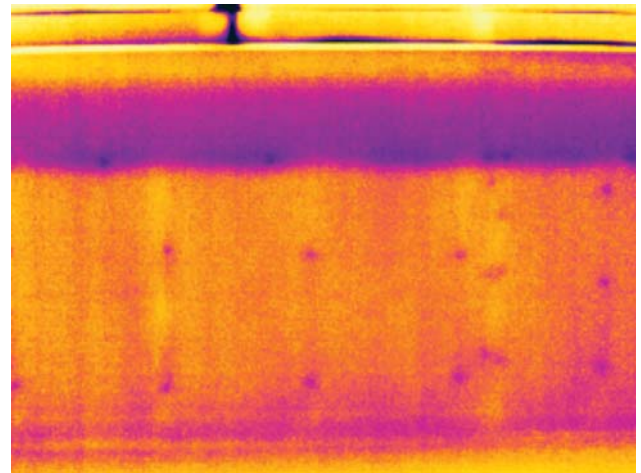
In addition, it is clear that whenever the façade requires structure to move in or out of plane with the main

Infrared image of structural support at window proud of insulation

superstructure, this will lead to substantial performance impact.

It is essential to avoid continuous support and assure that outriggers or brackets are used to create only the bare minimum number of thermal bridges. In one test case, we replaced a continuous section of tube steel with intermittent blades that cantilevered out to support a brick lintel and effected a 68% reduction in heat flow through the assembly. While our study was typically based on brackets spaced at 48" +/- on center, it should also be possible to increase spans well over 96" to realize far greater performance (at the expense of heavier structure).

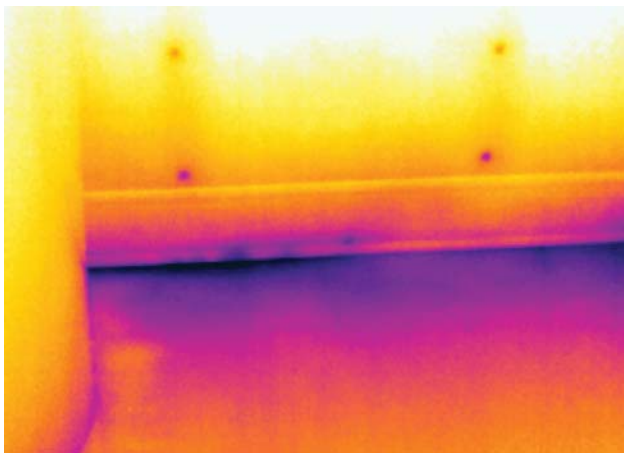
The wall transition above the foundation wall is consistently a problematic area for thermal performance. This transition has been observed to affect the wall R-value by as much as 70-75% for three factors. The transition of wall assemblies is usually necessary because most wall assemblies above grade are not able to withstand conditions below grade. The switch of wall assemblies usually results in an offset and discontinuity of the insulation. The second reason this is a difficult area to detail is that this offset typically occurs at the termination of waterproofing which results in the metal flashing spanning across the insulation, creating an additional thermal bridge. The third factor to take into account is that the transition often occurs where the slab on grade meets the foundation wall. The structural stability of the connection creates another discontinuity of the insulation that is hard to overcome.

Infrared image looking at the foundation wall transition

To determine ways to improve the performance we looked at a number of options for improved details. The first was a structural thermal break in the concrete slab where it connects

to the foundation wall for a foundation wall that was insulated on the interior. This allows for some thermal continuity between the slab insulation and the interior insulation. The most improved option was a concrete foundation wall built of a sandwich panel with insulation integral within the concrete. This allowed the insulation to be as continuous as possible with the above grade insulation, and minimizes the shelf condition at grade.

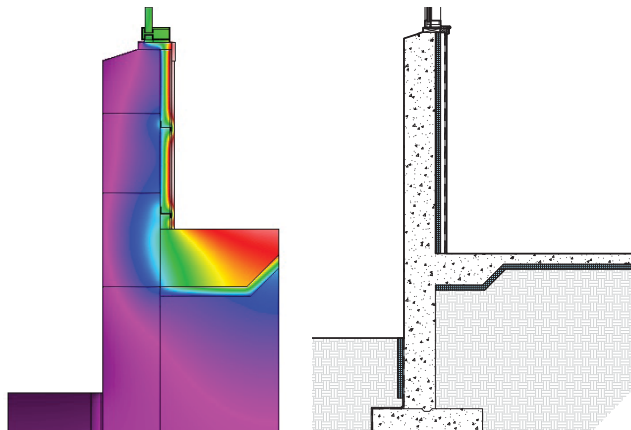
THERM Simulation and detail of the foundation wall transition

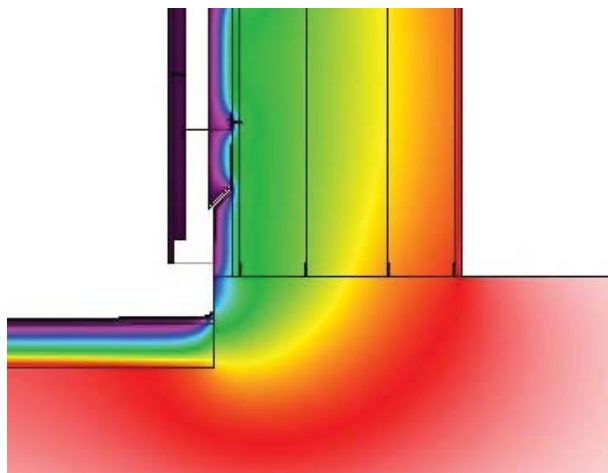
We found that the structure required to support the parapet, whether it is concrete or cold form metal framing, typically leads to a considerable gap between the façade insulation generally on the exterior of the parapet and the roof insulation which runs on the interior. Furthermore, wood nailers, cant strips and other roofing accessories tended to exaggerate these impacts.

THERM Simulation of roof to wall transition

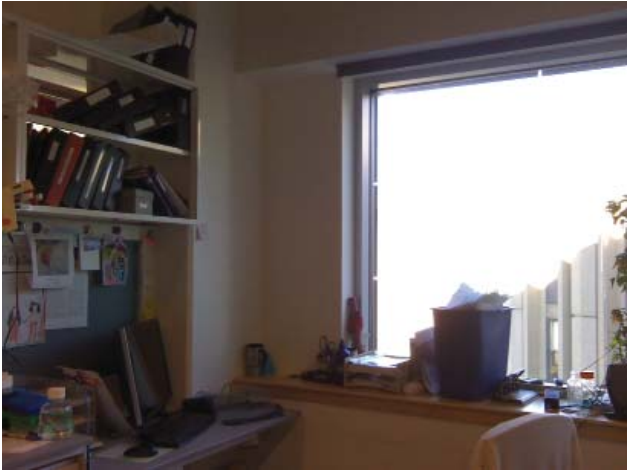
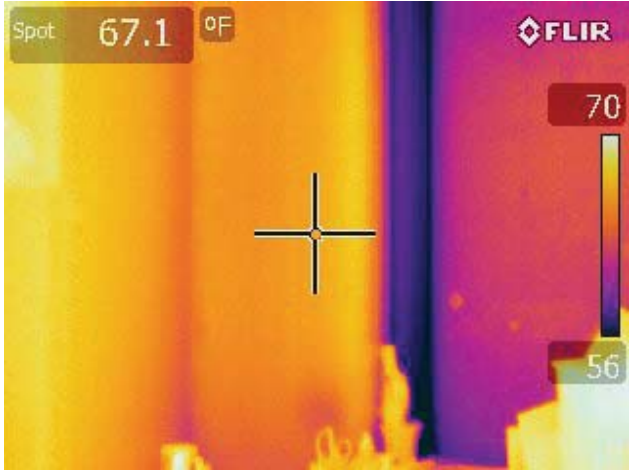
APPENDIX- 01a | RAINSCREENS: Vertical Z-Girts

Digital Image

Infrared Image

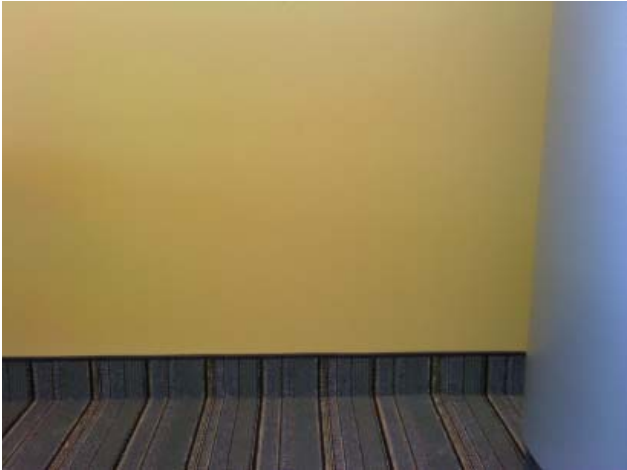
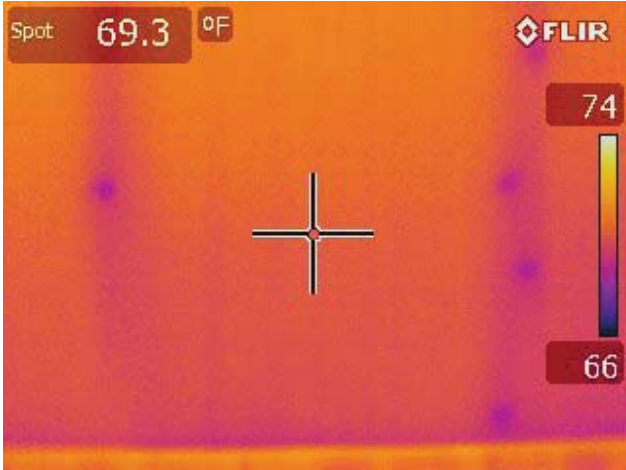
APPENDIX- 01b | RAINSCREENS: Clips

Calculated Baseline R-Value: 13.86 -
As-Built Condition
 Thermal Image R-Value: 9.70 - 30 %
 Simulated (THERM) R-Value: 8.66 - 38 %
Thermally Improved Condition
 See 1c-1e

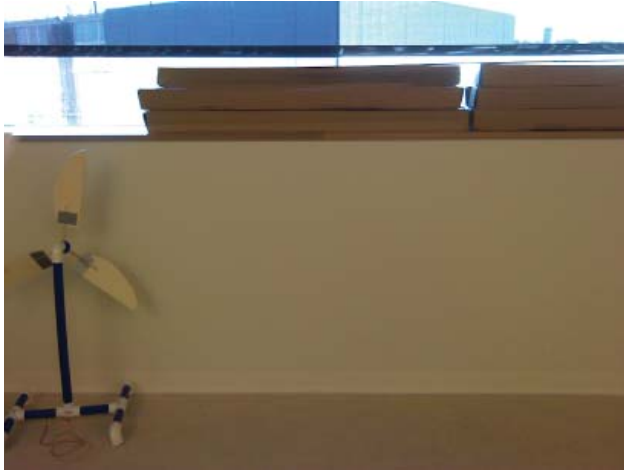
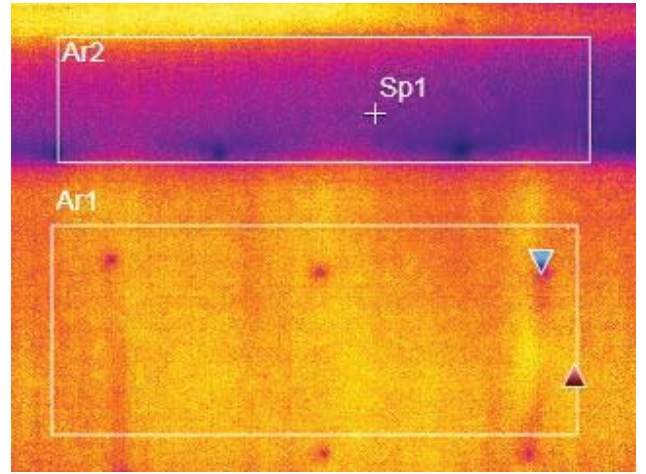
APPENDIX- 01c | RAINSCREENS: Horizontal Z-Girts

Calculated Baseline R-Value: 16.90 -
As-Built Condition
 Thermal Image R-Value: 9.21 - 46 %
 Simulated (THERM) R-Value: 11.05 - 35 %
Thermally Improved Condition
 Simulated (THERM) R-Value: 16.2 - 4 %

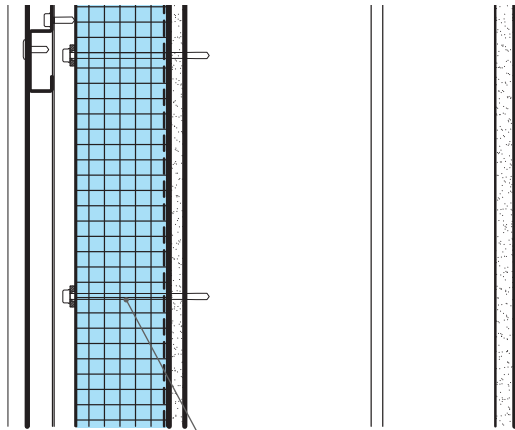
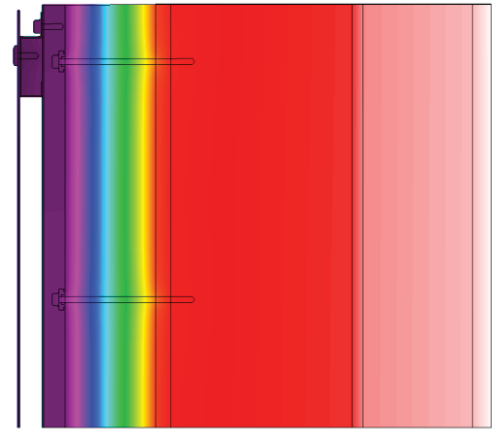
Thermally Improved Condition

R-16.2
(-46.6%)

vertical Z-girt changed to thermally broken support system with only bolts penetrating insulation

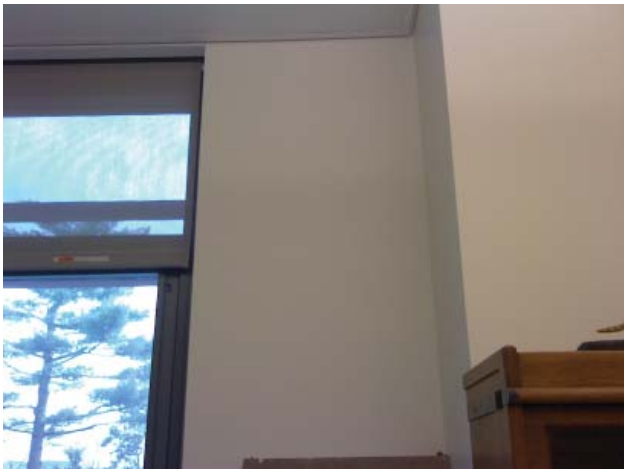
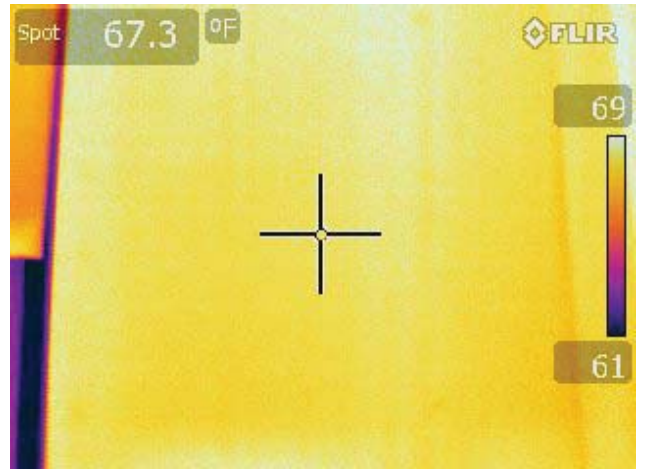
APPENDIX- 02c | MASONRY WALLS: CMU Back Up Wall Galvanized Ties

Calculated Baseline R-Value: 15.44 -
As-Built Condition
 Thermal Image R-Value: 12.3 - 20 %
 Simulated (THERM) R-Value: 13.28 - 14 %
Thermally Improved Condition
 Simulated (THERM) R-Value: 13.68 - 11 %

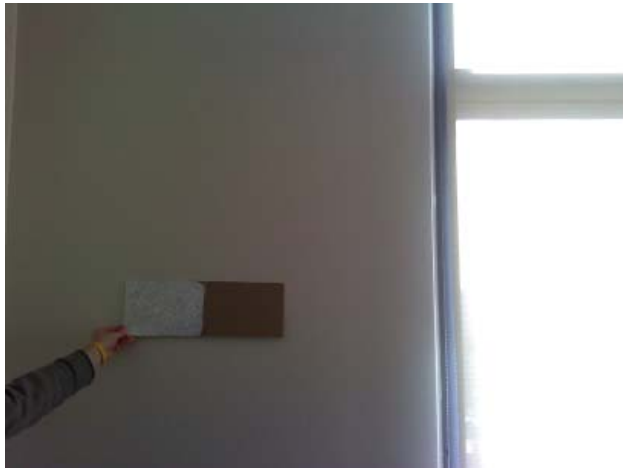
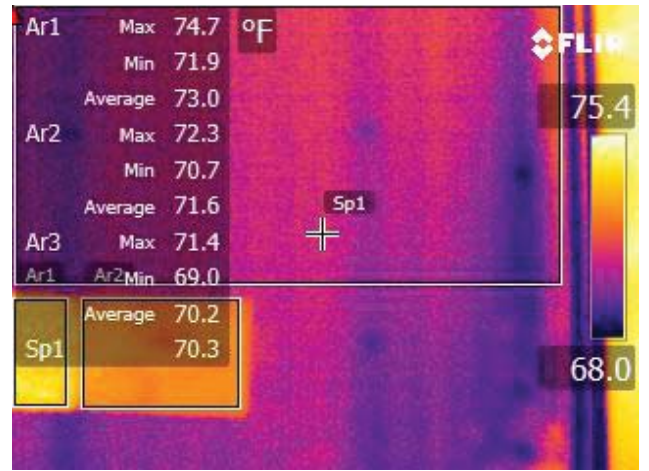
APPENDIX- 02b | MASONRY WALLS: Stud Back Up Wall with Galvanized Ties

Calculated Baseline R-Value: 15.71 -
As-Built Condition
 Thermal Image R-Value: 6.5 - 58 %
 Simulated (THERM) R-Value: 9.47 - 40 %
Thermally Improved Condition
 Simulated (THERM) R-Value: 10.53 - 33 %

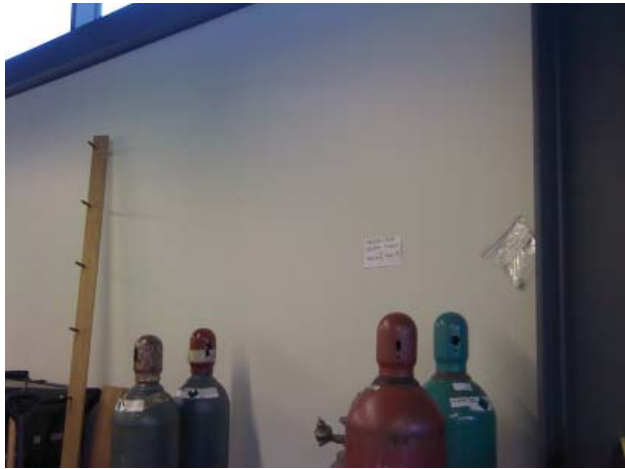
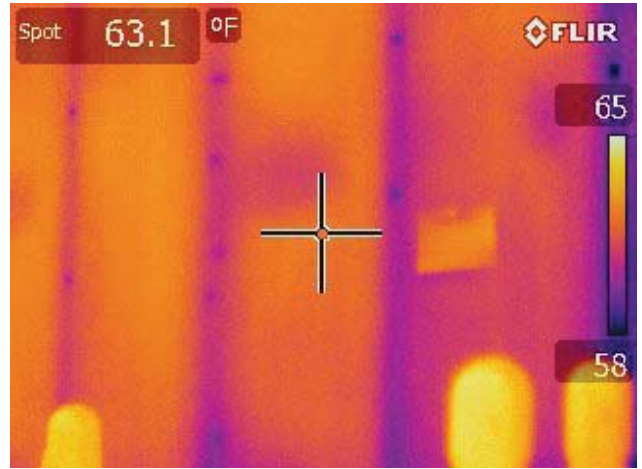
APPENDIX- 02c | MASONRY WALLS: Stud Back Up Wall with Galvanized Tie #2

Calculated Baseline R-Value: 17.89 -
As-Built Condition
 Thermal Image R-Value: 8.4 - 53 %
 Simulated (THERM) R-Value: 14.43 - 19 %
Thermally Improved Condition
 Simulated (THERM) R-Value: 15.85 - 11 %

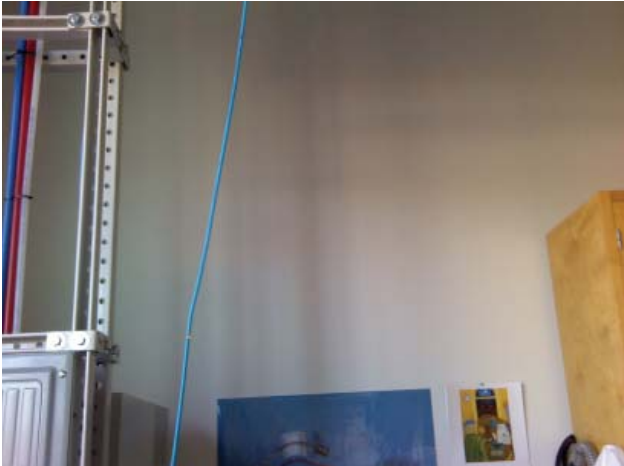
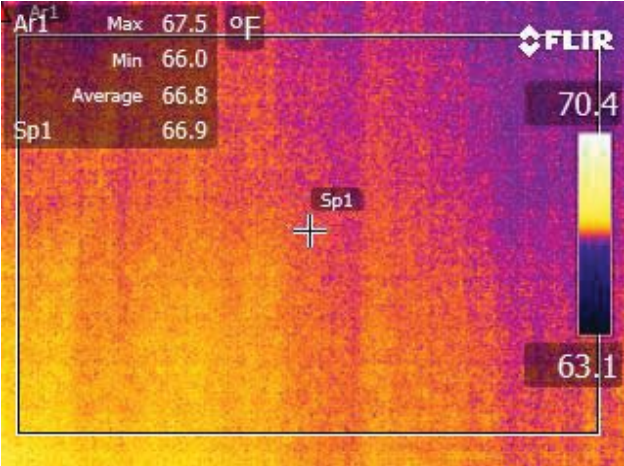
APPENDIX- 03a | METAL PANEL WALL SYSTEMS: Metal Panels with Insulated Joints

Calculated Baseline R-Value: 19.34 -
As-Built Condition
 Thermal Image R-Value: 18.67 - 3 %
 Simulated (THERM) R-Value: 17.55 - 9 %
Thermally Improved Condition
 Simulated (THERM) R-Value: N/A -

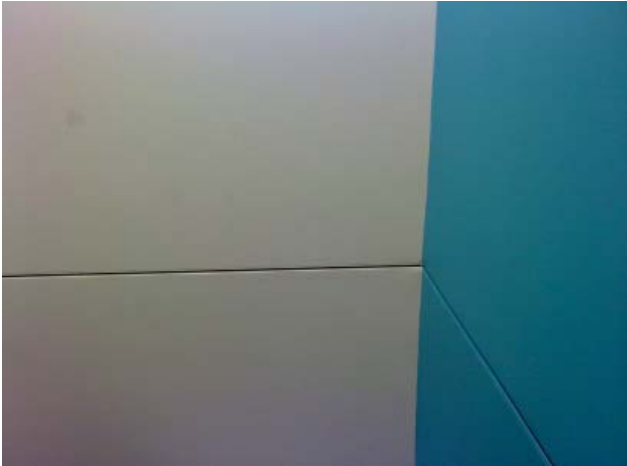
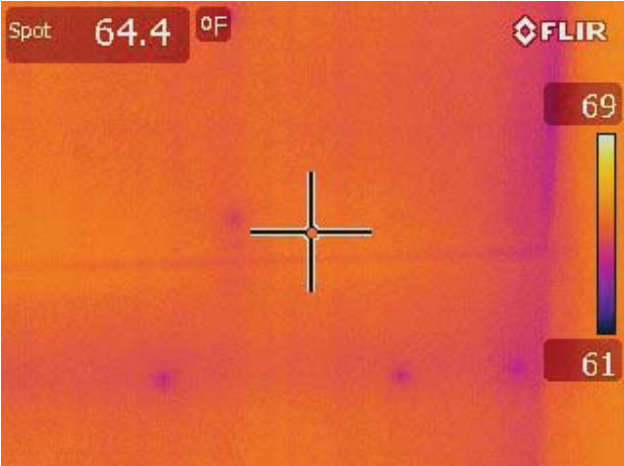
APPENDIX- 03b | METAL PANEL WALL SYSTEMS: Metal Panels with Uninsulated Joints

Calculated Baseline R-Value: 20.81 -
As-Built Condition
 Thermal Image R-Value: 6.80 - 67 %
 Simulated (THERM) R-Value: 4.23 - 80 %
Thermally Improved Condition
 See 3a N/A -

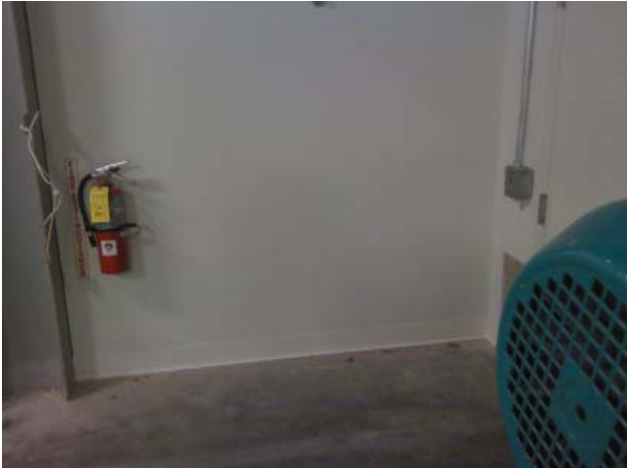
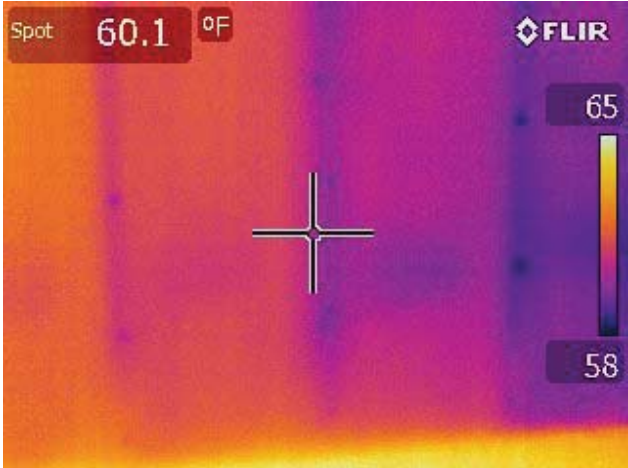
APPENDIX- 03c | METAL PANEL WALL SYSTEMS: Metal Panels with Continuous Metal Clips

Calculated Baseline R-Value: 19.77 -
As-Built Condition
 Thermal Image R-Value: 5.95 - 70 %
 Simulated (THERM) R-Value: 9.70 - 51 %
Thermally Improved Condition
 See 3a N/A -

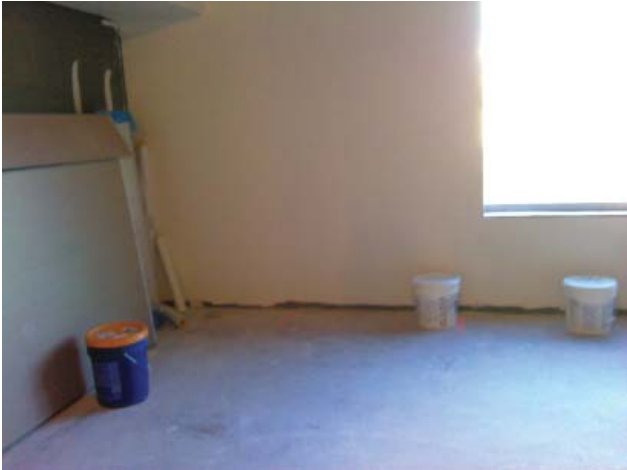
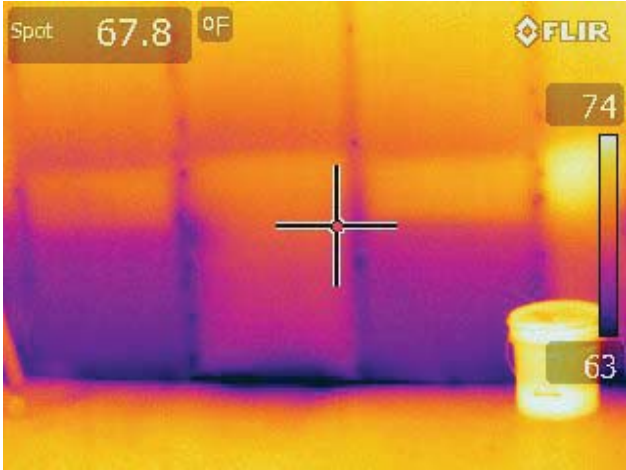
APPENDIX- 04a | CURTAIN WALLS: Insulation Between Mullions (Typical)

Calculated Baseline R-Value: 20.42 -
As-Built Condition
 Thermal Image R-Value: 5.75 - 72 %
 Simulated (THERM) R-Value: 6.17 - 70 %
Thermally Improved Condition
 Simulated (THERM) R-Value: NA

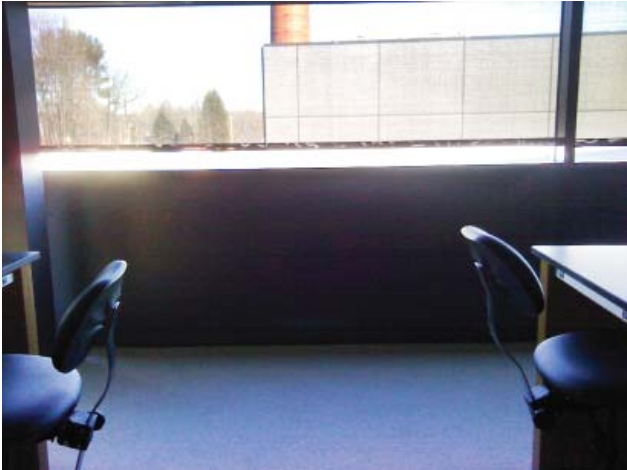
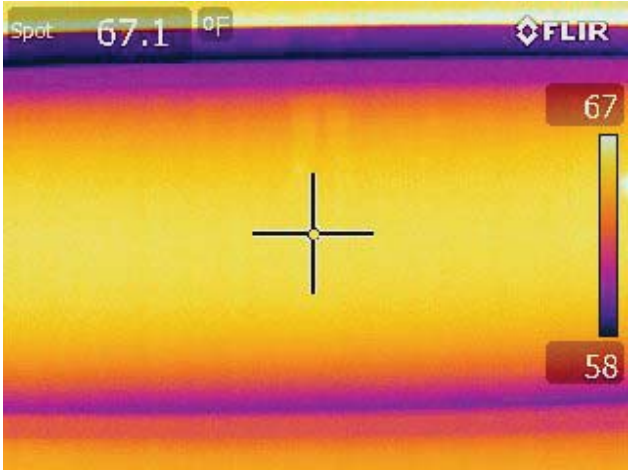
APPENDIX- 04b | CURTAIN WALLS: Insulation within Mullion

Calculated Baseline R-Value: 14.16 -
As-Built Condition
 Thermal Image R-Value: 6.18 - 56 %
 Simulated (THERM) R-Value: 4.92 - 62 %
Thermally Improved Condition
 Simulated (THERM) R-Value: NA

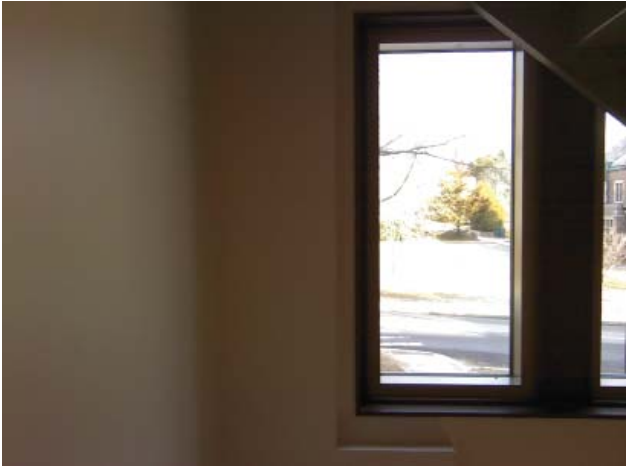
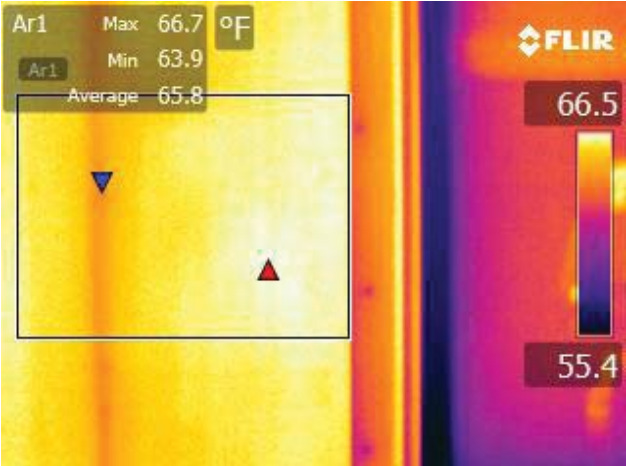
APPENDIX- 05b | INSULATING EXISTING BUILDINGS: Studs Pulled 1" Back From Existing Wall

Calculated Baseline R-Value: 16.84 -
As-Built Condition
 Thermal Image R-Value: 12.44 - 26 %
 Simulated (THERM) R-Value: 14.11 - 16 %
Thermally Improved Condition
 See 05c

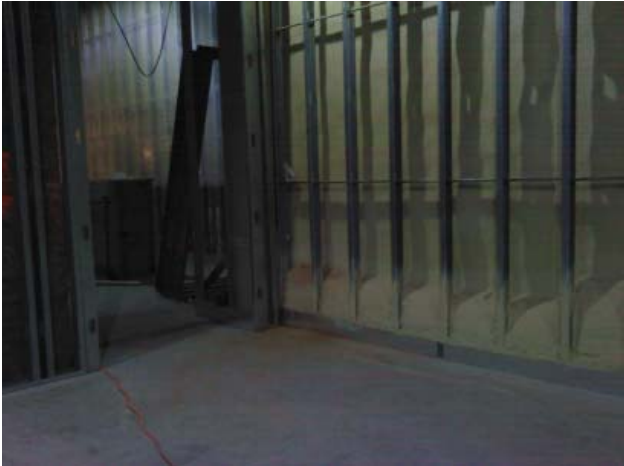
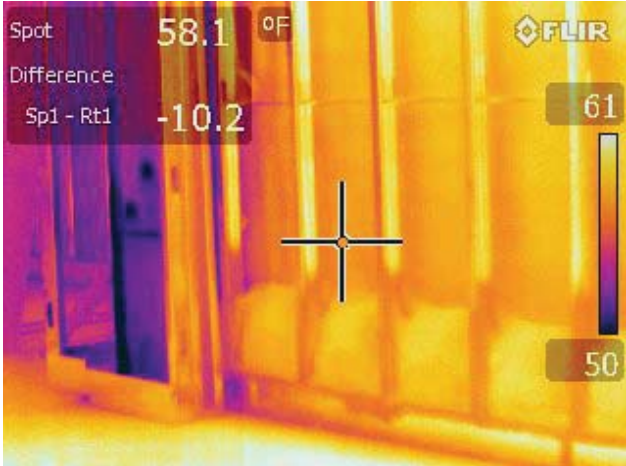
APPENDIX- 05c | INSULATING EXISTING BUILDINGS: Studs Separated From Insulation

Calculated Baseline R-Value: 29.23 -
As-Built Condition
 Thermal Image R-Value: 20.16 - 31 %
 Simulated (THERM) R-Value: 28.78 - 1.5 %
Thermally Improved Condition
 N/A -

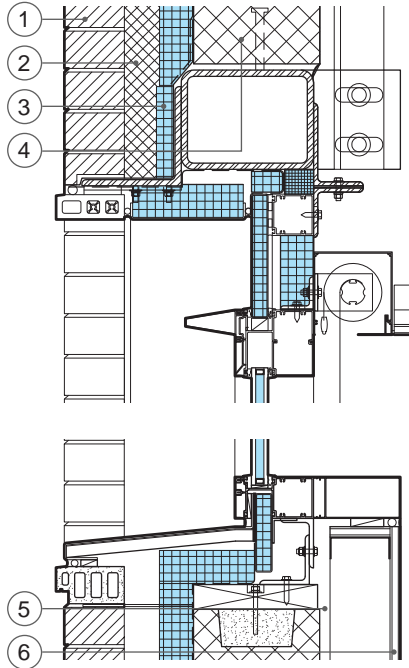
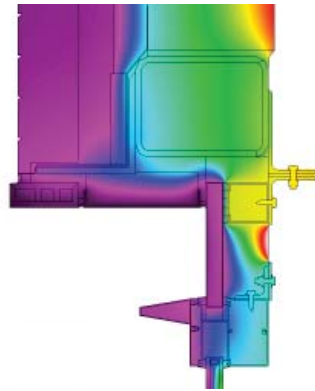
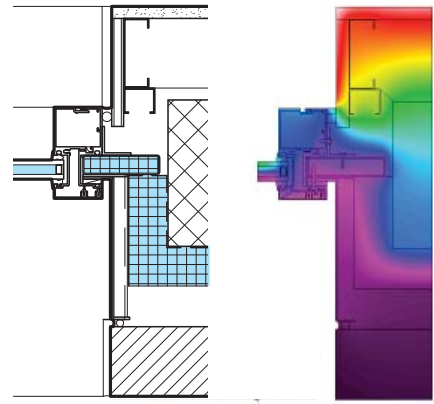
APPENDIX- 06a | WINDOW TRANSITIONS: Recessed Relationship with Thermal Barrier

Calculated Baseline R-Value: 15.39 -
As-Built Condition
 Thermal Image R-Value: 6.58 - 57 %
 Simulated (THERM) R-Value:
 Head 6.46 - 58 %
 Jamb 6.58 - 51 %
 Sill 4.60 - 70 %

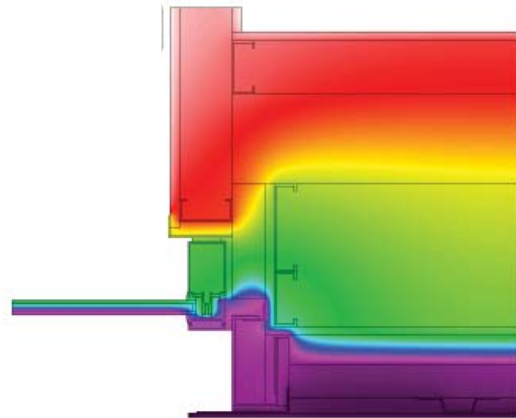
R-8.76

Calculated Baseline R-Value: 13.86 -
As-Built Condition
 Thermal Image R-Value: N/A
 Simulated (THERM) R-Value: 8.76 - 37 %
Thermally Improved Condition
 Simulated (THERM) R-Value: 11.16 - 19 %

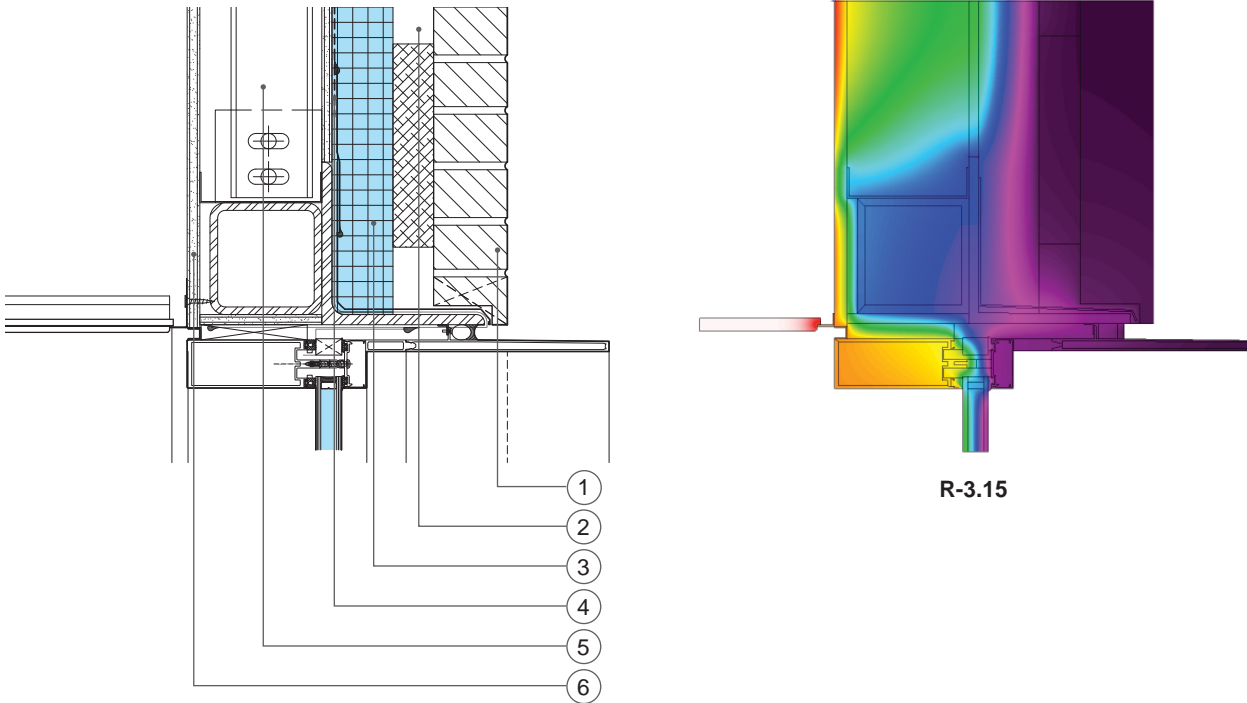
APPENDIX- 06c | WINDOW TRANSITIONS: Recessed Relationship with Thermal Barrier

Calculated Baseline R-Value: 19.82 -
As-Built Condition
 Thermal Image R-Value: 8.91 - 55 %
 Simulated (THERM) R-Value: 3.15 - 84 %
Thermally Improved Condition
 Simulated (THERM) R-Value: 7.08 - 64 %

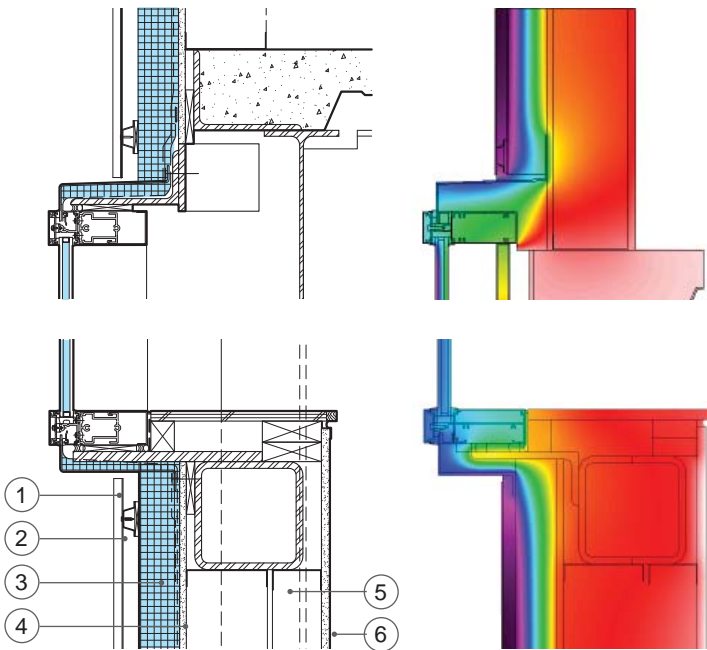
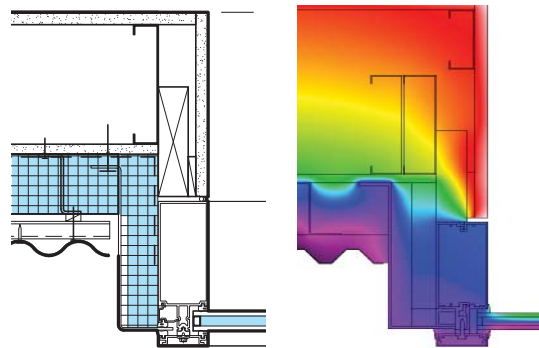
Calculated Baseline R-Value: 18.78 -
As-Built Condition
 Thermal Image R-Value: 8.58 - 54 %
 Simulated (THERM) R-Value:
 Head 10.48 - 44 %
 Jamb 9.36 - 50 %
 Sill 10.39 - 45 %

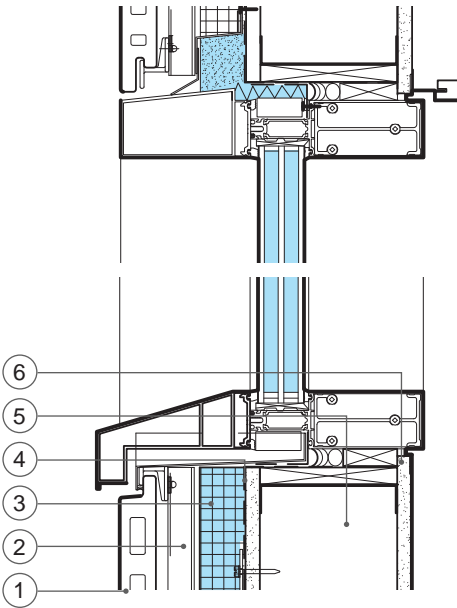
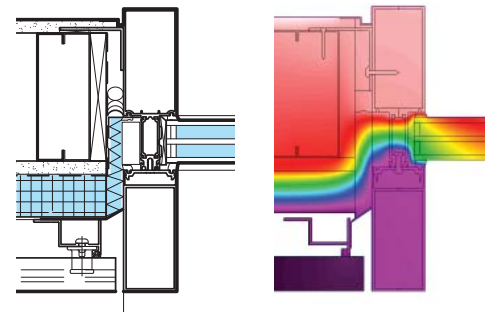
APPENDIX- 06f | WINDOW TRANSITIONS: Inline Relationship with Thermal Barrier

Calculated Baseline R-Value: 13.86 -
As-Built Condition
 Thermal Image R-Value: 7.50 - 46 %
 Simulated (THERM) R-Value:
 Head 6.46 - 53 %
 Jamb 7.65 - 45 %
 Sill 6.46 - 53 %

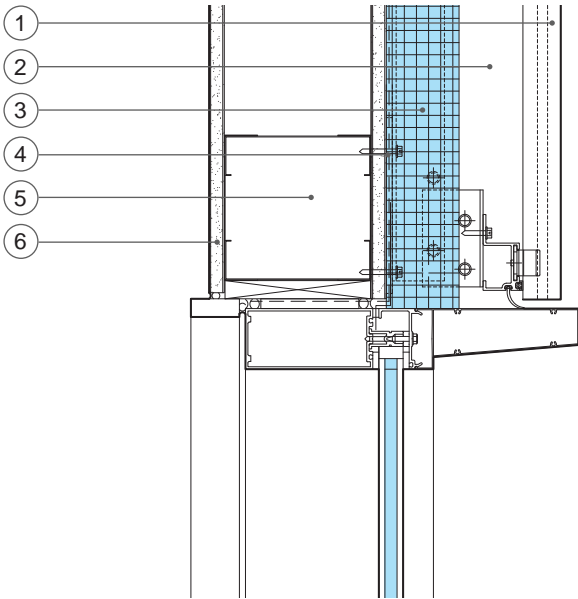
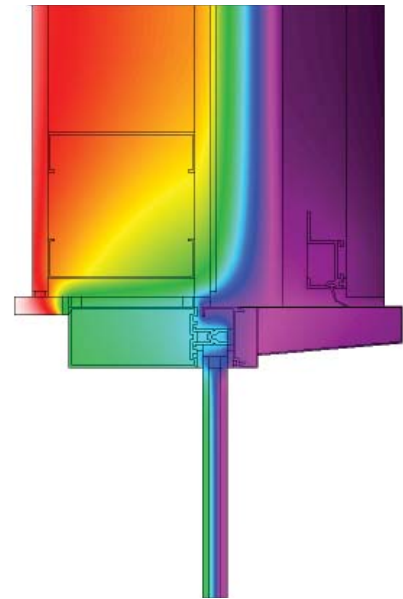
APPENDIX- 06g | WINDOW TRANSITIONS: Inline Relationship with Thermal Barrier

Calculated Baseline R-Value: 20.74 -
As-Built Condition
 Thermal Image R-Value: 7.94 - 62 %
 Simulated (THERM) R-Value: 7.12 - 66 %

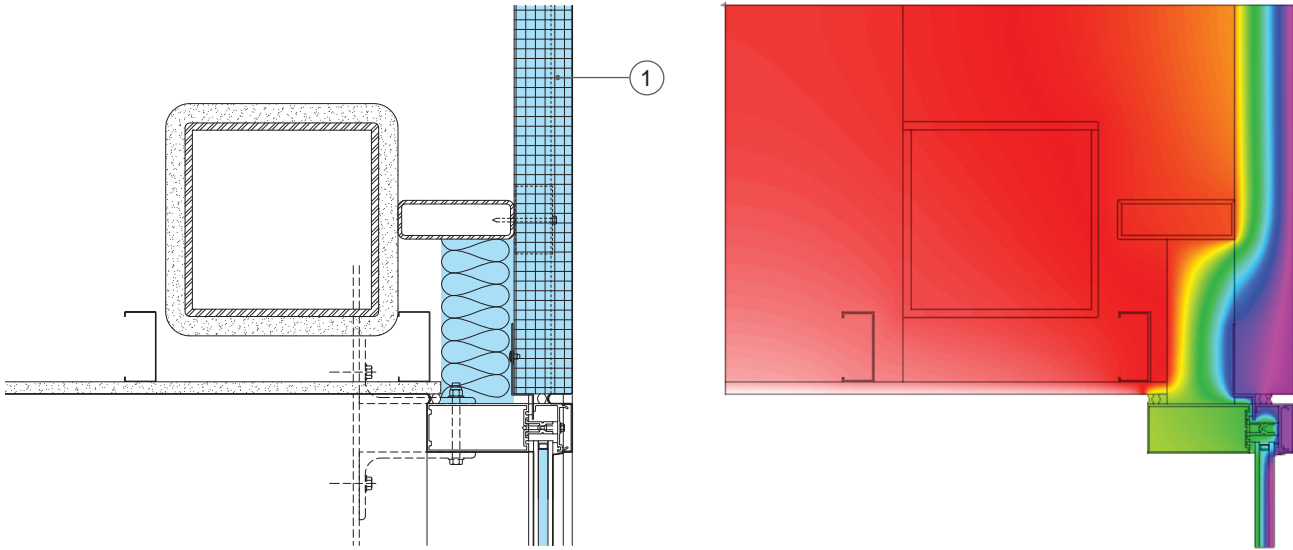
APPENDIX- 06h | WINDOW TRANSITIONS: Inline Relationship with Thermal Barrier

Calculated Baseline R-Value: 22.85 -
As-Built Condition
 Thermal Image R-Value: 9.14 - 60 %
 Simulated (THERM) R-Value: 9.57 - 58 %

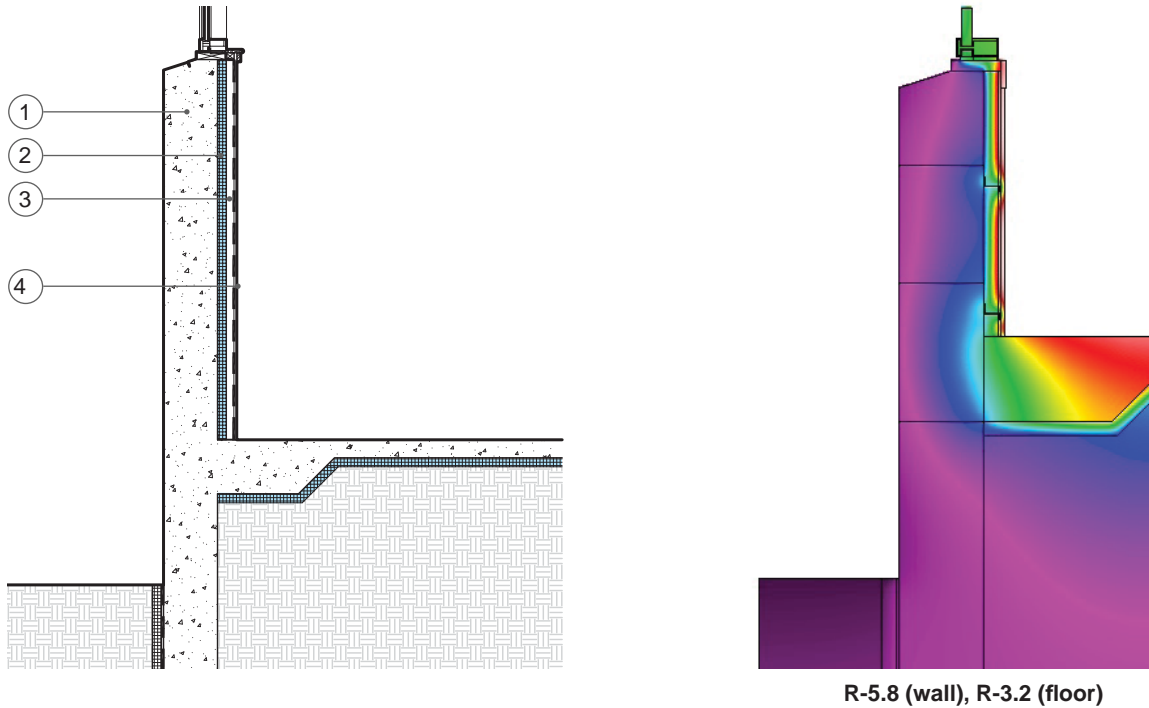
APPENDIX- 07b | FOUNDATION TO WALL TRANSITIONS: Foundation Wall Transition 2

Simulated (THERM) R-Value (wall): 6.1 -55.6 %
 Simulated (THERM) R-Value (floor): 5.85 -

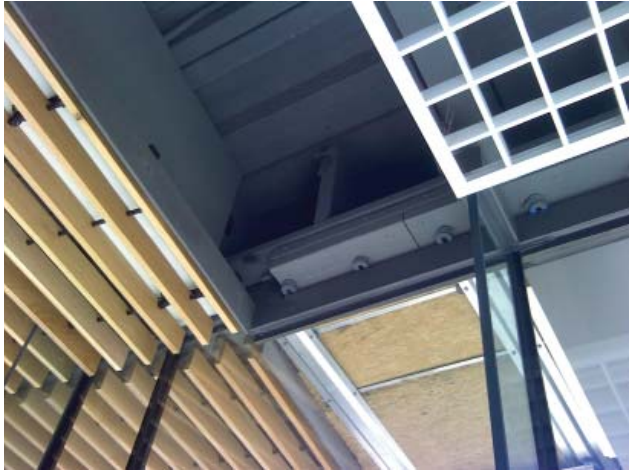
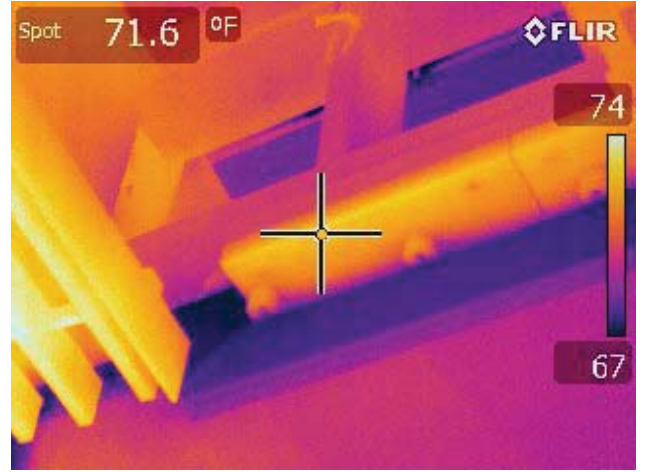
APPENDIX- 09a | SOFFITS: Soffit at Rain Screen Wall

Calculated Baseline R-Value: 19.14 -
As-Built Condition
 Thermal Image R-Value: N/A -
 Simulated (THERM) R-Value: 17.2 - 10 %
Thermally Improved Condition
 Simulated (THERM) R-Value: 28.3 +48 %

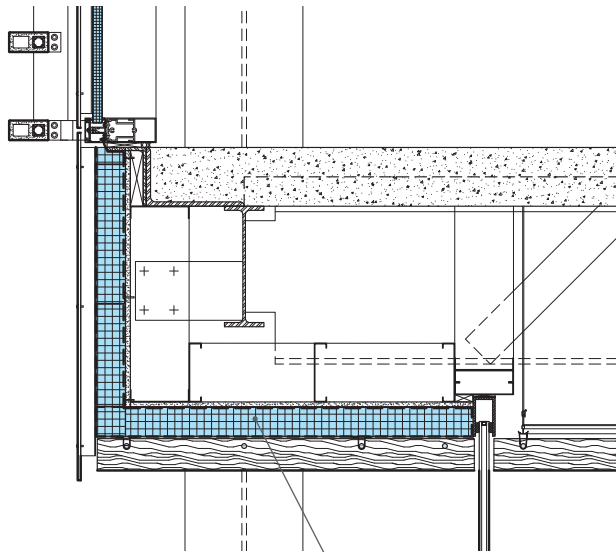
Thermally Improved Condition

z-girts have been replaced with stainless steel bolts and plate out of the plane of insulation

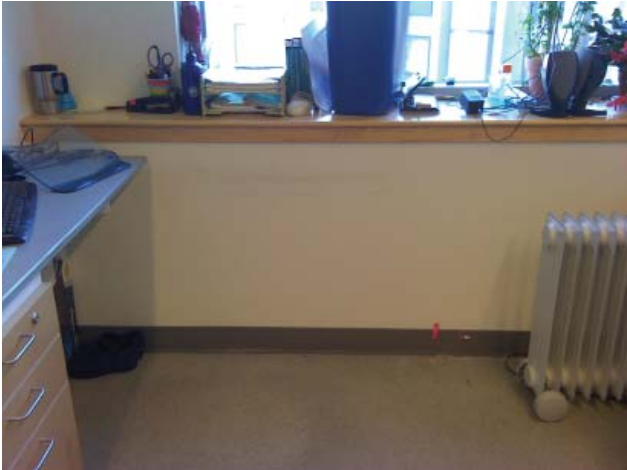
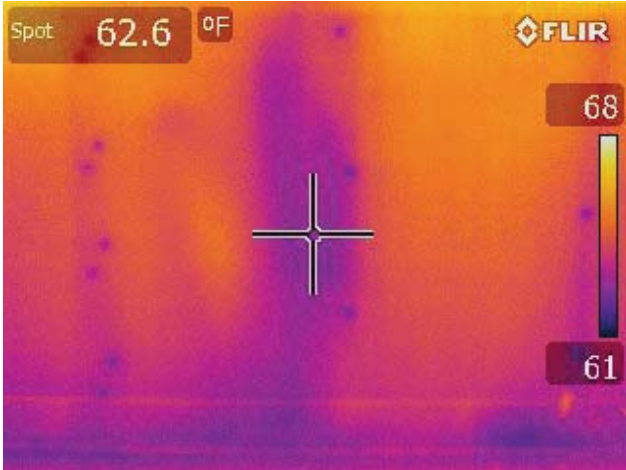
APPENDIX- 10a | ROOF TO WALL TRANSITIONS: Stud Back Up Wall with Insulation and Blocking

Calculated Baseline R-Value: 13.86 -
As-Built Condition
 Thermal Image R-Value: 3.88 - 75 %
 Simulated (THERM) R-Value: 6.40 - 54 %
Thermally Improved Condition
 Simulated (THERM) R-Value: N/A N/A

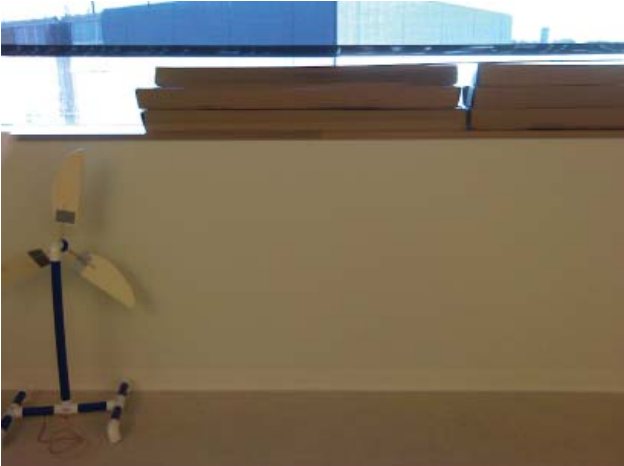
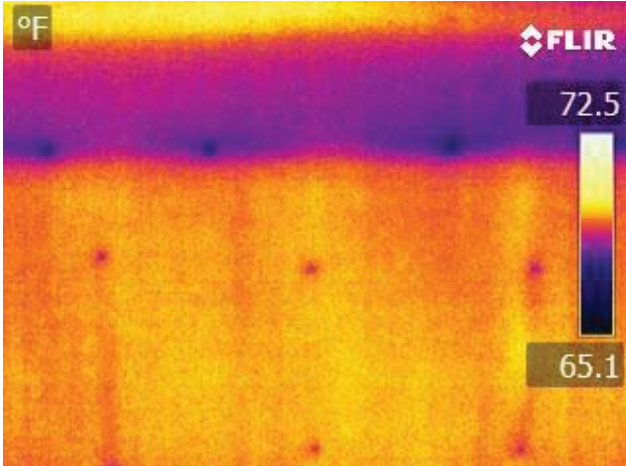
APPENDIX- 10b | ROOF TO WALL TRANSITIONS: Stud Back Up Wall with Continuous Insulation

Calculated Baseline R-Value: 16.74 -
As-Built Condition
 Thermal Image R-Value: 8.2 - 49 %
 Simulated (THERM) R-Value: 14 - 14 %
Thermally Improved Condition
 Simulated (THERM) R-Value: N/A -

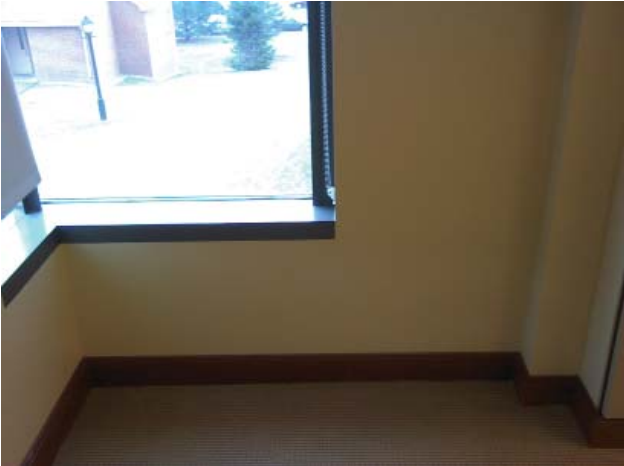
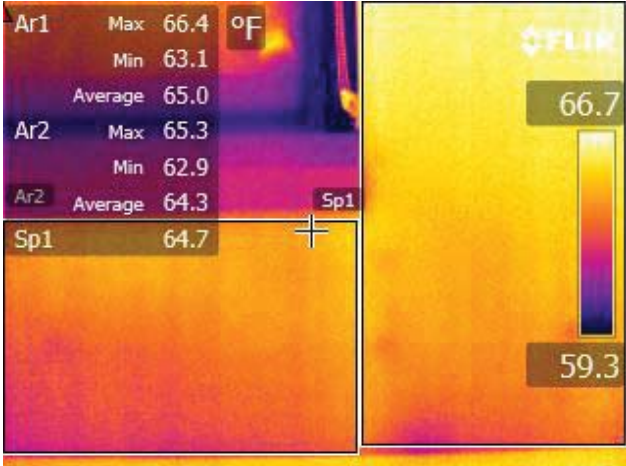
APPENDIX- 10c | ROOF TO WALL TRANSITIONS: CMU Back Up with Continuous Insulation

Calculated Baseline R-Value: 15.42 -
As-Built Condition
 Thermal Image R-Value: 5.5 - 64 %
 Simulated (THERM) R-Value: 5.5 - 64 %
Thermally Improved Condition
 Simulated (THERM) R-Value: N/A N/A

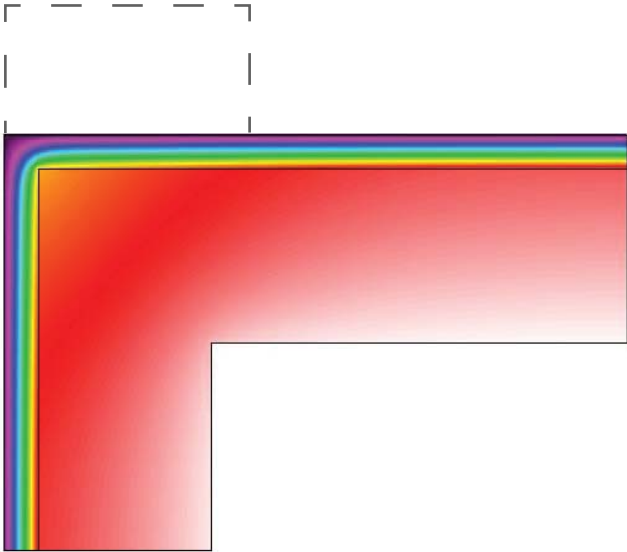
R-15.33
Insulating beneath parapet

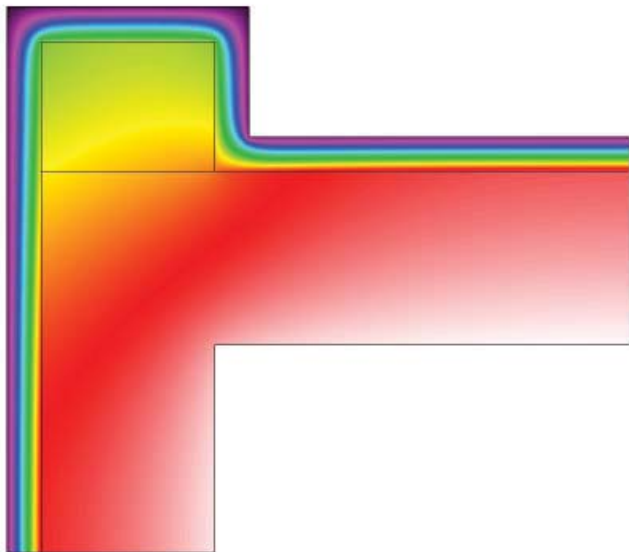
R-13.42
Insulating around 1'-3" tall parapet

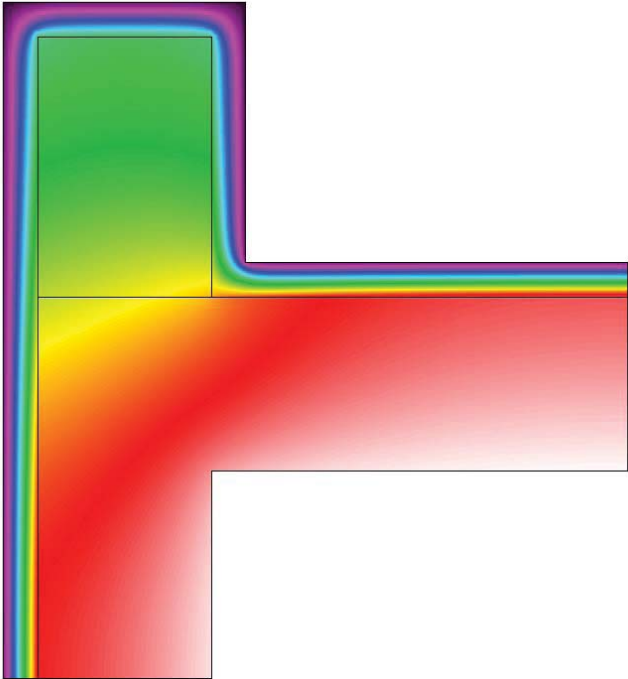
R-12.25
Insulating around 2'-6" tall parapet

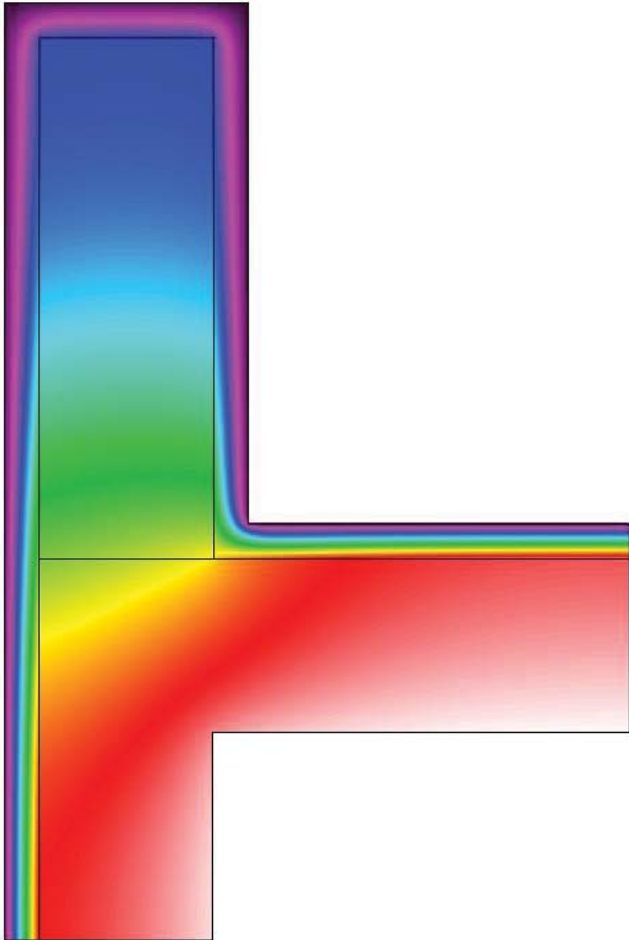
R-11.27
Insulating around 5'-0" tall parapet
