THERMAL PERFORMANCE OF FAÇADES

2012 AIA UPJOHN GRANT
RESEARCH INITIATIVE

Final Report | November 2014

PAYETTE

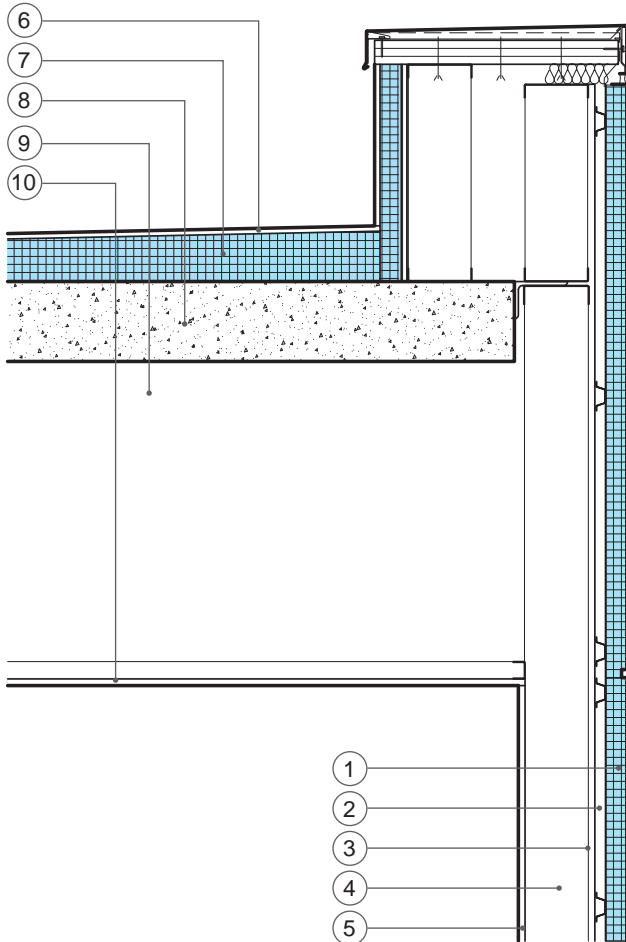
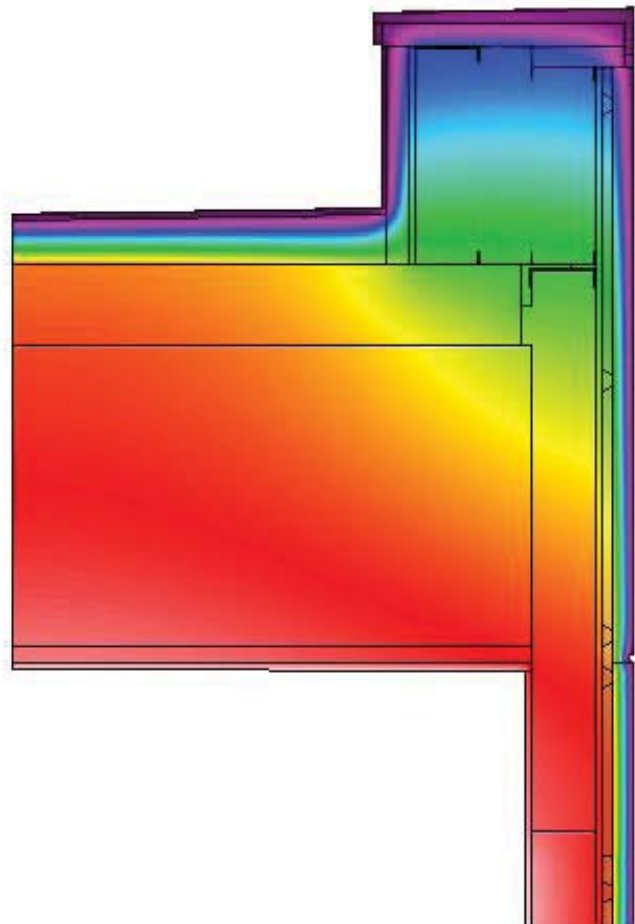
Calculated Baseline R-Value:	22.34	-
As-Built Condition		
Thermal Image R-Value:	N/A	-
Simulated (THERM) R-Value:	8.57	-61.6 %
Thermally Improved Condition		
Simulated (THERM) R-Value:	10.65	- 52.3 %

R-8.57

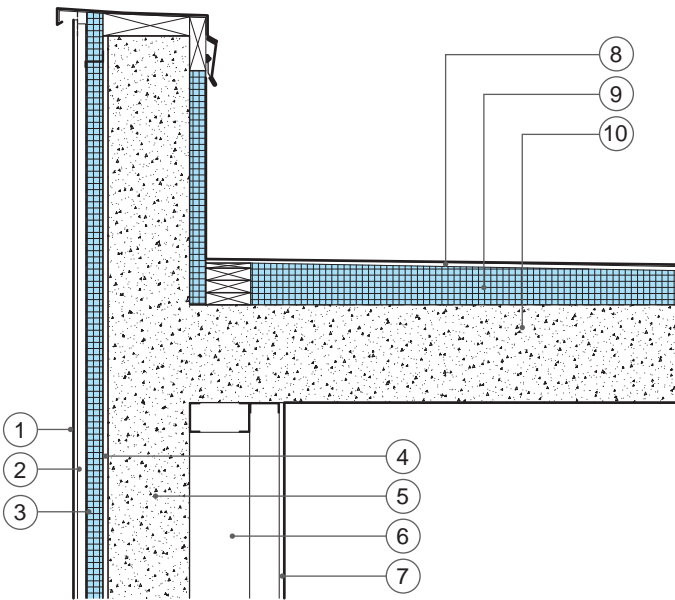
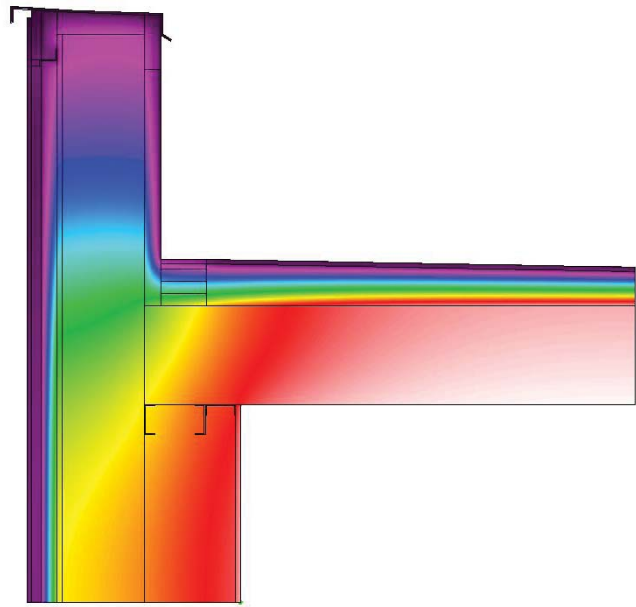
Calculated Baseline R-Value:	23.15	-
As-Built Condition		
Thermal Image R-Value:	N/A	-
Simulated (THERM) R-Value:	11.61	- 49.8 %
Thermally Improved Condition		
Simulated (THERM) R-Value:	14.18	- 38 %

R-11.61

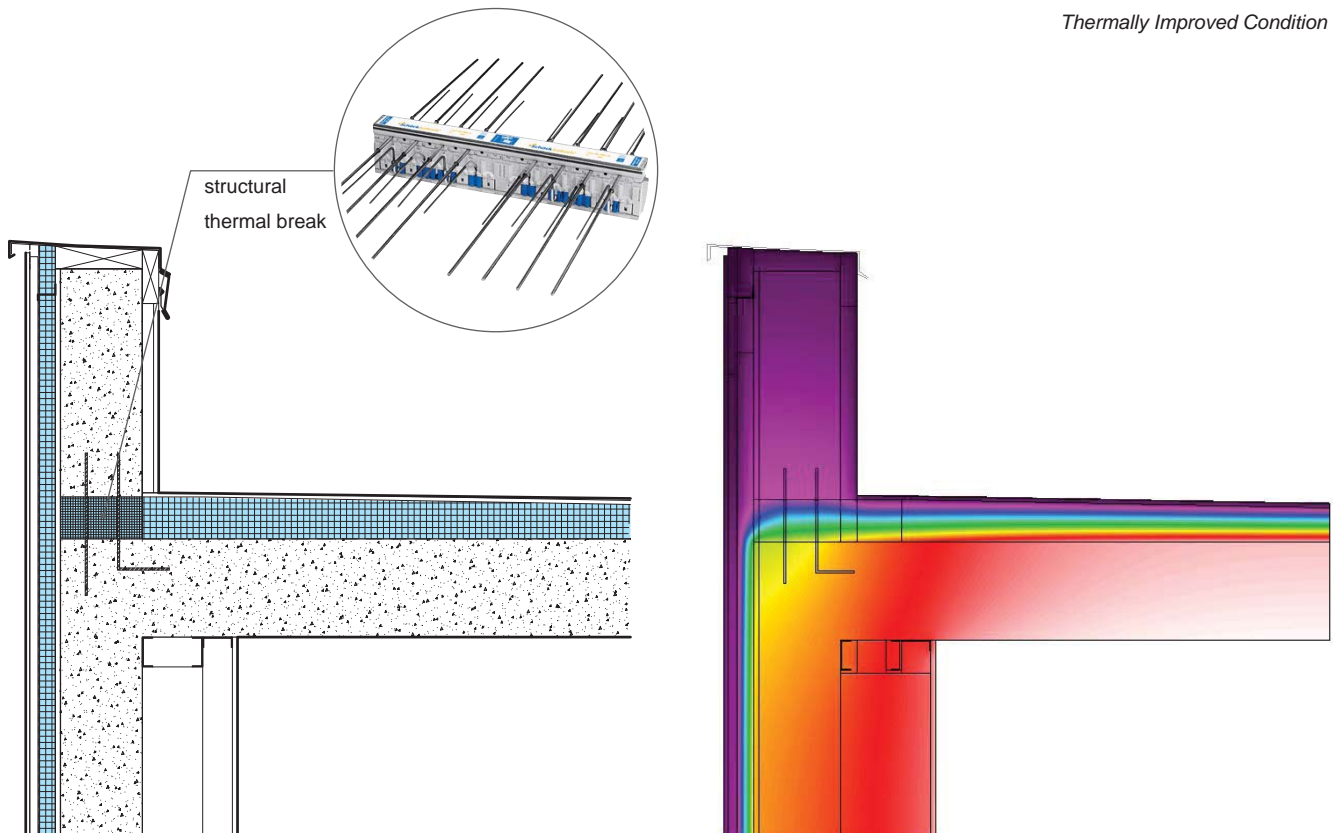
R-14.18
(+22%)

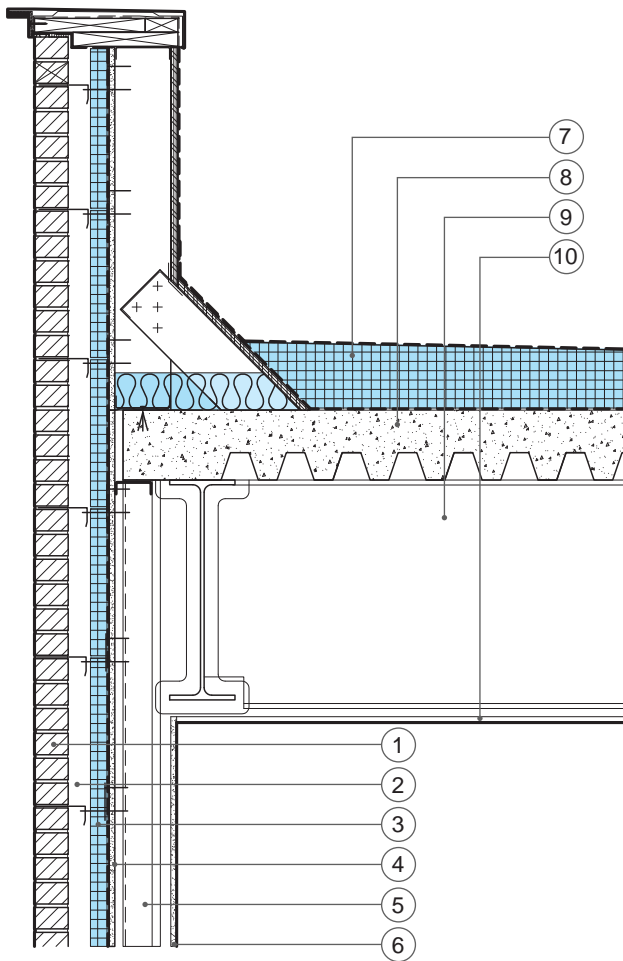
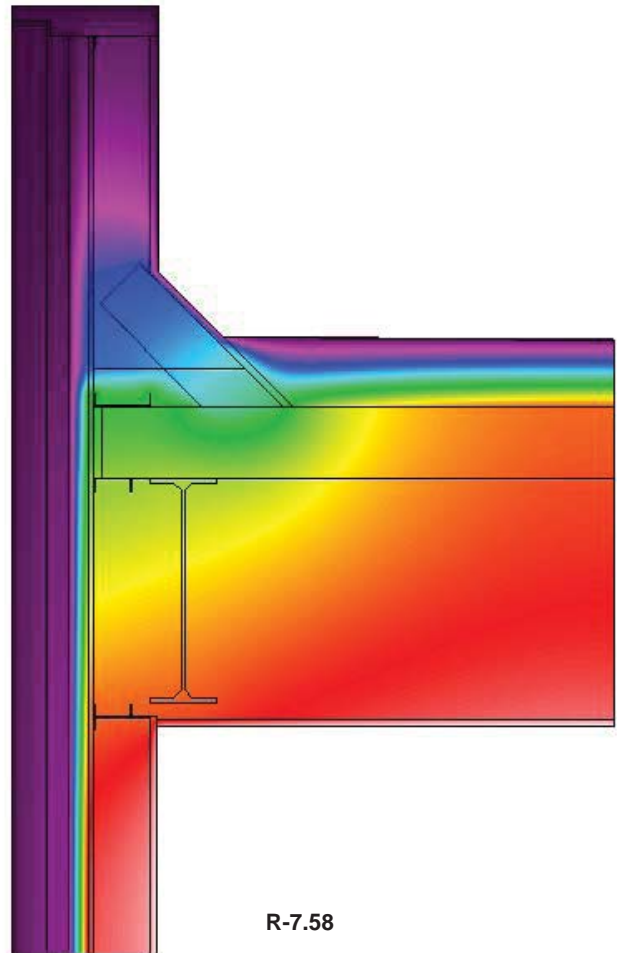
Calculated Baseline R-Value:	26.1	-
As-Built Condition		
Thermal Image R-Value:	N/A	-
Simulated (THERM) R-Value:	7.58	- 70.9 %
Thermally Improved Condition		
Simulated (THERM) R-Value:	12.51	- 52 %

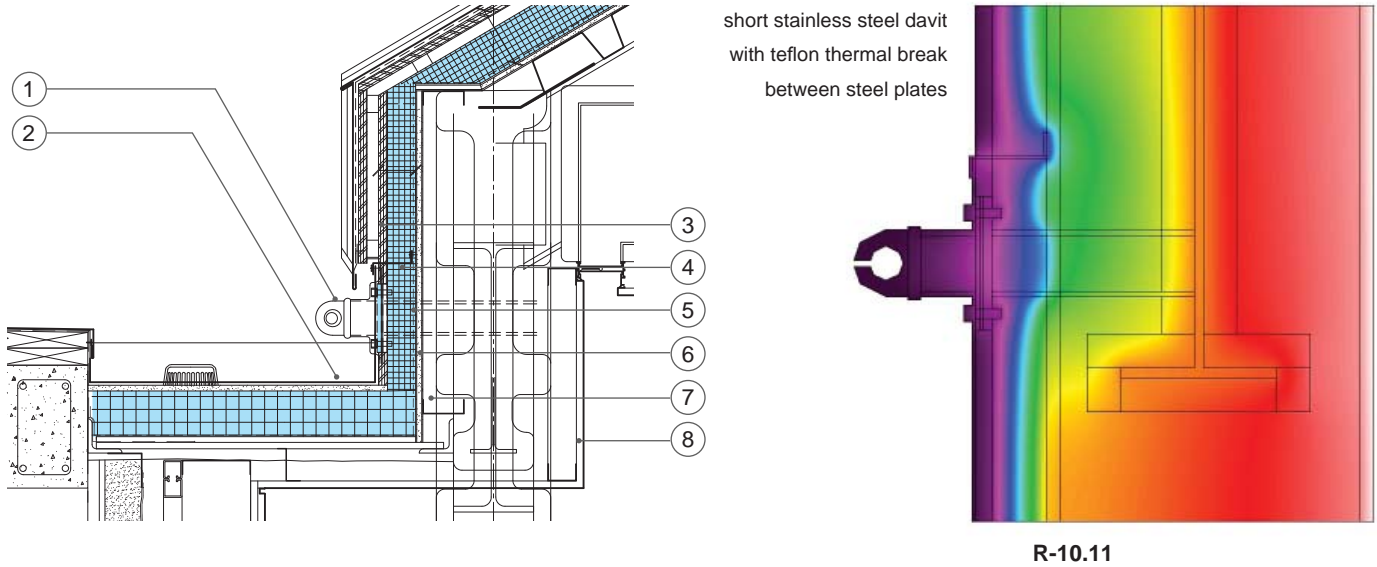
Calculated Baseline R-Value: 17.75 -
As-Built Condition
 Thermal Image R-Value: 5.76 - 67 %
 Simulated (THERM) R-Value: 10.07 - 43 %
Thermally Improved Condition
 Simulated (THERM) R-Value: N/A N/A

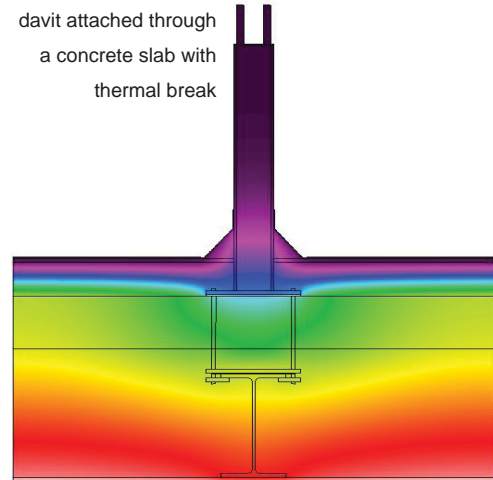
+ 23.5%

davit attached through a concrete slab with thermal break

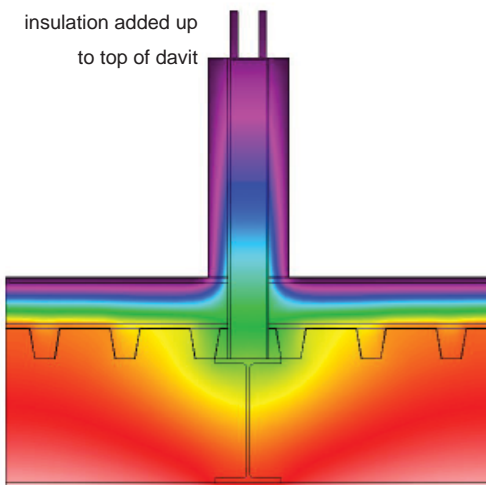
+ 30.9%

insulation added up to top of davit

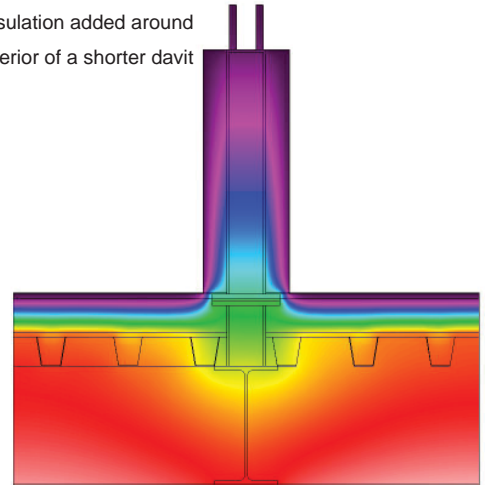
+ 53.9%

insulation added around exterior of a shorter davit

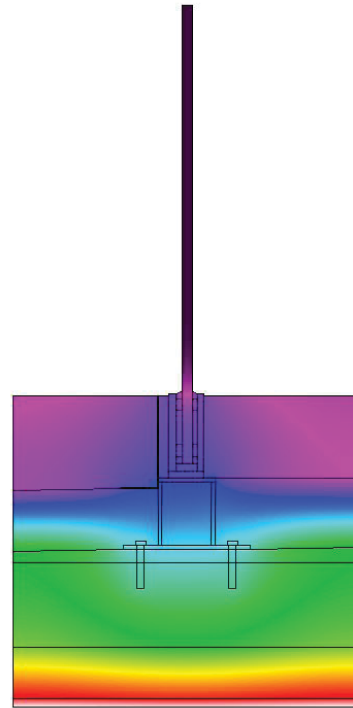
Calculated Baseline R-Value: 24.02 -
As-Built Condition
 Thermal Image R-Value: - -
 Simulated (THERM) R-Value: 4.75 -80 %
Thermally Improved Condition
 Simulated (THERM) R-Value: 7.75 - 67.7 %

R-4.75

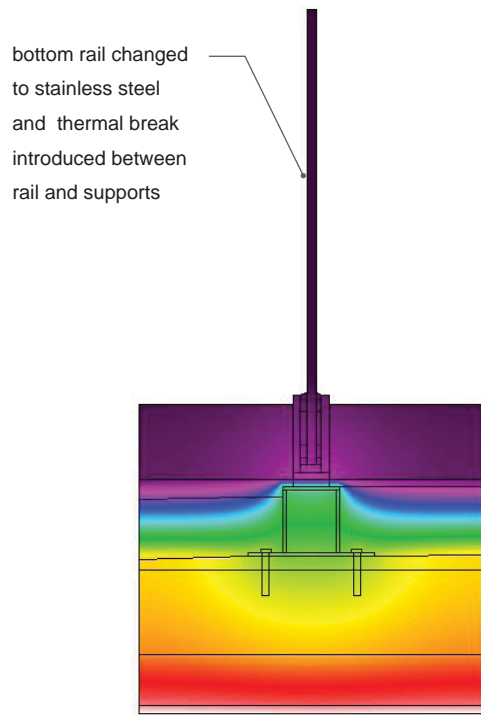
R-7.3
(+ 53.6%)

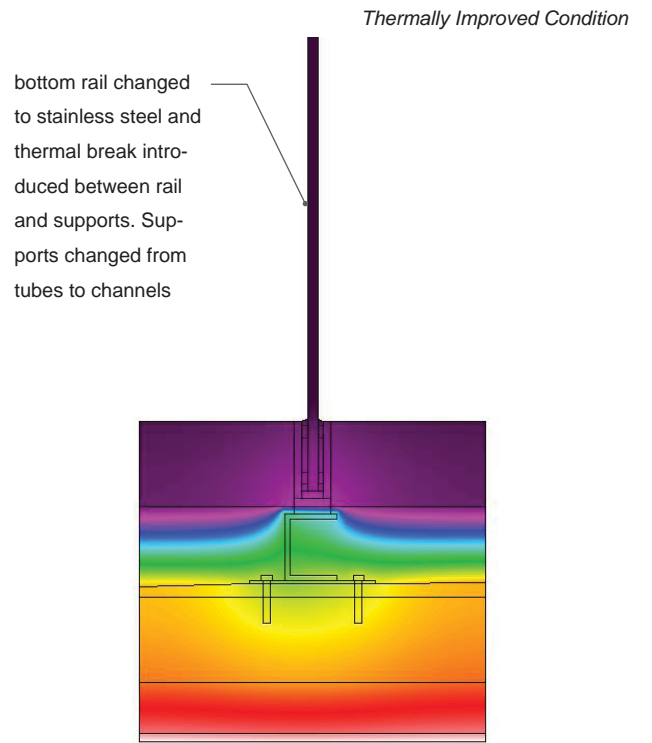
R-7.75
(+ 63.2%)

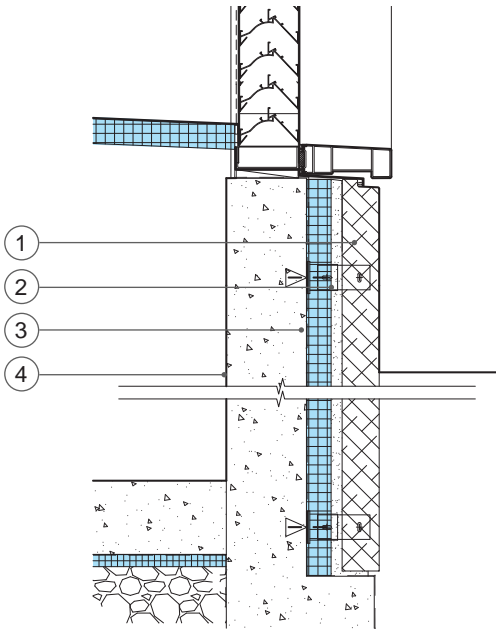
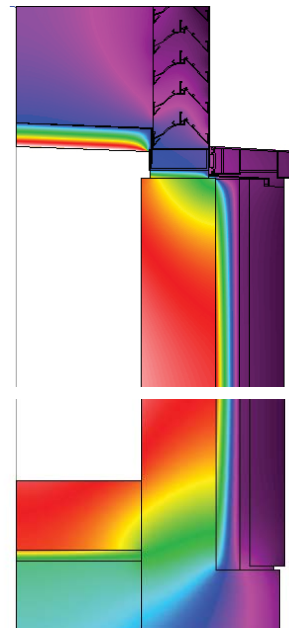
Calculated Baseline R-Value: 11.49 -
As-Built Condition
 Simulated (THERM) R-Value: 5.68 - 58 %
Thermally Improved Condition
 Simulated (THERM) R-Value: 6.53 - 52 %

R-5.68

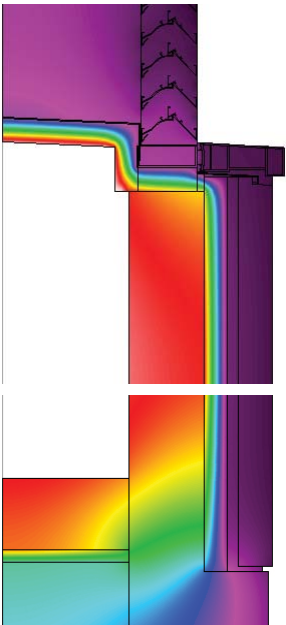
R-6.53
(+15%)

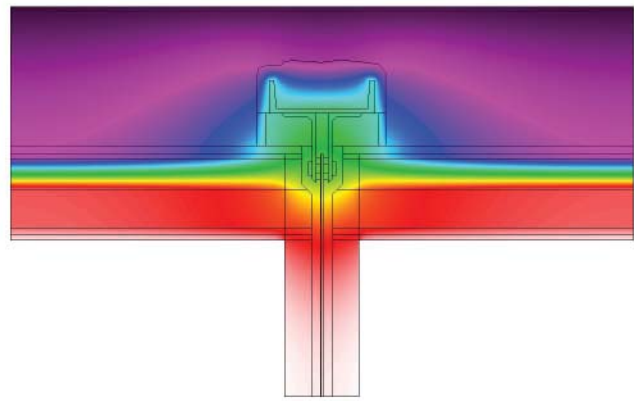
Calculated Baseline R-Value: 29.17 -
As-Built Condition
 Thermal Image R-Value: 8.47 - 71 %
 Simulated (THERM) R-Value: 16.62 - 43 %
Thermally Improved Condition
 Simulated (THERM) R-Value: 22.66 - 22 %

R-16.62

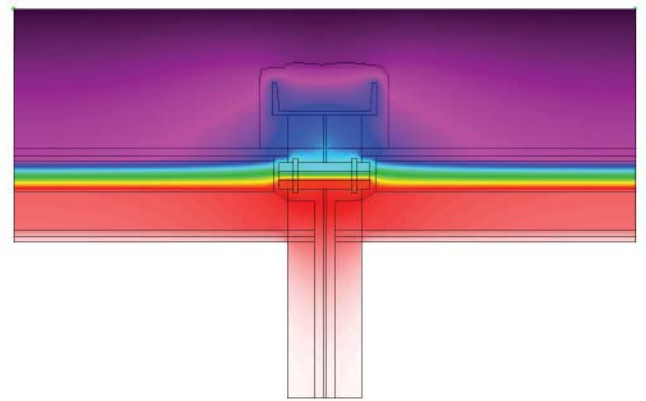
R-22.66
(+36%)

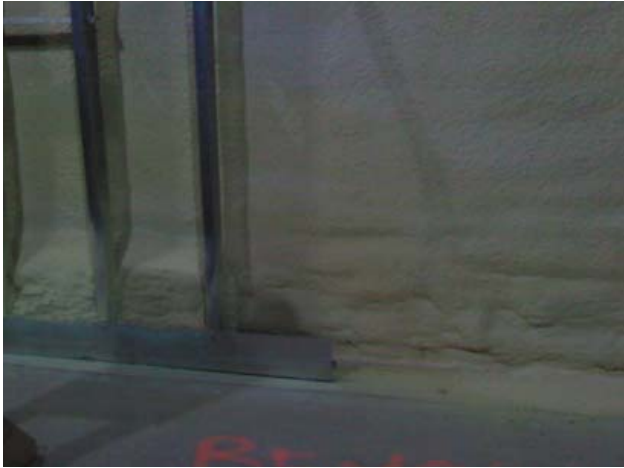
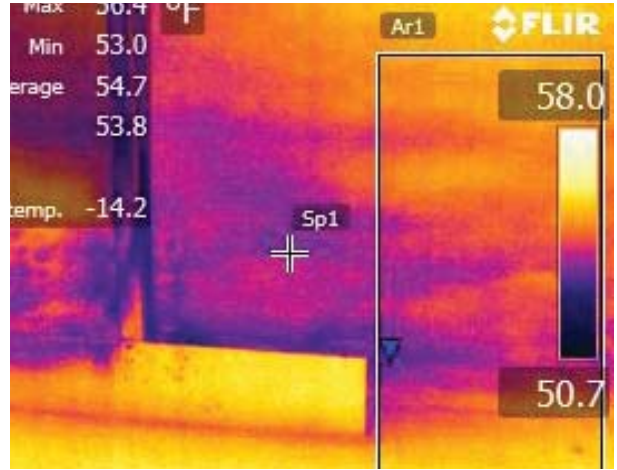
Digital Image

Calculated Baseline R-Value: 29.55 -
As-Built Condition
 Thermal Image R-Value: 15.33 - 48 %
 Simulated (THERM) R-Value: 16.14 - 45 %
Thermally Improved Condition
 Simulated (THERM) R-Value: 21.10 - 29 %

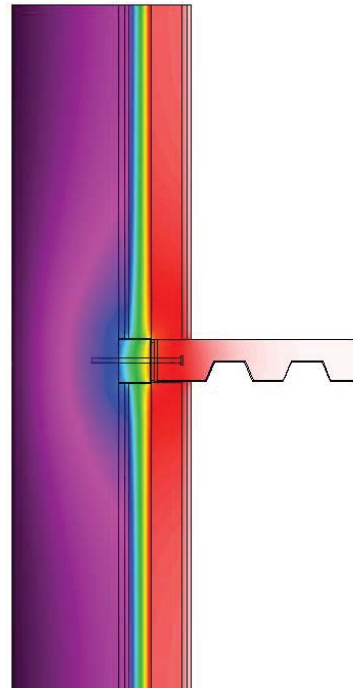
R-21.10
(+30.7%)

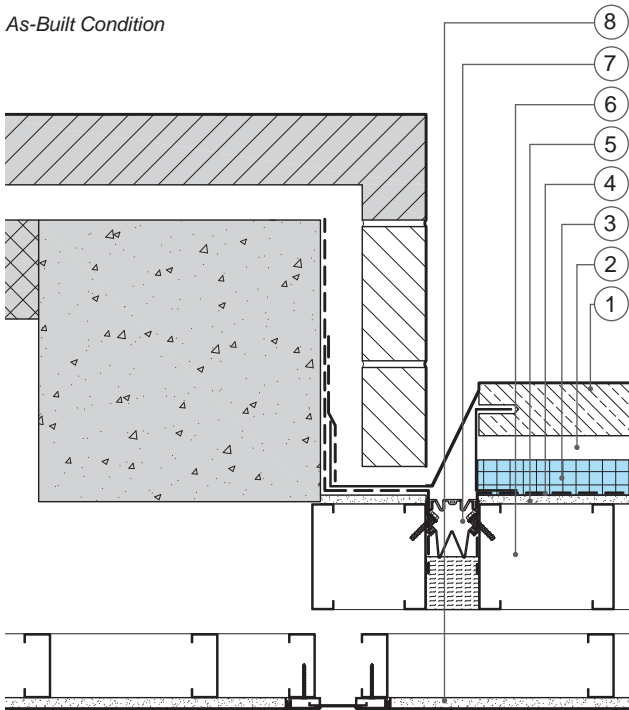
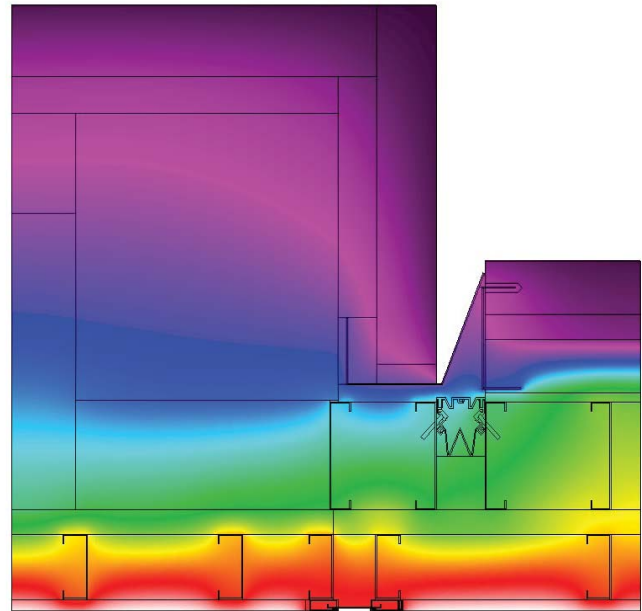
Calculated Baseline R-Value: 17.69 -
As-Built Condition
 Thermal Image R-Value: 6.77 - 62 %
 Simulated (THERM) R-Value: 7.88 - 55.5%
Thermally Improved Condition
 Simulated (THERM) R-Value: 13.72 - 22 %

R-7.88

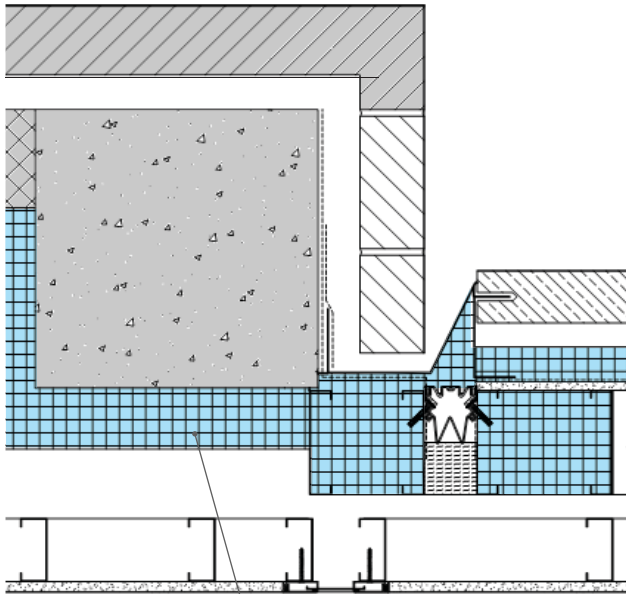
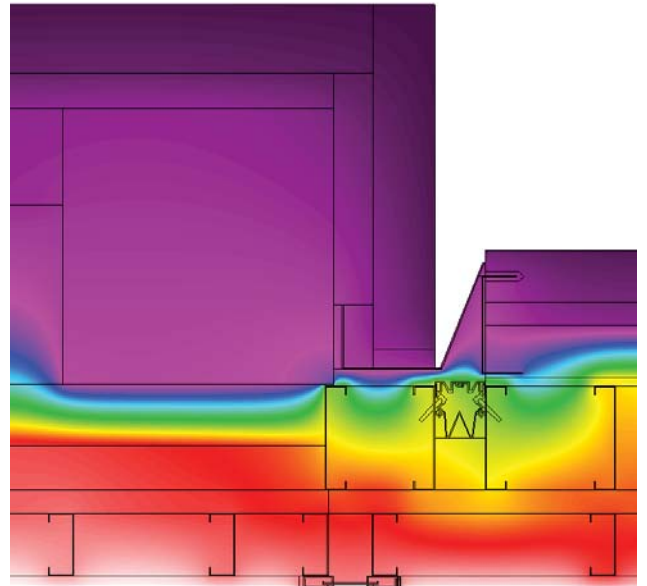
R-13.72
(+74%)

spray foam insulation
added to existing wall,
and at frame for joint

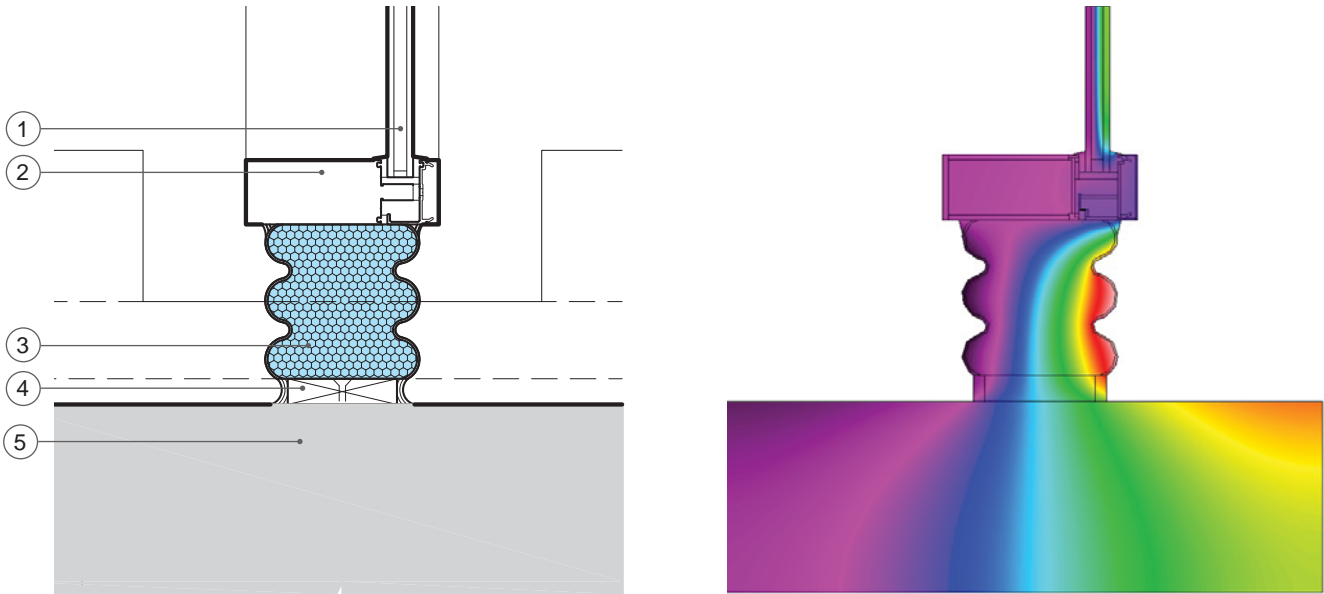
Calculated Baseline R-Value: 11.85 -
As-Built Condition
 Thermal Image R-Value: N/A N/A
 Simulated (THERM) R-Value: 2.30 - 81%
Thermally Improved Condition
 Simulated (THERM) R-Value: N/A N/A
