# Re-glazing of an All Glass Tower

**MICHAEL AOKI-KRAMER, BA, JD, LEED AP**  
RDH BUILDING SCIENCES INC, SEATTLE, WA

JAMES HIGGINS – RDH BUILDING ENGINEERING LTD.  
BRIAN HUBBS, P.ENG. – RDH BUILDING ENGINEERING LTD.  
GRAHAM FINCH, MASC, P.ENG. – RDH BUILDING ENGINEERING LTD.  
ED THIESSEN, P.ENG. – RDH BUILDING ENGINEERING LTD.

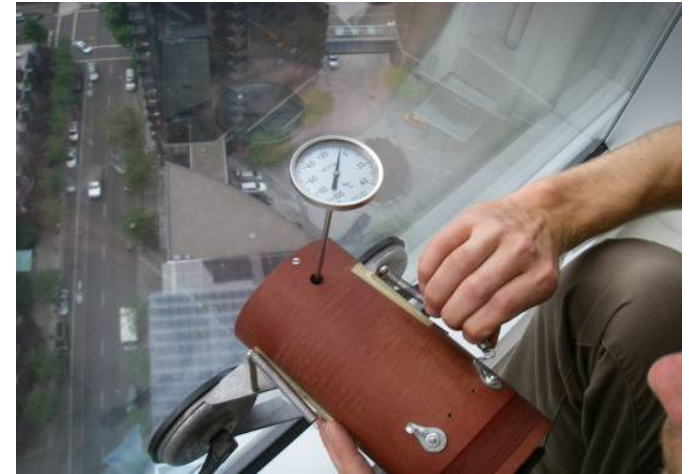
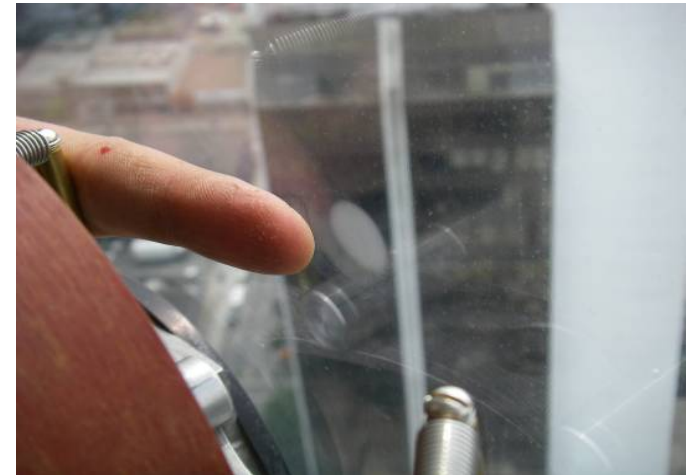
- Visual Review
  - Rating based on visual observation and level of fogging and low-e corrosion damage visible from 10 feet away
- Dew/frost-point testing (ASTM E-576)
  - Measures how dry the IGU airspace is and estimate the saturation level of the desiccant
  - Can estimate remaining service life of IGUs
  - Can quantify failed units and units close to failure

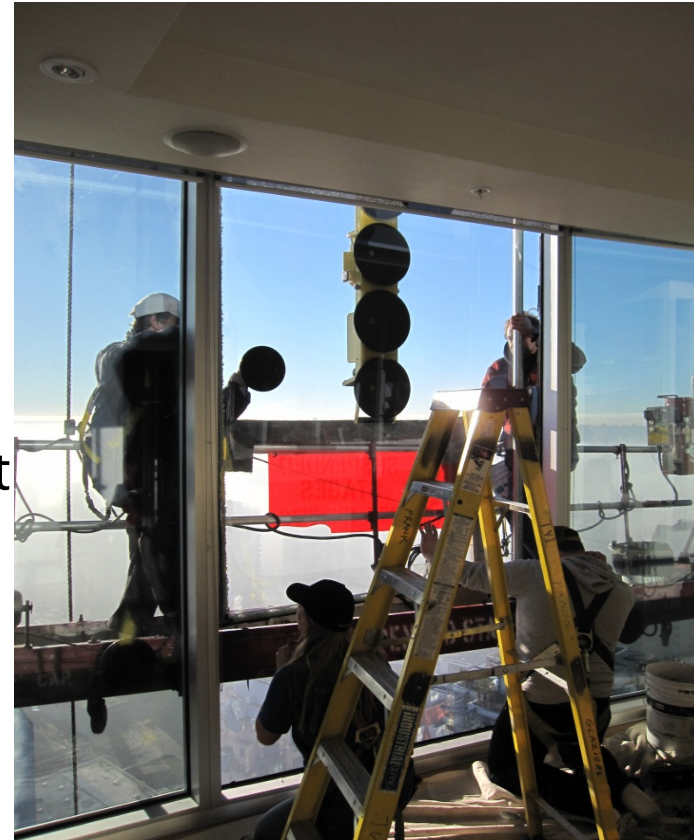
- Further testing procedures:
  - Desiccant saturation measmnt.
  - Pressure testing
    - › Measure leakage rate of IGUs
  - Flow testing
    - › Measure flow through the desiccant tube in service
  - Eventual removal
    - › For visual and laboratory testing
    - › Delayed for several years to get safety variance to remove IGUs

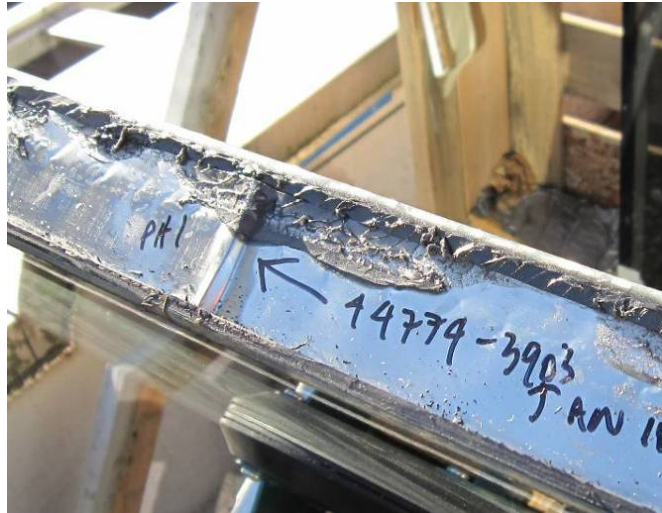
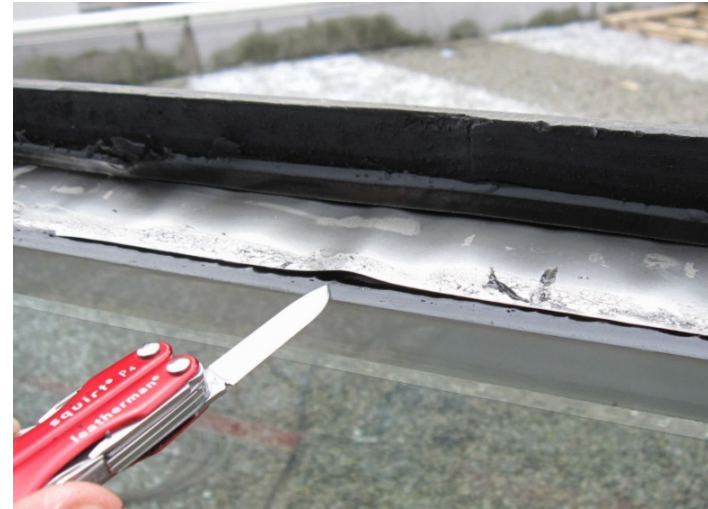
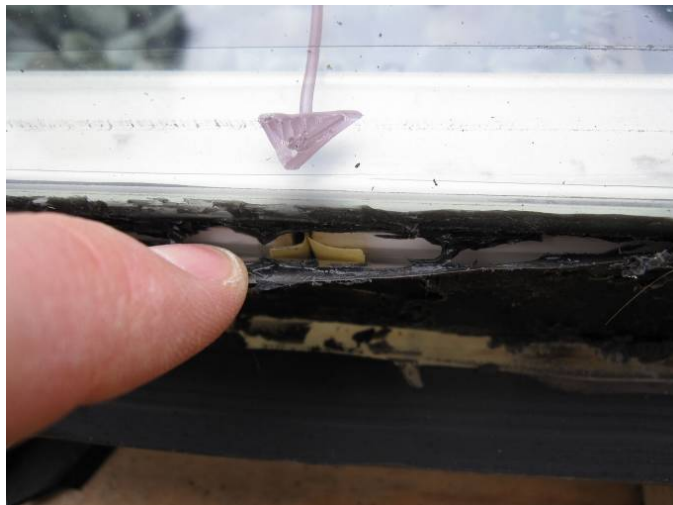
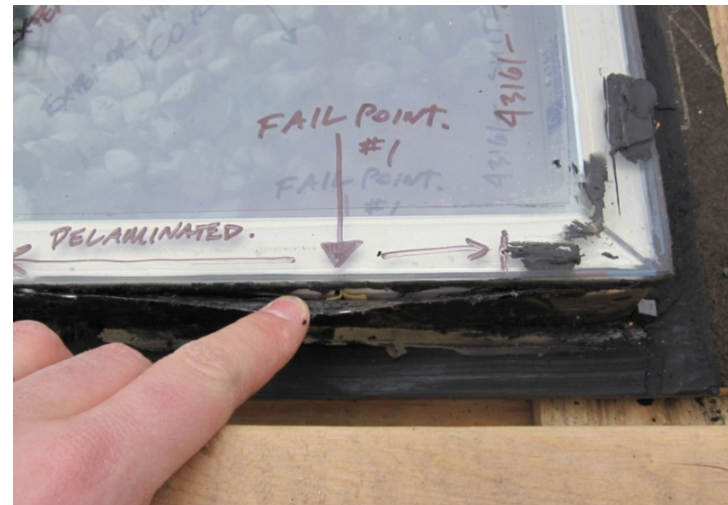
# IGU Removal and Testing

- Systemic failure of IGUs due to an inadequately sealed “thermally efficient” edge spacer
  - PVC, aluminum, stainless steel foil & hot-melt butyl differential expansion/contraction
  - No real durable structural edge seal
  - Removable desiccant tubes easily overwhelmed in service
  - IGU failure led to frequent fogging and permanent corrosion of silver low-e coating on surface #2
- All residential IGUs need to be replaced
- Cooling HVAC units and in particular ducting is undersized for the clear glazing used.
- Mechanical under design can be resolved using high performance glazing in most suites

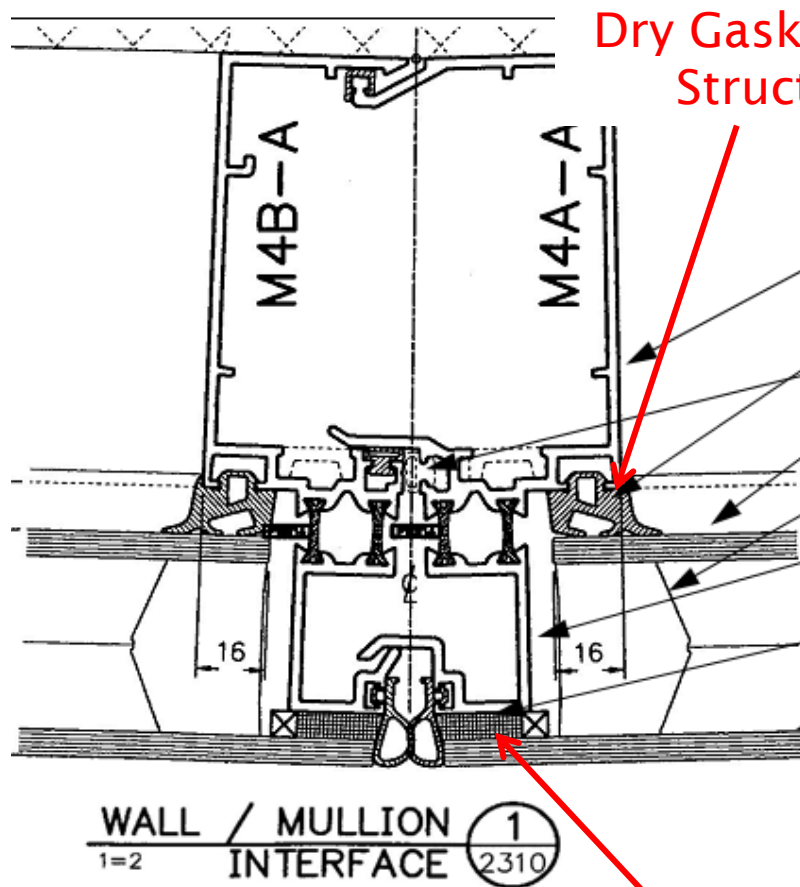
Original Design  
Done in Factory: Ideal  
Conditions

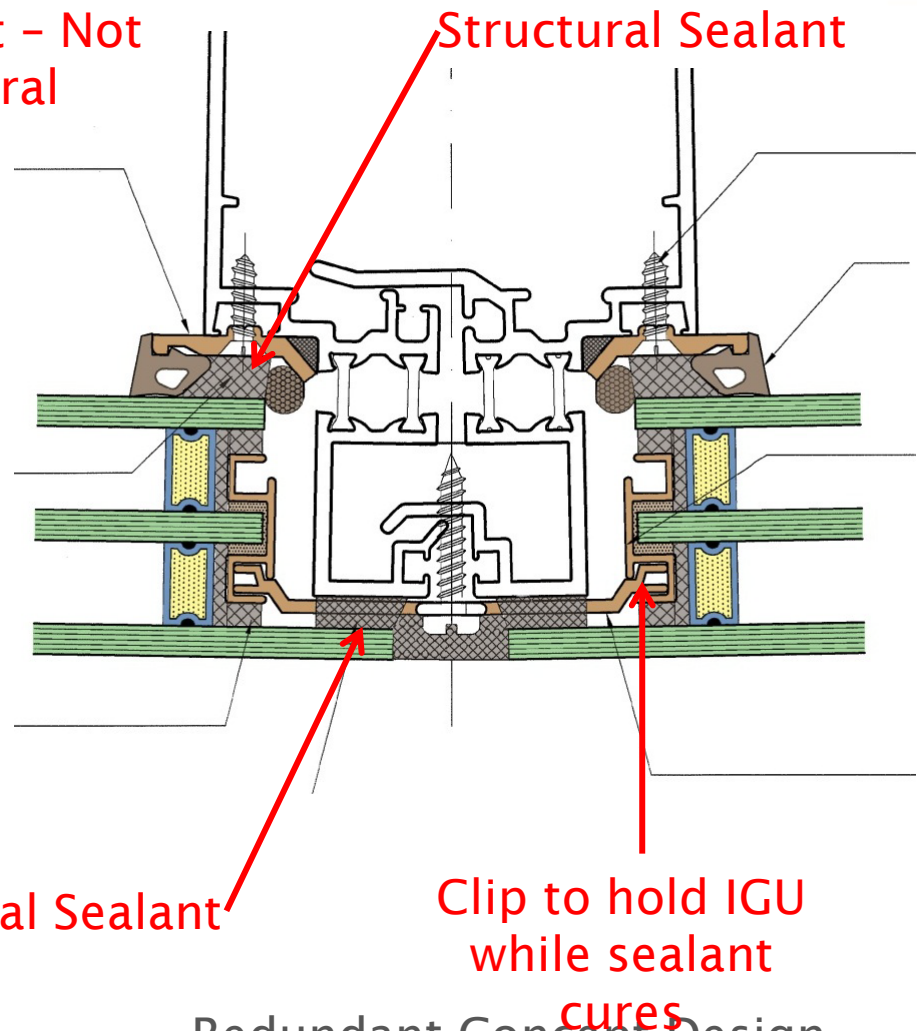
Redundant Concept Design  
Done in the Field
