Louis Kahn's Stainless Steel Glazing System: Performance Upgrades in the Richards Building

Aaron Davis, AIA

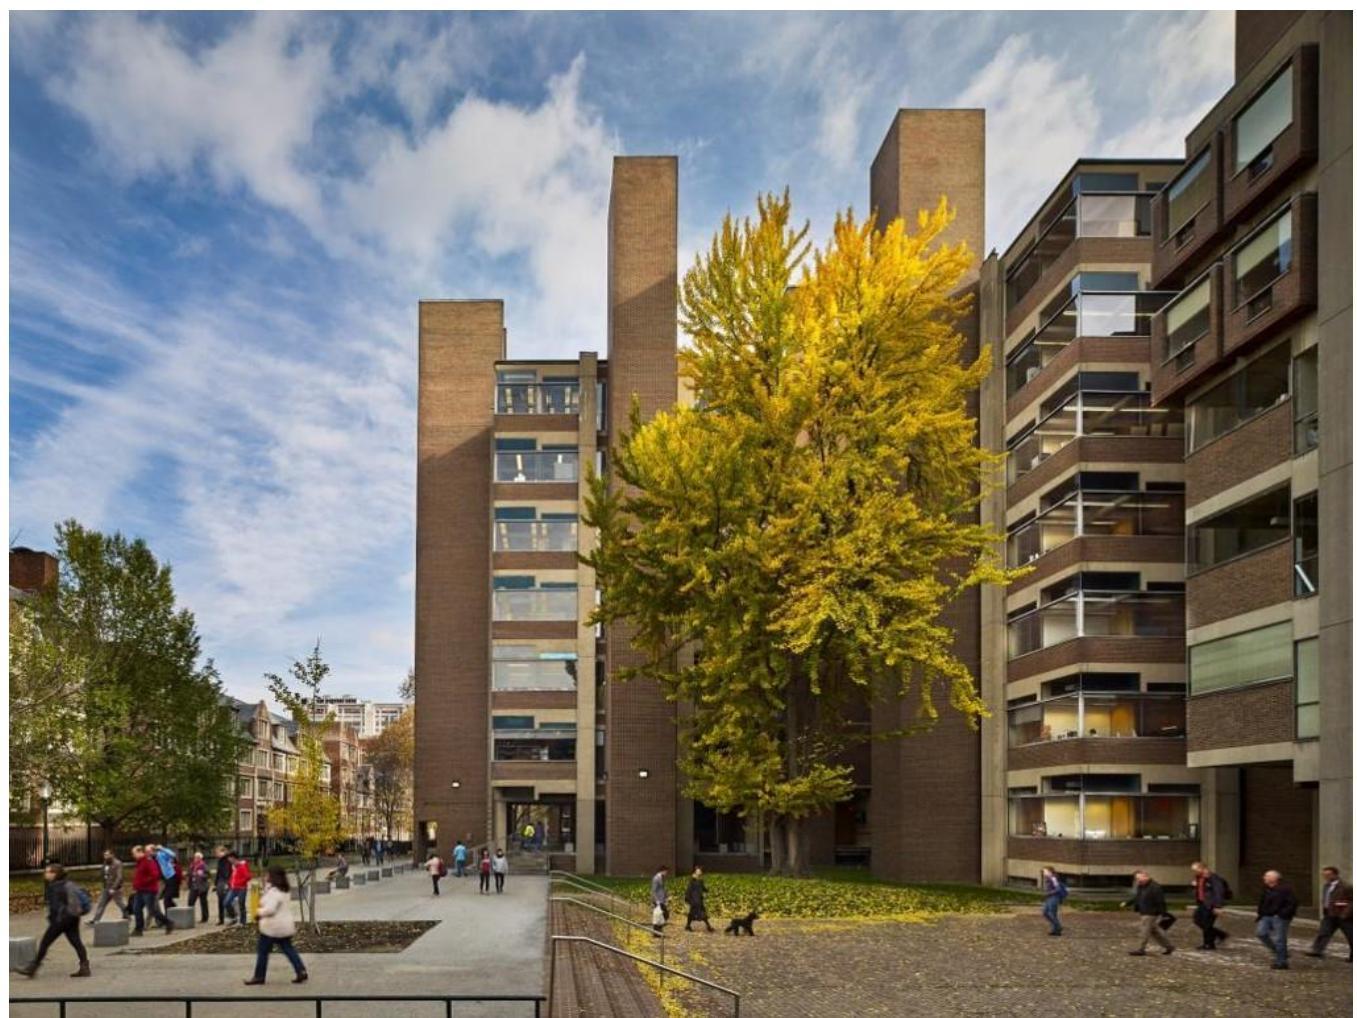
Figure 11 View of Richards from College Walk. Remediated wing is foreground-right. Credit: Halkin Mason

The project addresses many of the issues that confront working with mid-century modern structures. Though balancing respect for its Landmark status as a signature work of Louis Kahn against solving acute functional performance issues made this an especially exacting project, our success should not be considered an anomaly for these types of projects (Figs. 11 & 12).

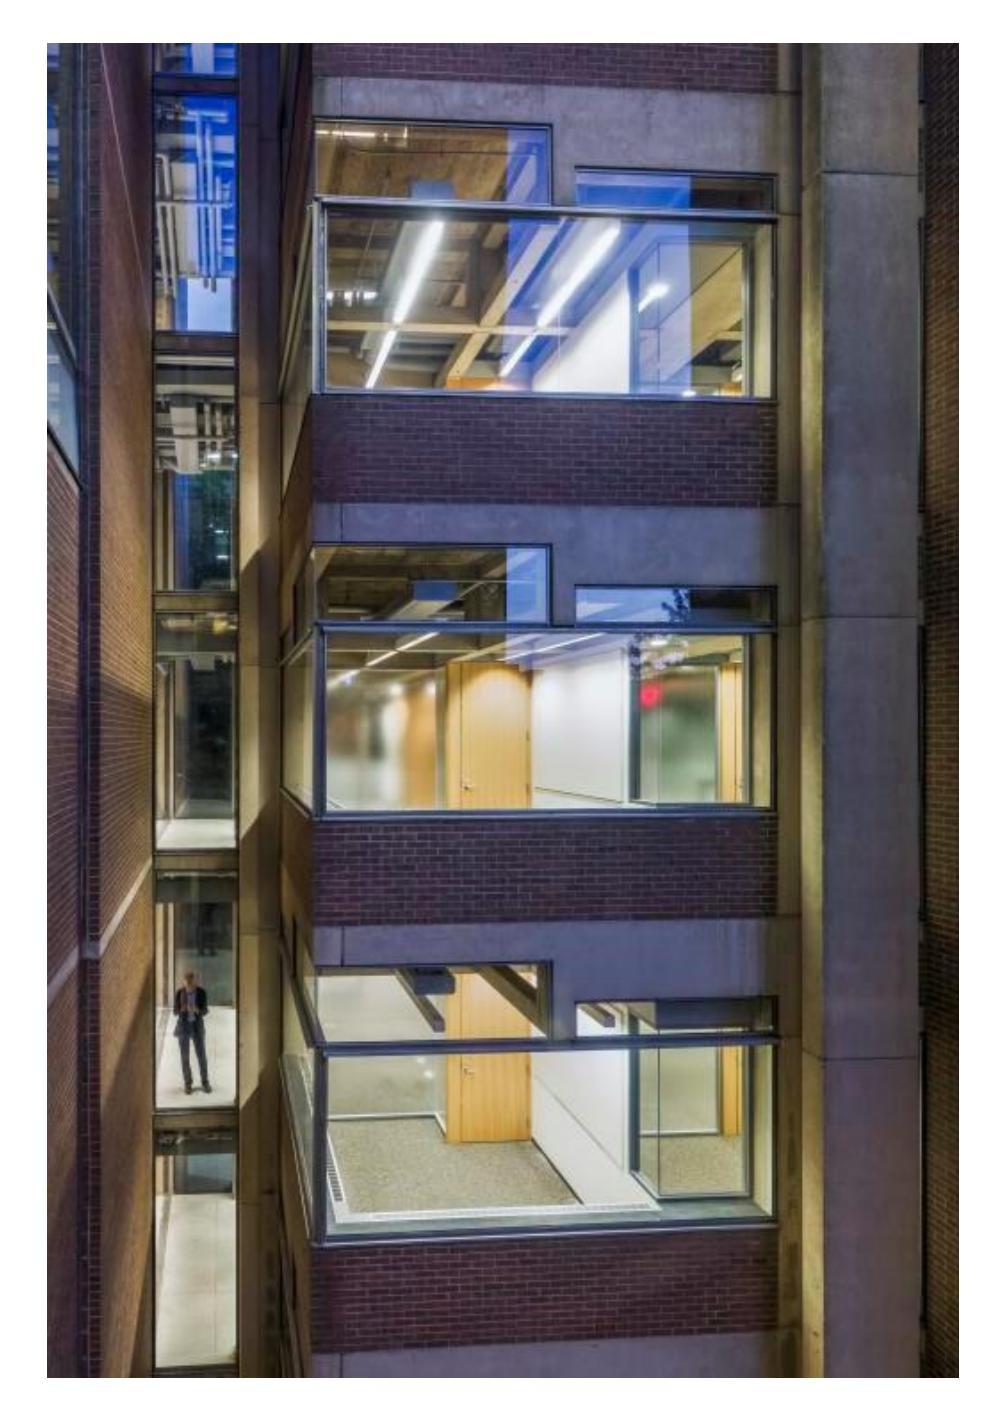
Figure 12 View of remediated wing, looking at the laboratory spaces and connection to the service core. Credit: Jeff Goldberg, ESTO
