## **A New Paradigm for the Design of Sustainable Buildings**

Warren Knowles, P.Eng., Brian Hubbs, P.Eng., Paul Kernan, MAIBC, Graham Finch, MASc, <sup>1</sup>

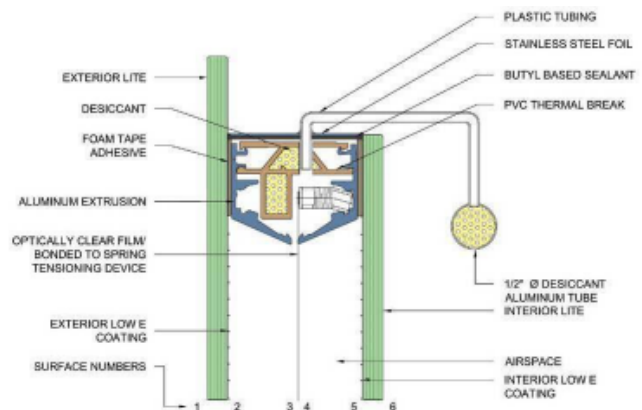
A unique characteristic of the IGU's is that they are allowed to vent and pressure equalize to the interior of the building. The venting is achieved by means of a small breather tube that is attached to a spigot that penetrates through the stainless steel edge band to the interior of the IGU. The breather tube is attached to a large aluminum tube filled with desiccant on the interior of the building. When temperature variation, wind pressure and atmospheric pressure change the volume of air inside the IGU, it is intended that small volumes

Figure 9: Typical insulated glazing unit

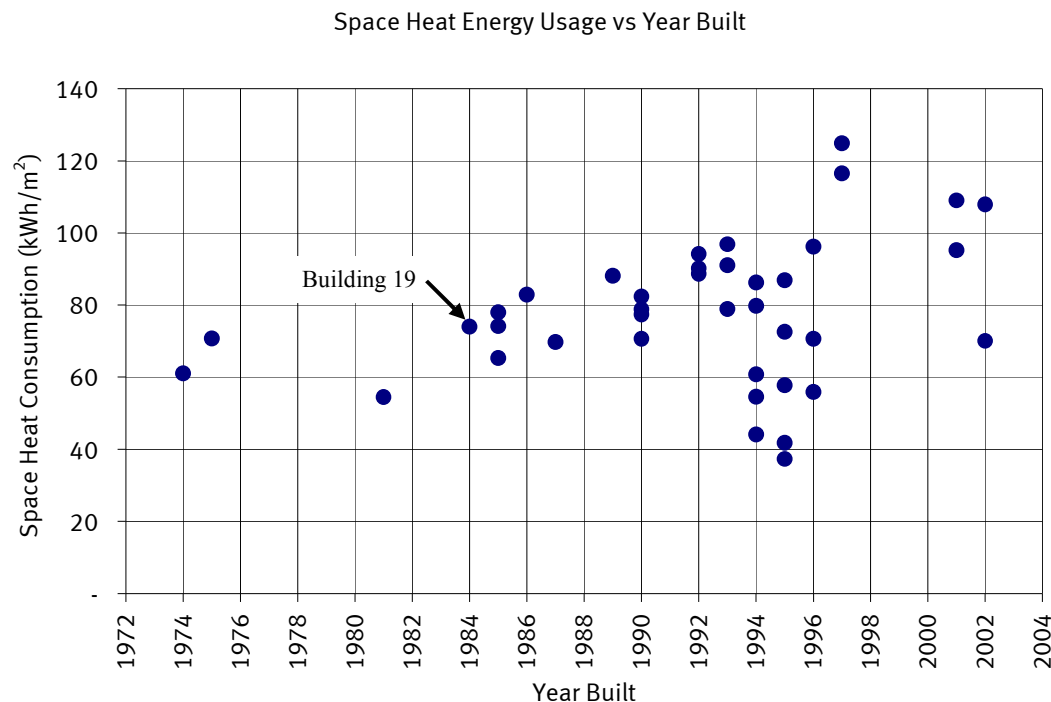
The Research Study: Energy Consumption and Conservation in Mid and High Rise Residential Buildings in British Columbia (the Study, RDH 2009) included numerous examples of buildings that did not meet the performance expectations of the original designers. Exterior moisture management, energy consumption, heat transfer characteristics, condensation potential, occupant comfort, and durability and other actual performance characteristics consistently did not meet the original design intent at these buildings. Although the sample set of buildings is limited, the findings show a trend of increased energy consumption for newer buildings.

Figure 14: Space heat energy consumption per floor area of 39 buildings verses year built.
