## **Title: Building Envelope Upgrade at Frank Lloyd Wright's Solomon R. Guggenheim Museum**

William B. Rose (1) and Angel Ayón (2)

The Solomon R. Guggenheim Museum in New York, the last major work by Frank Lloyd Wright completed in 1959, was the focus of a major restoration effort from 2004 to 2008. Throughout its service life, the building has performed admirably, but with some prominent building-envelope flaws. In response to evidence of cracking, the museum undertook an extended study prior to remediation. The principal focus of the remediation was architectural and structural—heat and moisture analysis was part of the overall effort. One part of the heat and moisture analysis was investigation and measurement of conditions in the wall assembly.

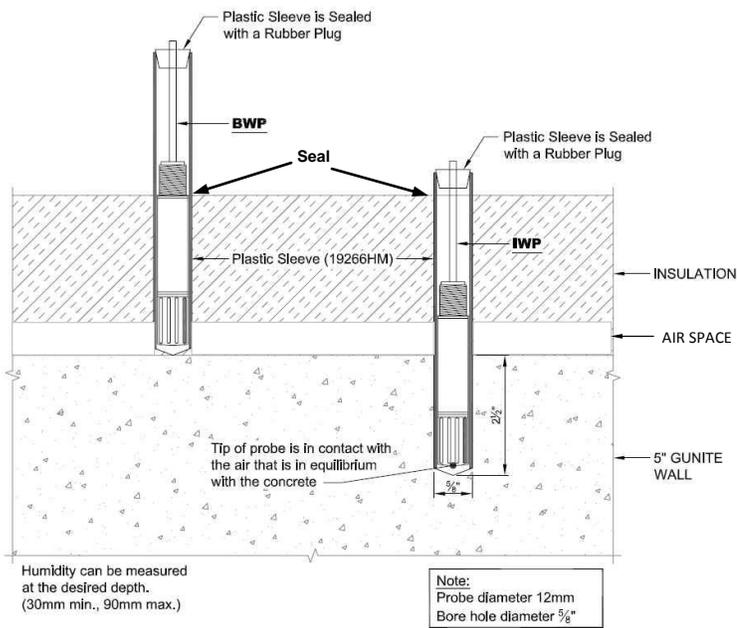
For the initial monitoring campaign, four sensors to detect temperature and relative humidity were placed in the wall on Ramp 4. The Main Rotunda has a total of six ramps, and the uppermost ramp provides overhanging protection against rain to the ones below. See Figure 1. The exhibition space between the gunite wall and two adjacent load-bearing concrete walls are known as “bays” (see Figure 2).

Two sensors were installed in south-facing bay 44 and two sensors were installed in west-facing bay 47. One sensor was installed so that it captured the air temperature and humidity of a “bubble” at the inside of the gunite wall panel (named “IWP” location in the reports) and another at the interface of the gunite and the insulation (named “BWP” or behind wall panel in the reports). See Figure 5. Monitoring data was collected from March 2005 to October 2005. There was no scaffolding in place during this time, and the exterior cocoon finish was in place. Thus the results from this campaign represent normal performance of the wall.

**Figure 5. Temperature and humidity sensor placement in the walls of the Main Rotunda, Ramp 4 and Ramp 6.**

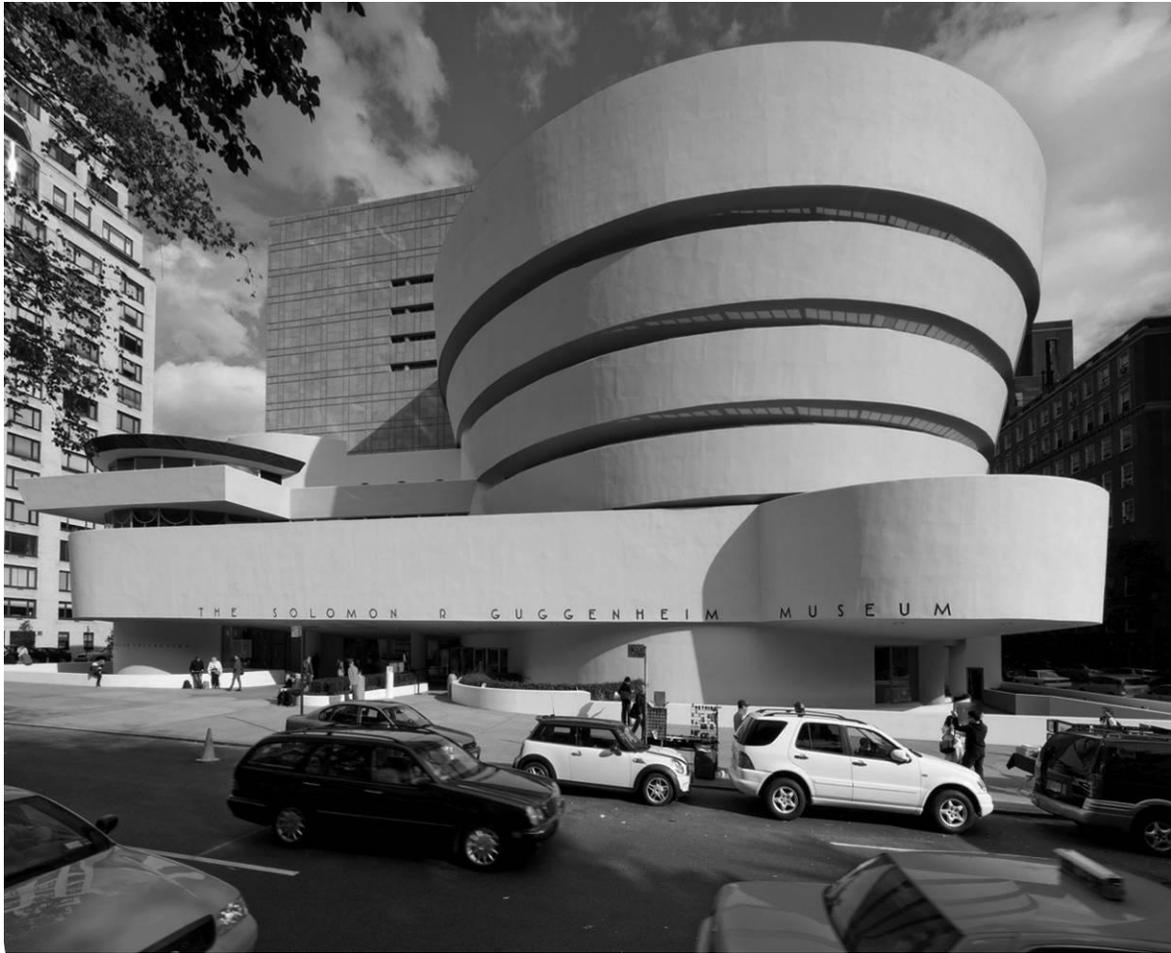
**Figure 13. The Solomon R. Guggenheim Museum after completion of the work  
© D. Heald, The Solomon R. Guggenheim Foundation, 2009**

Corrective measures to fill the gaps and voids in the gunite and to provide an air barrier at the interior of the wall were recommended. As with many projects of this type, the consultants responsible for making recommendations of this type are not in a position to document the level of compliance with the recommendations. Discussions of indoor humidity settings and mechanical pressurization were conducted in the course of the

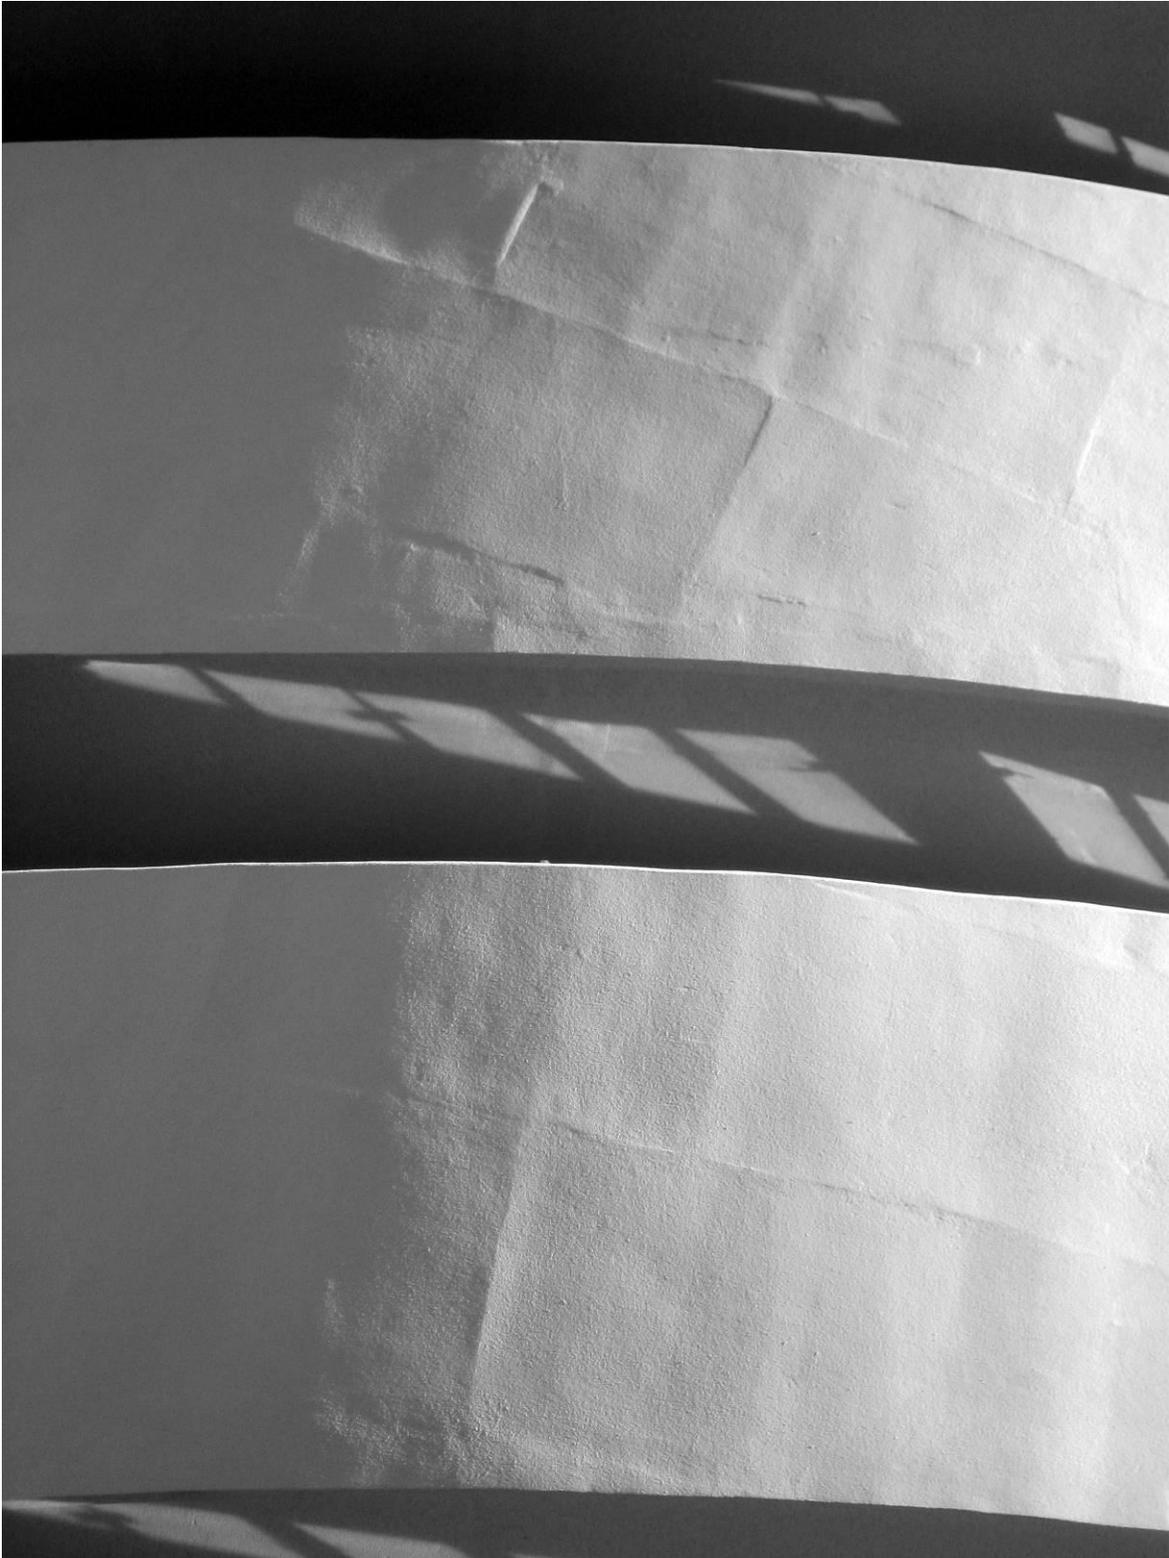
**Figure 13. Detail of Rotunda wall showing original formwork marks after exterior conservation work. © A. Ayón, WASA/Studio A, 2009**
