## New Construction or Deep Retrofit?

Roadmap to Build a Case for Deep Retrofit

**TEAM LINKoln**

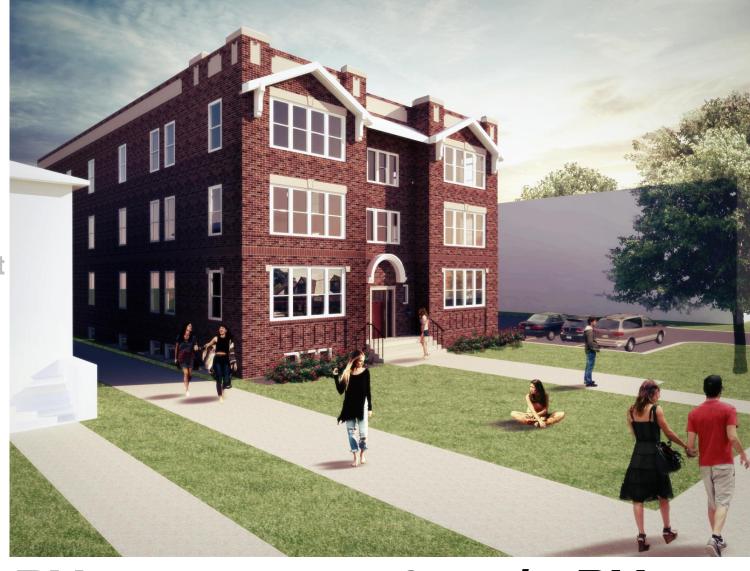
Energy Bill: \$308 w/o PV \$82 w/PV

HERS Rating: 35 w/o PV 12 w/PV

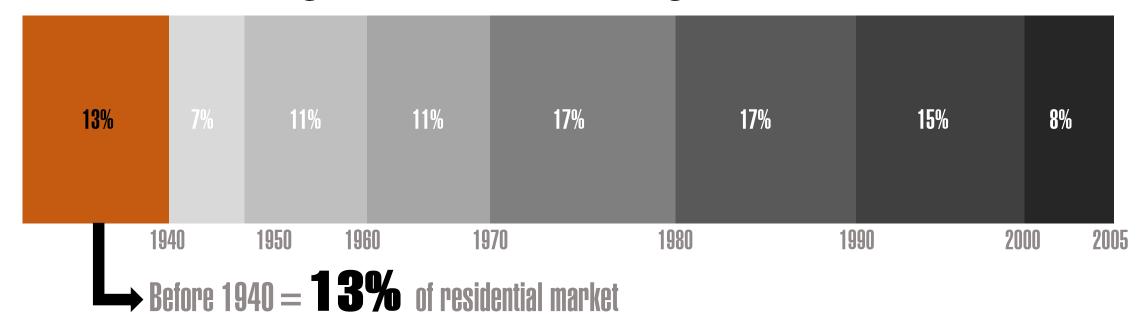
# Age of U.S. Building Stock<sup>1</sup>

82 billion S.f. of existing space will be demolished and replaced

between 2005 and 2030<sup>2</sup>

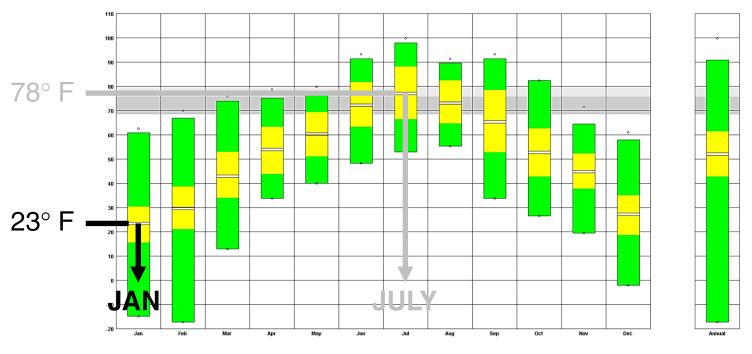
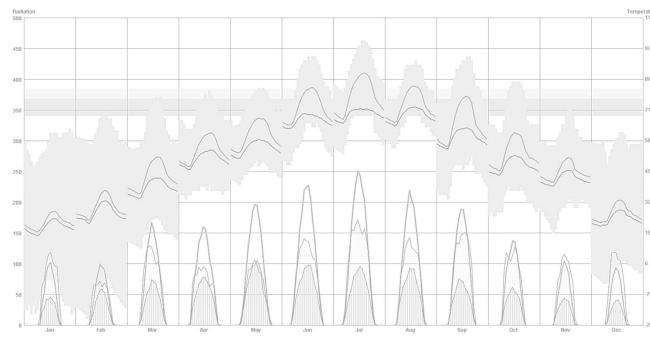
### TEMPERATURE

Average Max Temp: 78° F

Average Min. Temp: 23° F

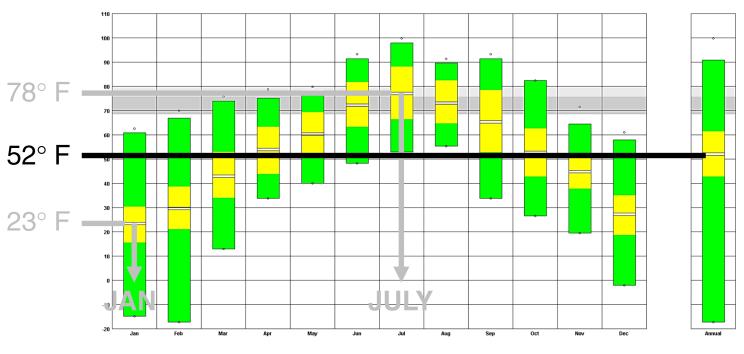
### TEMPERATURE

Average Min. Temp: 23° F

Average Annual Temp: 52° F

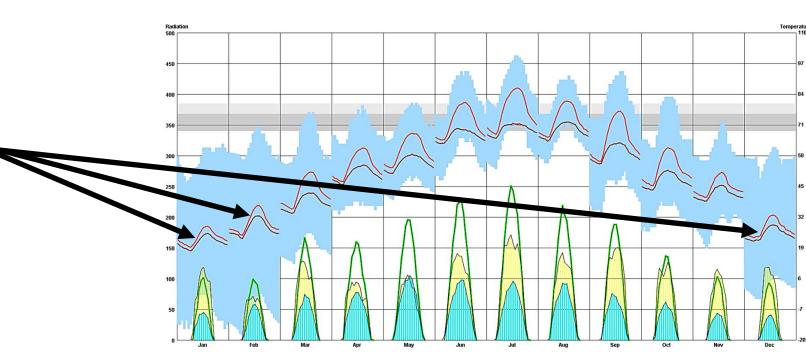
Condensation and Freeze Thaw (FT) Potential

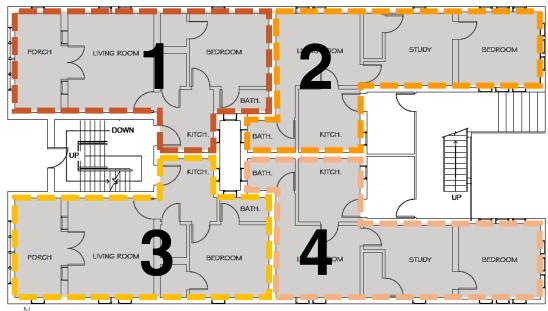
EXISTING UPPER FLOOR PLAN
3/16"=1'-00"

- Lack of Green Infrastructure
- 4 units per floor
- Closed layout
- Ineffective daylighting
- Poor MEP layout
- Non ADA compliant

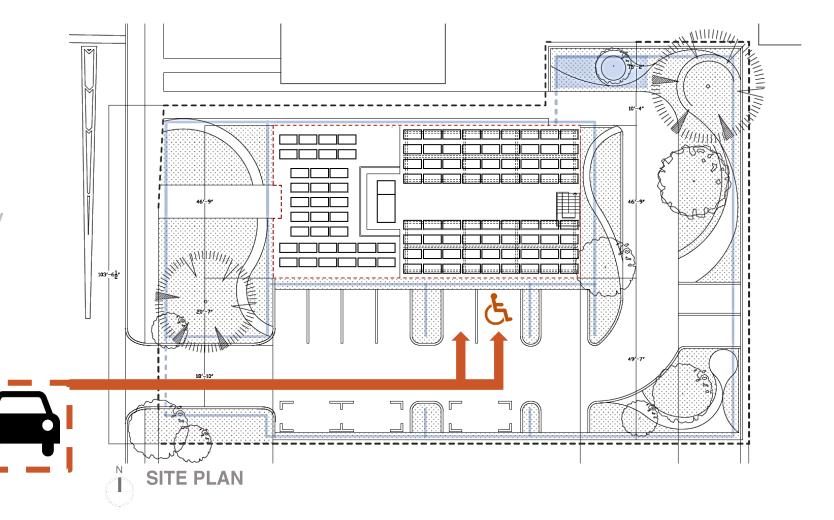
2 electrical car charging stations →

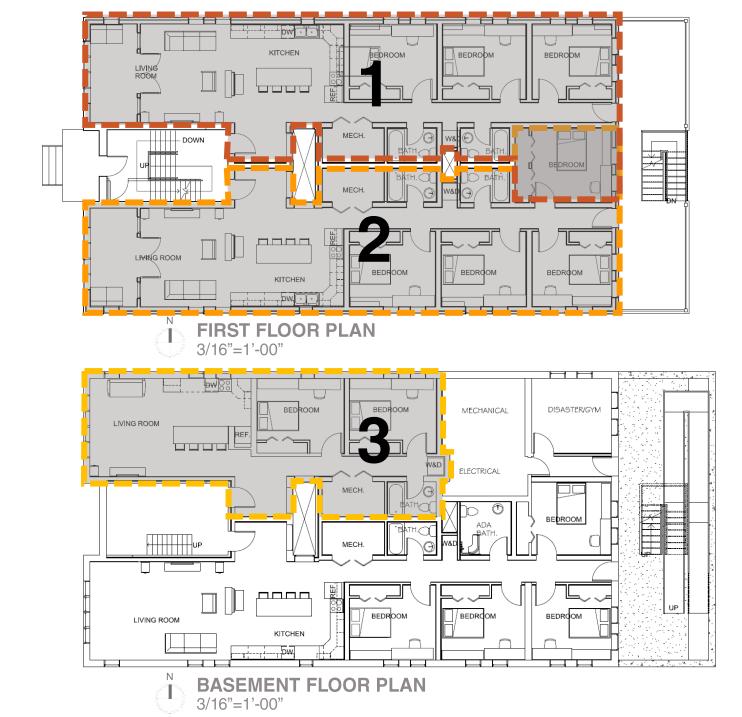
• 4-Bedroom:1510 s.f.

• 3-Bedroom: 1346 s.f.

• 2-Bedroom: 889 s.f.

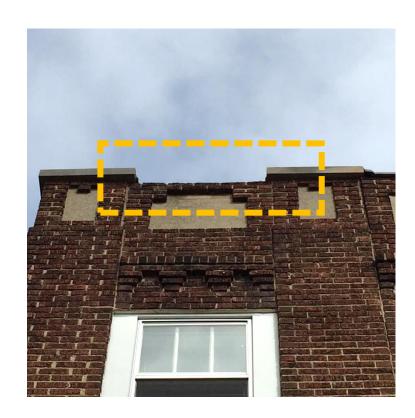
### EXISTING ENVELOPE — COPING AND PARAPET

- Discontinuous and segmented cap
- Inadequate and improper drip edgesDeterioration and degradation of cladding due to bulk water penetration

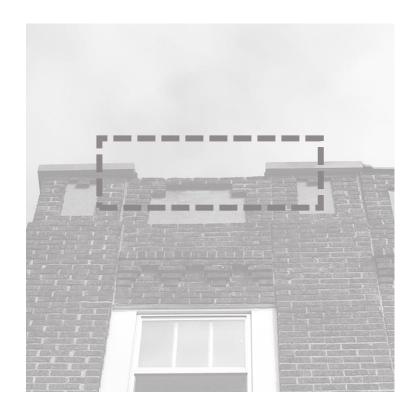
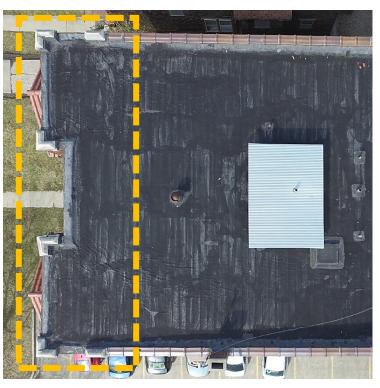
### EXISTING ENVELOPE — COPING AND PARAPET

- Discontinuous and segmented cap
- Inadequate and improper drip edges
  Deterioration and degradation of cladding due to bulk water penetration

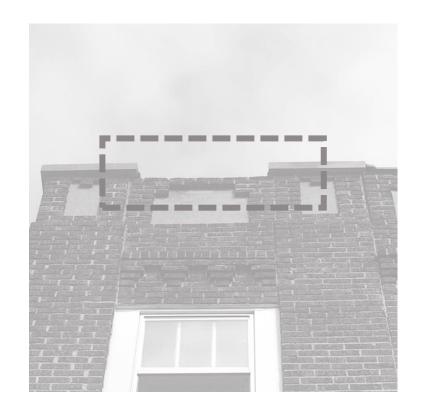
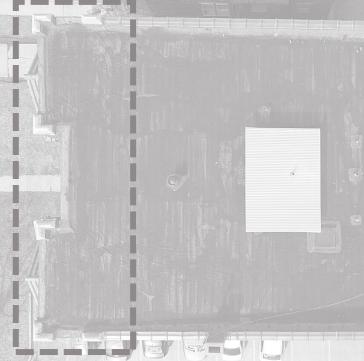
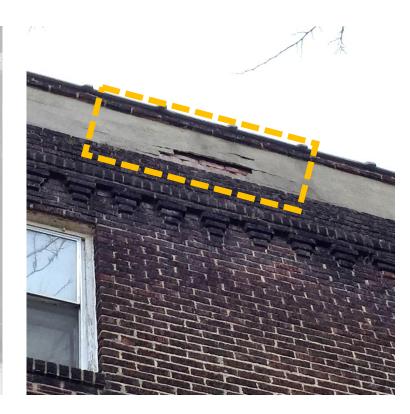
- Discontinuous and segmented cap
- Inadequate and improper drip edges

Deterioration and degradation of cladding due to bulk water penetration

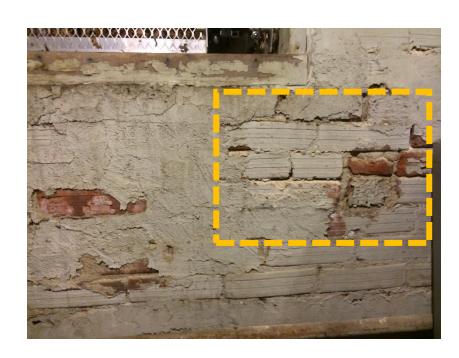
### **EXISTING ENVELOPE - GROUND CONTACT AND SPLASHBACK**

- Moisture absorption, capillary uptake, and interior spalling
- Subfluorescence damagesSplashback of rainfall from the roof onto the wall surfaces

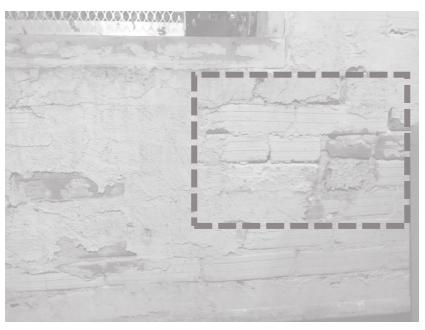
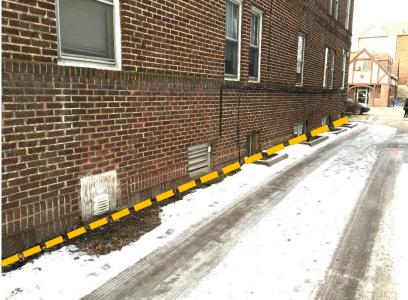
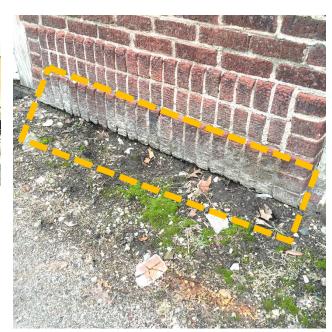
### **EXISTING ENVELOPE - GROUND CONTACT AND SPLASHBACK**

- Moisture absorption and capillary uptake and interior spalling
- Subfluorescence damages
  Splashback of rainfall from the roof onto the wall surfaces

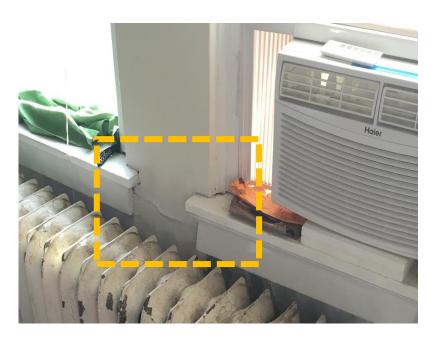
- Window connection details
- Water penetration and existing water shedding strategies (rowlock window sills)
- Air infiltration and exfiltration
- High maintenance windows

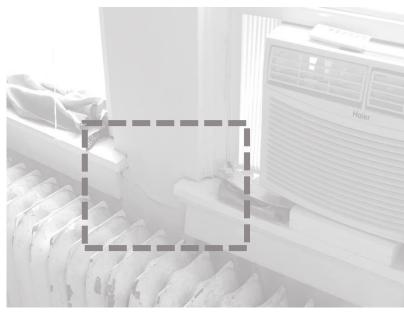
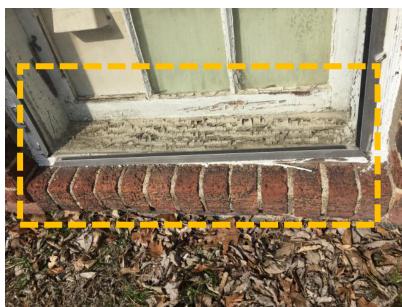
- Window connection details
- Water penetration and existing water shedding strategies (rowlock window sills)
- Air infiltration and exfiltration
- High maintenance windows

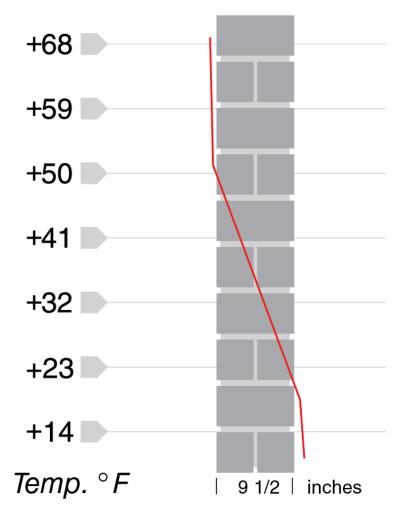
- Interstitial condensation
- Freeze-thaw (FT) damage
- Rot and mold growth

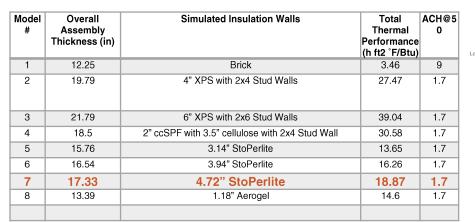
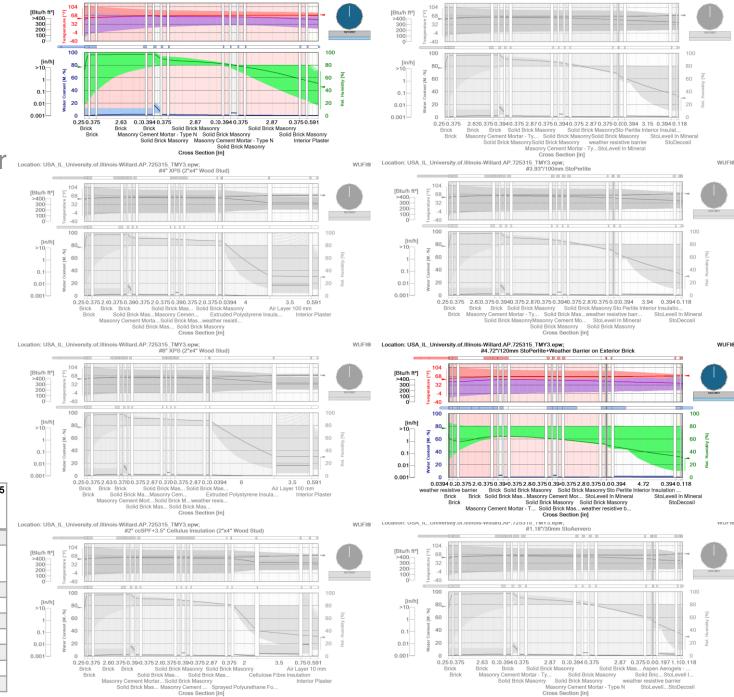
#### **EVALUATE AND ADDRESS**

- Interstitial condensation, total water content of building envelope assembly
- Overall relative humidity in building envelope components

#3.14"/80mm StoPerlite

Location: USA\_IL\_University.of.Illinois-Willard.AP.725315\_TMY3.epw;

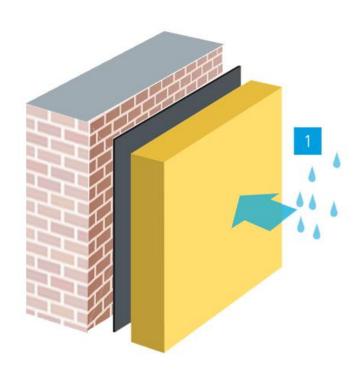
#### 1 Moisture penetrates the diffusion-open internal insulation system<sup>1</sup>

- 2 Water can condense in the bonding layer behind the insulation board
- 3 The insulation board absorbs this moisture and actively distributes it within the system
- 4 By unburdening the system (i.e. through airing) the moisture balance is maintained within the insulated interior, thereby positively influencing drying.

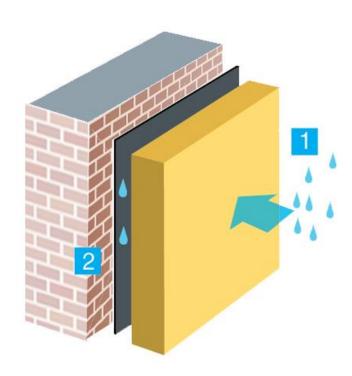
- 1 Moisture penetrates the diffusion-open internal insulation system
- 2 Water can condense in the bonding layer behind the insulation board
- 3 The insulation board absorbs this moisture and actively distributes it within the system 4 By unburdening the system (i.e. through airing) the moisture balance is maintained
- within the insulated interior, thereby positively influencing drying.

Masonry

Bonding layer

Insulation board

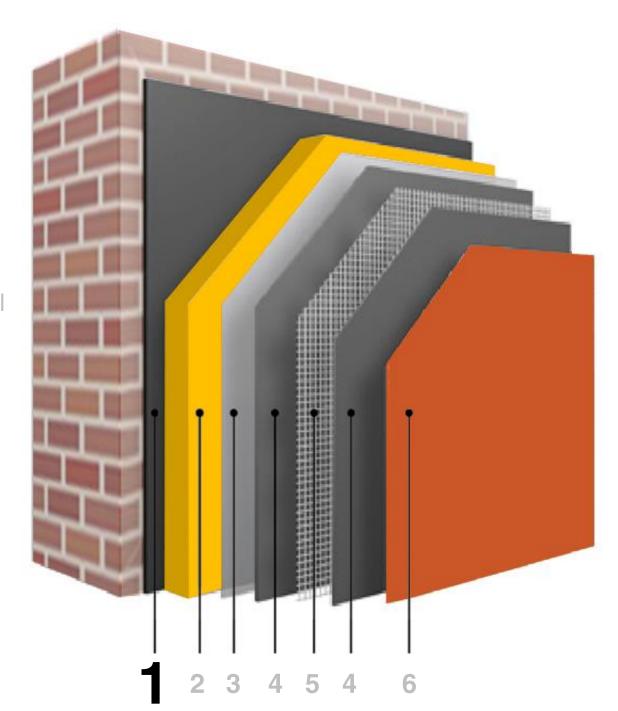
#### **PROPOSE**

**1 Bonding:** StoLevell In Mineral

2 Insulation: Sto Perlite Internal Insulation Board

3 Primer: StoPrim Silicate

4 Reinforcing compound: StoLevell In Mineral

5 Reinforcing mesh: Sto Glass Fibre Mesh F

6 Top coat

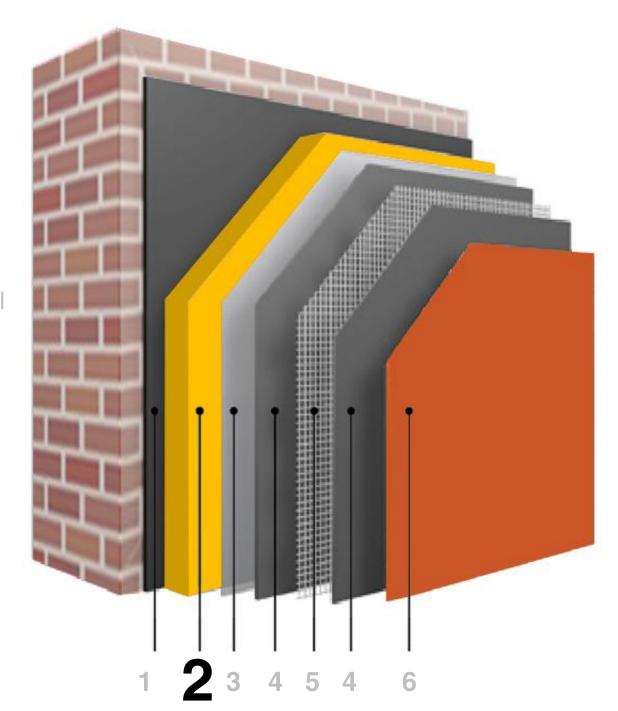
#### **PROPOSE**

- 1 Bonding: StoLevell In Mineral
- 2 Insulation: Sto Perlite Internal Insulation Board
- 3 Primer: StoPrim Silicate
- 4 Reinforcing compound: StoLevell In Mineral
- 5 Reinforcing mesh: Sto Glass Fibre Mesh F
- 6 Top coat

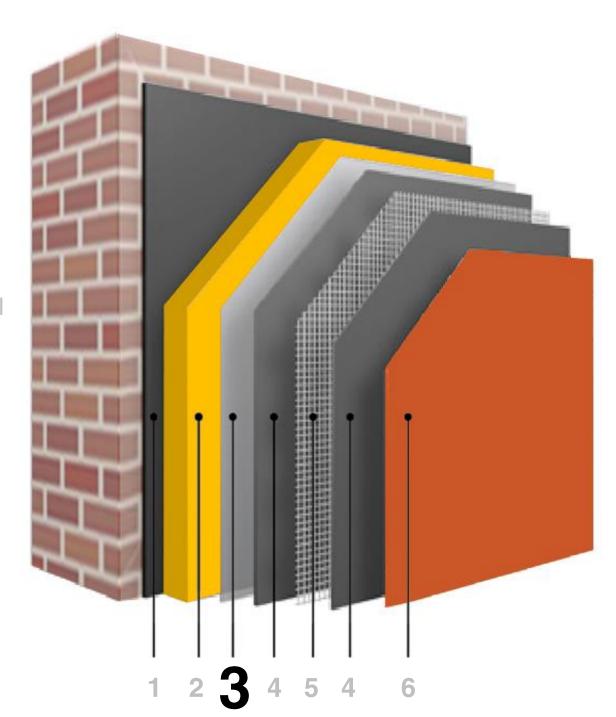
#### **PROPOSE**

1 Bonding: StoLevell In Mineral

2 Insulation: Sto Perlite Internal Insulation Board

3 Primer: StoPrim Silicate

4 Reinforcing compound: StoLevell In Mineral

5 Reinforcing mesh: Sto Glass Fibre Mesh F

6 Top coat

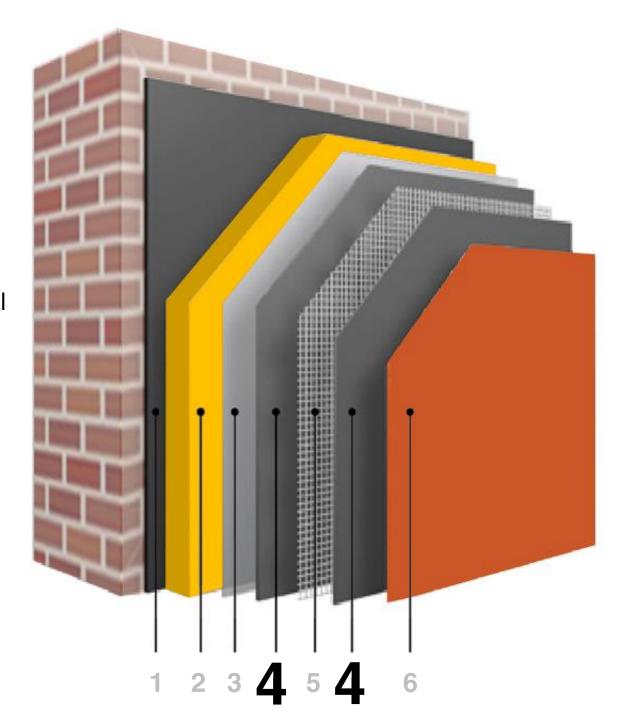
#### **PROPOSE**

- 1 Bonding: StoLevell In Mineral
- 2 Insulation: Sto Perlite Internal Insulation Board
- 3 Primer: StoPrim Silicate
- 4 Reinforcing compound: StoLevell In Mineral
- 5 Reinforcing mesh: Sto Glass Fibre Mesh F
- 6 Top coat

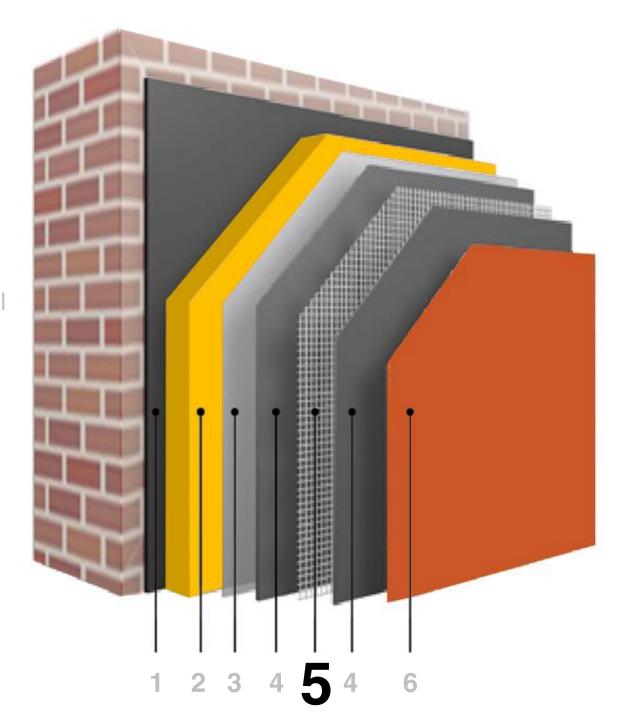
#### **PROPOSE**

1 Bonding: StoLevell In Mineral

2 Insulation: Sto Perlite Internal Insulation Board

3 Primer: StoPrim Silicate

4 Reinforcing compound: StoLevell In Mineral

5 Reinforcing mesh: Sto Glass Fibre Mesh F

6 Top coat

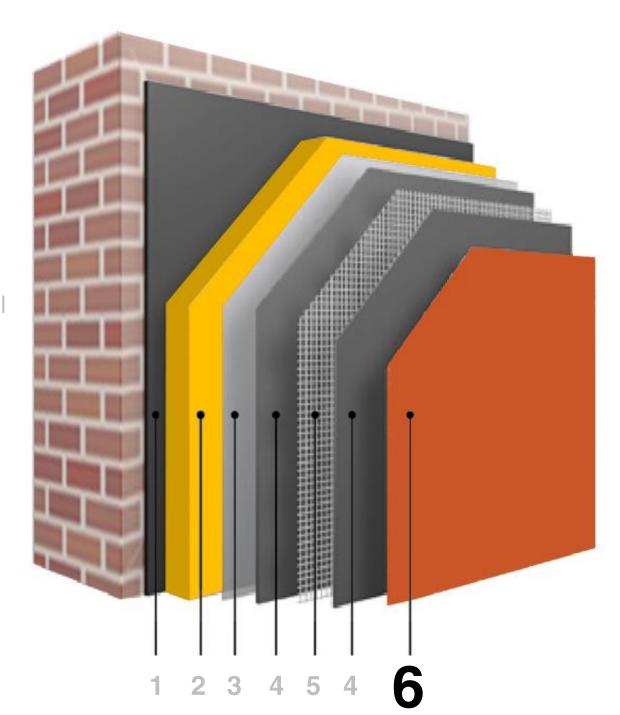
#### **PROPOSE**

1 Bonding: StoLevell In Mineral

2 Insulation: Sto Perlite Internal Insulation Board

3 Primer: StoPrim Silicate

4 Reinforcing compound: StoLevell In Mineral

5 Reinforcing mesh: Sto Glass Fibre Mesh F

6 Top coat

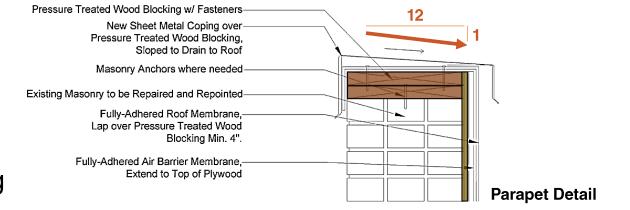
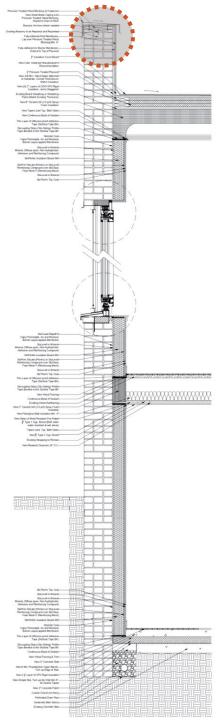
#### **PROPOSE**

- New continuous coping that is sloped inward
- Proper drip edge and flashing cap
- New roof membrane wrap up and over the parapet

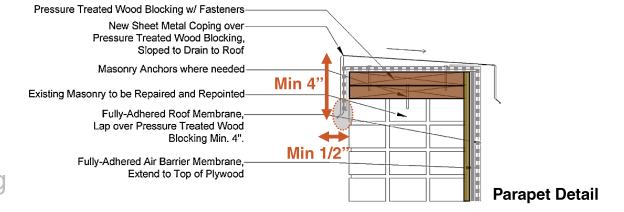
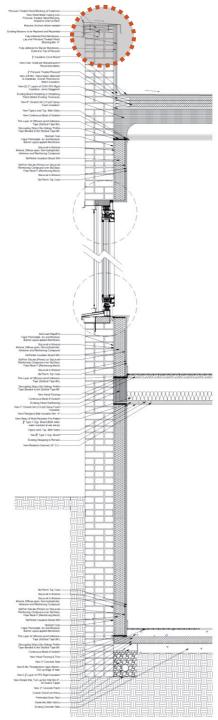
#### **PROPOSE**

- New continuous coping that is sloped inward
- Proper drip edge and flashing cap
- New roof membrane wrap up and over the parapet

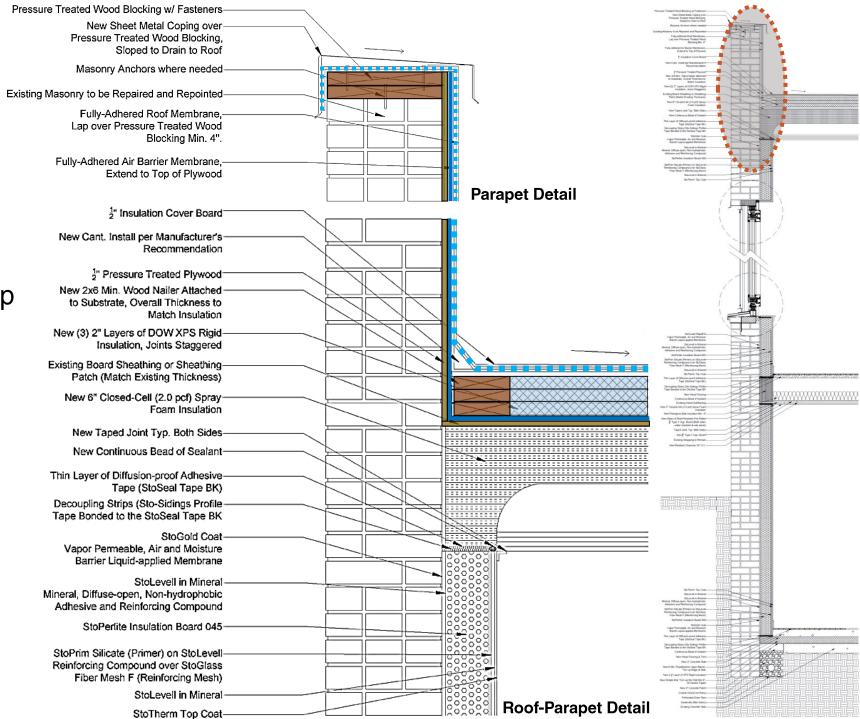
#### **PROPOSE**

- New continuous coping that is sloped inward
- Proper drip edge and flashing cap
- New roof membrane wrap up and over the parapet

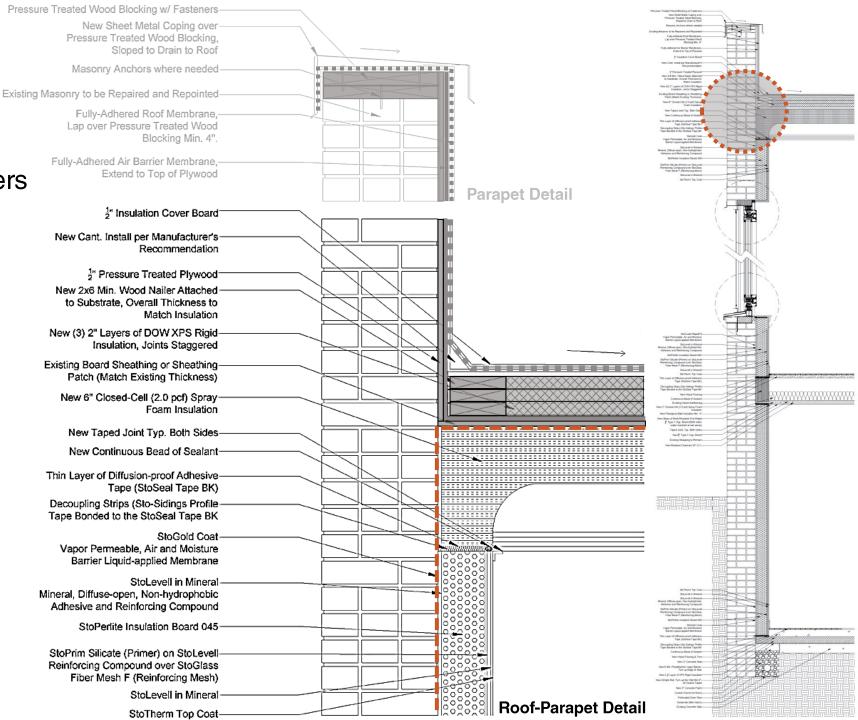
#### **PROPOSE**

- Water and air control layers
- Vapor control layer (diffused-open)
- Thermal control layer

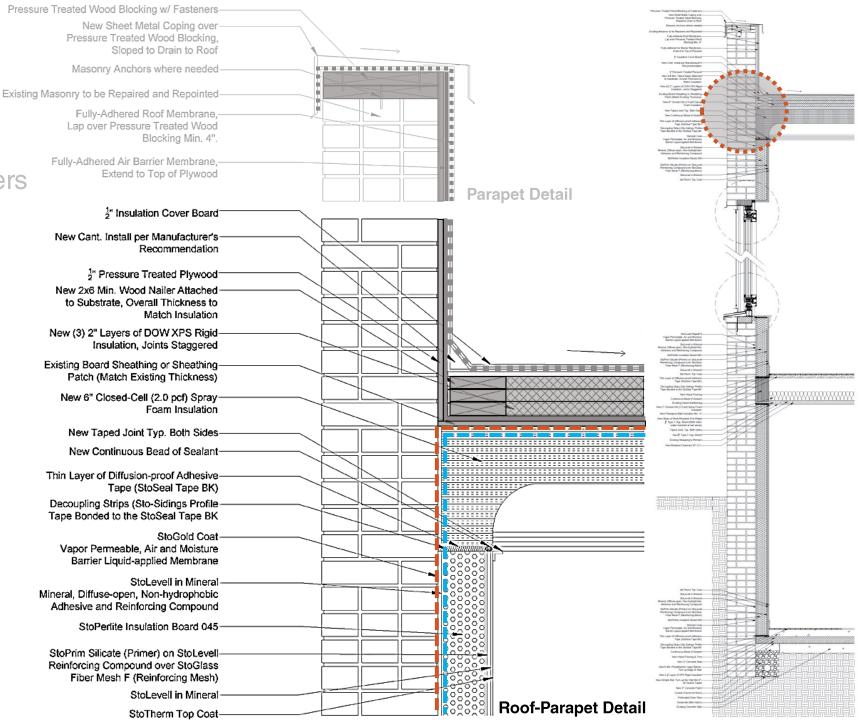
#### **PROPOSE**

- Water and air control layers
- Vapor control layer (diffused-open)
- Thermal control layer

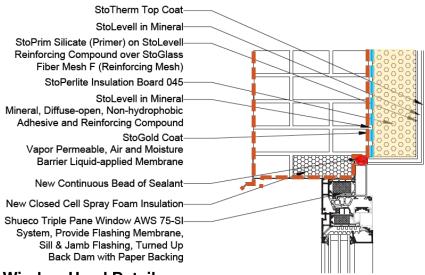
**Window Head Detail**

- Water and air control layers
- Vapor control layer (diffused-open)
- Thermal control layer

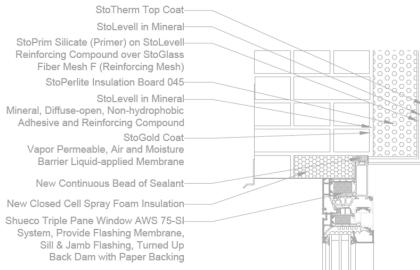
#### **Window Head Detail**

- Water and air control layers
- Vapor control layer (diffused-open)
- Thermal control layer

U-0.22 SHGC<sub>1</sub>-0.24 SHGC<sub>2</sub>-0.40

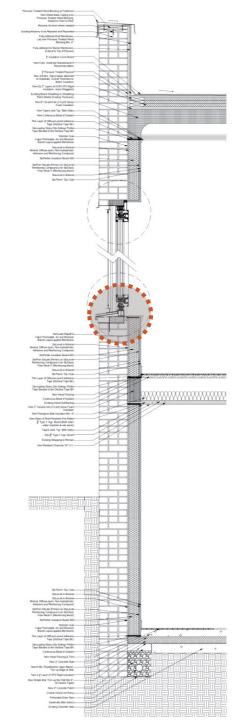
#### Window Head Detail

StoTherm Top Coat StoLevell in Mineral StoPrim Silicate (Primer) on StoLevell-Reinforcing Compound over StoGlass Fiber Mesh F (Reinforcing Mesh) StoPerlite Insulation Board 045 StoLevell in Mineral-Mineral, Diffuse-open, Non-hydrophobic Adhesive and Reinforcing Compound StoGold Coat Vapor Permeable, Air and Moisture Barrier Liquid-applied Membrane New Continuous Bead of Sealant New Closed Cell Spray Foam Insulation Shueco Triple Pane Window AWS 75-SI System, Provide Flashing Membrane, Sill & Jamb Flashing, Turned Up Back Dam with Paper Backing

New Wood Sill & Trim-

Decoupling Strips (Sto-Sidings Profile Tape Bonded to the StoSeal Tape BK

Thin Layer of Diffusion-proof Adhesive-Tape (StoSeal Tape BK)

New Continuous Bead of Sealant

Shueco Triple Pane Window AWS 75-SI-System, Provide Flashing Membrane, Sill & Jamb Flashing, Turned Up Back Dam with Paper Backing

New Closed Cell Spray Foam Insulation-

StoGold Coat-

Vapor Permeable, Air and Moisture Barrier Liquid-applied Membrane

StoLevell in Mineral-Mineral, Diffuse-open, Non-hydrophobic Adhesive and Reinforcing Compound

StoPerlite Insulation Board 045

StoPrim Silicate (Primer) on StoLevell-Reinforcing Compound over StoGlass Fiber Mesh F (Reinforcing Mesh)

StoLevell in Mineral

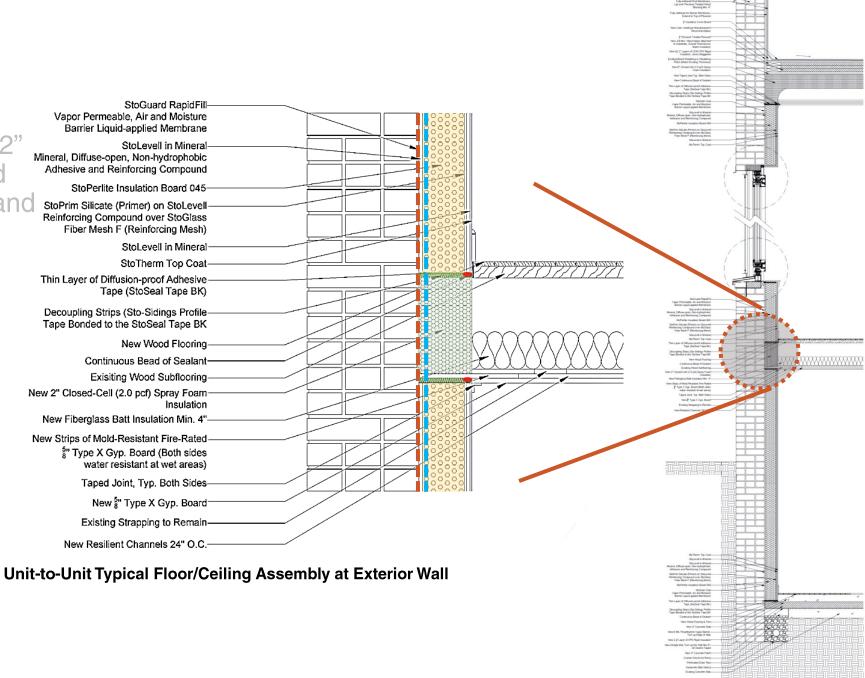
Use of maximum 1.5" to 2" ccSPF where embedded wood timber structures and rim joists are in contact with exterior wall

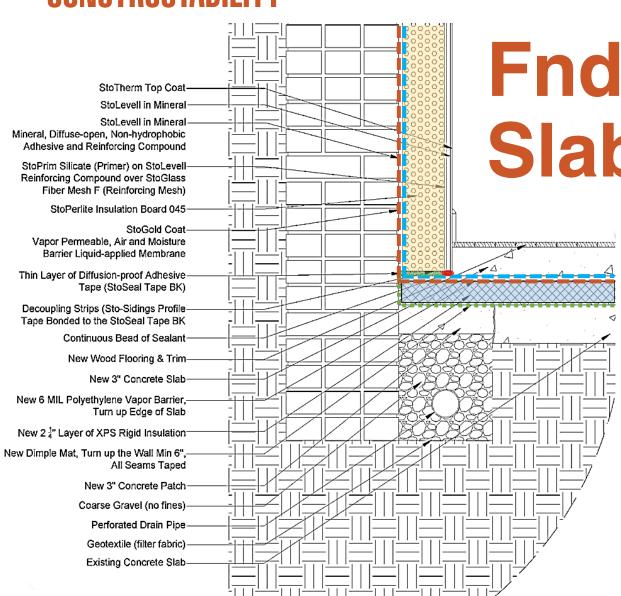
# Fndn: R-19 Slab: R-12

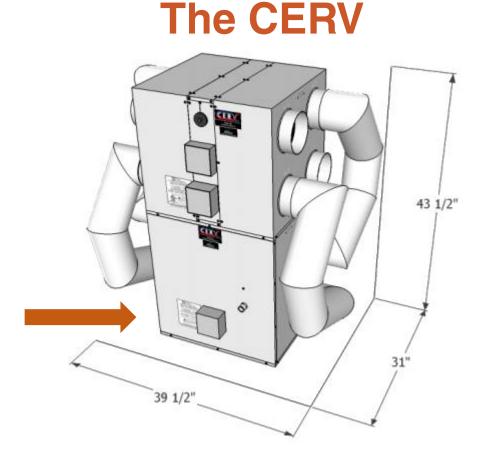
# **Conditioning Module:**

**Built in ASHP and Temperature Sensors**

## The CERV

43 1/2"

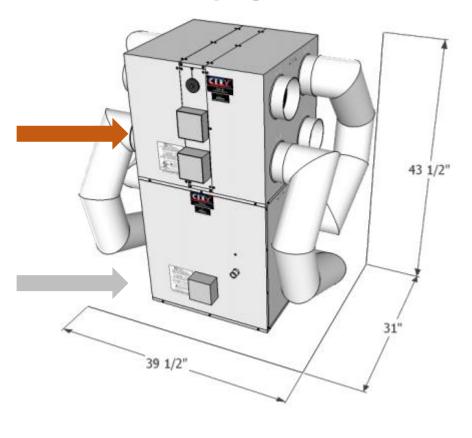
Operates based on **Set points**:

CO2/VOC ppm > 1000

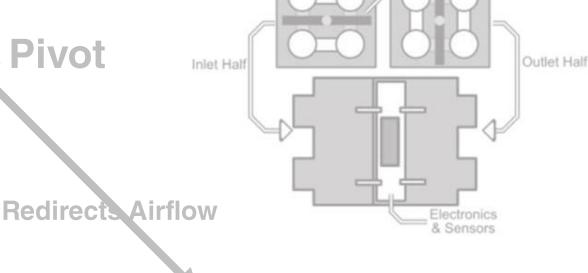
# Internal Dampers Pivot

## **Example: Ventilation Heating**

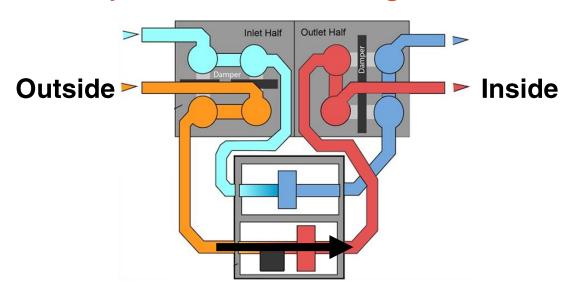
COP = 3.5 (w/out Fan) COP = 2.7 (w/ Fan) **Removed**

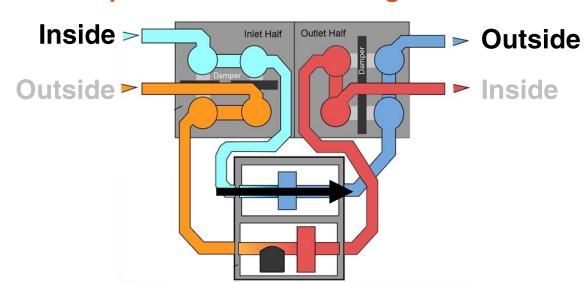
## **Example: Ventilation Heating**

COP = 3.5 (w/out Fan) COP = 2.7 (w/ Fan)

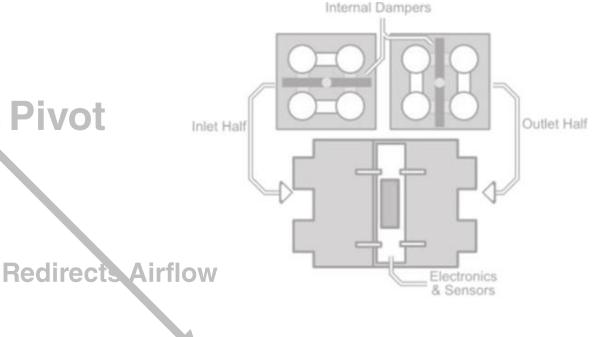
Internal Dampers Pivot

Fresh Air Control Module:

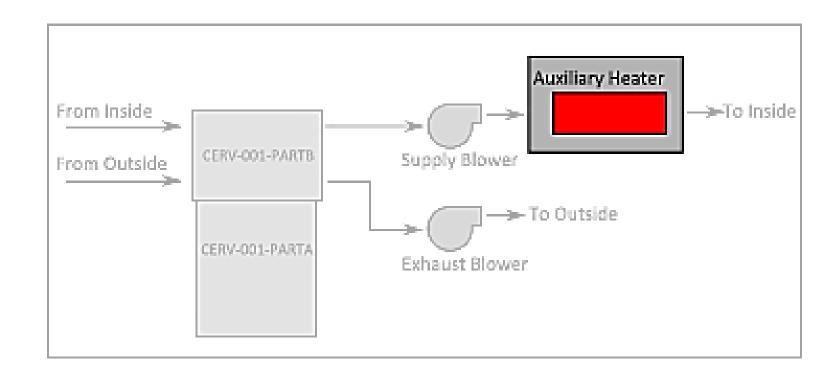
**CERV Average Total Heating Capacity = 5.5** kBtu/hr

**CERV w/Duct Heater Average Total Heating Capacity = 14 kBtu/hr**

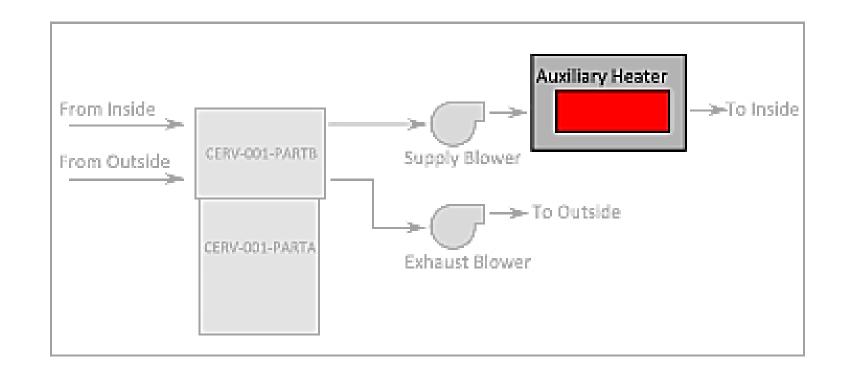
**CERV Average Total Heating Capacity = 5.5** kBtu/hr

CERV w/Duct Heater Average Total Heating Capacity = 14 kBtu/hr

Design Heating Load = 8.4 kBtu/hr-unit

**Sufficient System**

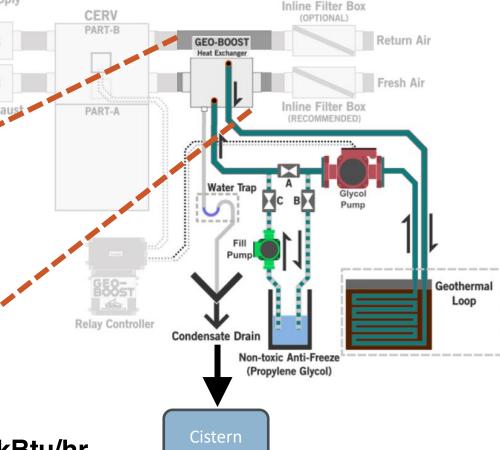
Geo-Boost
Liquid-to-Air
Heat Exchanger

Supply Air

Inline Supply

Capacity to ADD or REMOVE 1.6 to 2.6 kBtu/hr depending on ground conditions

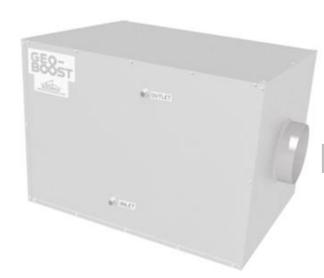
Geo-Boost
Liquid-to-Air
Heat Exchanger

Supply Air

Inline Supply

CERV PART-B Return Air Fresh Air PART-A **Water Trap** Geothermal Loop Relay Controller Condensate Drain Non-toxic Anti-Freeze (Propylene Glycol) Cistern

Inline Filter Box

**CERV Average Total Cooling Capacity = 3.8** kBtu/hr

CERV w/Geo-Boost Total Cooling Capacity = 5.4 to 6.2 kBtu/hr

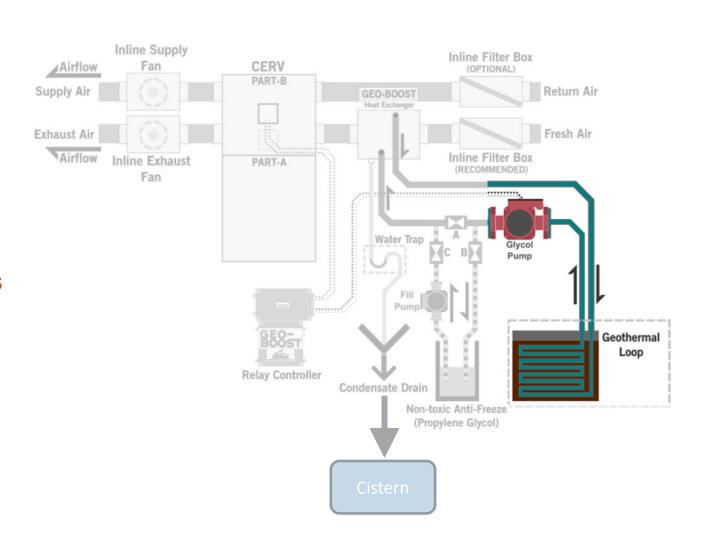
## Vertical wells: Closed-geothermal loops

300' of ½" PEX per main loop = 2400' PEX 1:1 mix of propylene glycol and water

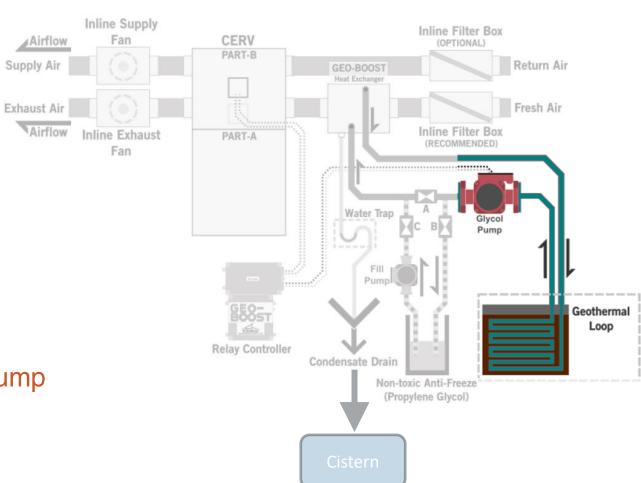
Stiebel Eltron CP3S15-62FC circulation pump

340 Btu/hr Pump 1 − 2 gpm flowrate

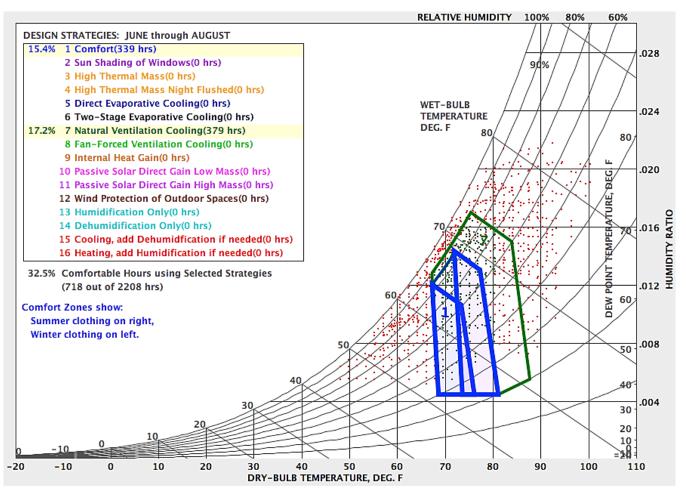
**Climate Consultant 5.5 Output for Champaign-Willard Airport**

Achieved 17.2%

with Natural Ventilation Alone

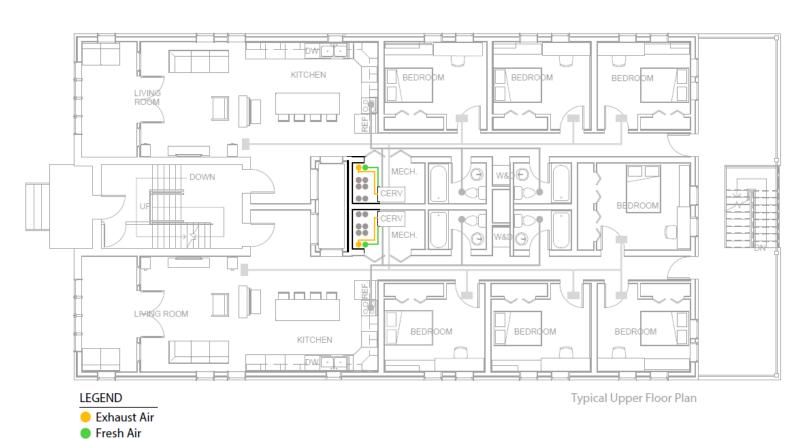
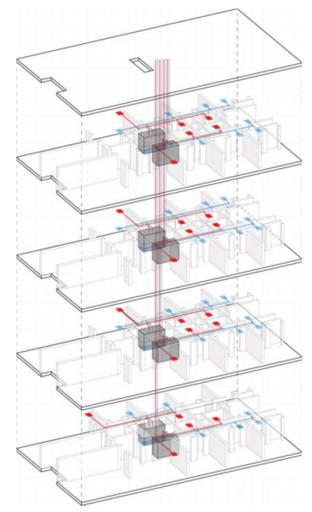
# **HVAC SYSTEMS LAYOUT**

- Supply Air
- Return Air

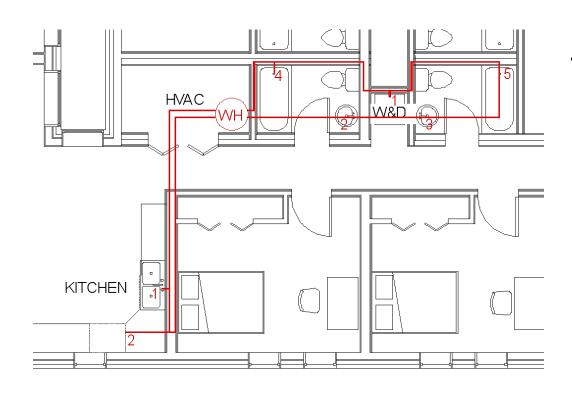
#### **Hot Water Delivery System Layout**

- Pipe storage limit: 0.5 gallons
- ASPE performance: 10s hot water waiting time

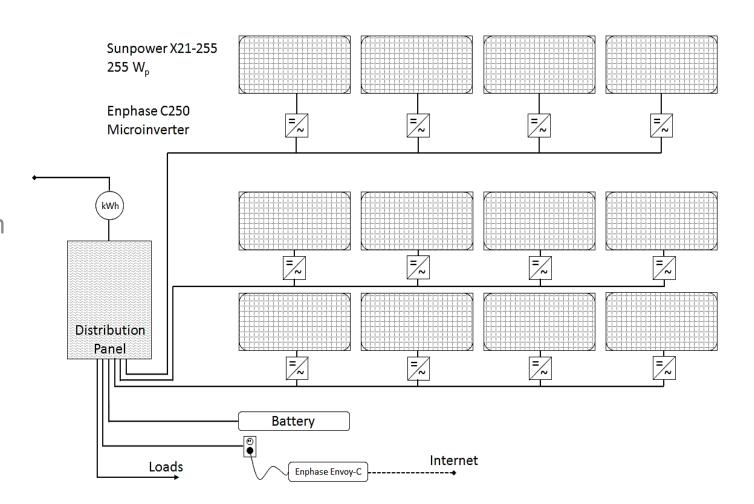
### PV SYSTEM DESIGN

#### 107 Panels (27 kW)

- Sunpower 21.5%
- Enphase micro-inverter
- Tilt: 180° South at 29° Tilt
- Annual Production: 37,700 kWh
- Offsets 92% of total consumption

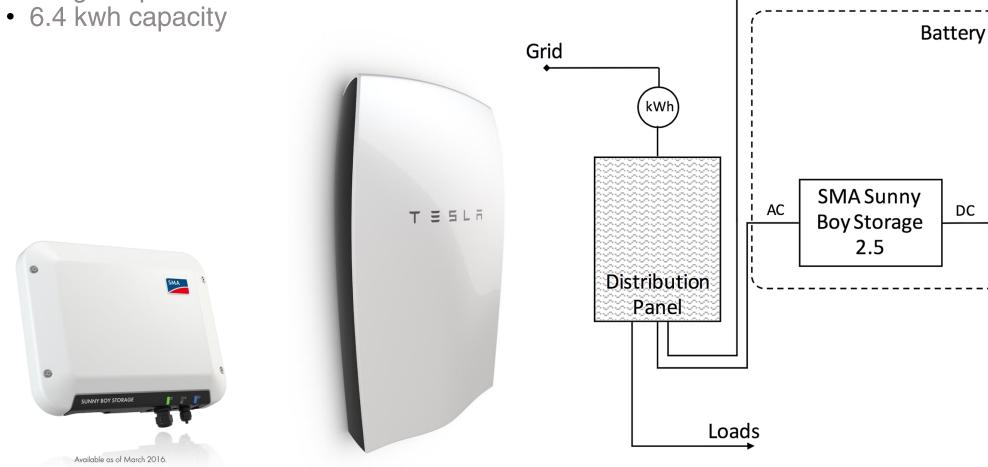
### **LED LIGHTING BACKUP POWER**

- Grid compatible
- Off-grid operations

**PV System**

Tesla **Powerwall** 6.4 kWh
