Weathered OSB air and water leakage testing

**Rosetta Stone
Dynamic
Vapor
Permeability &
Diffusive Air
Movement
Measurement
Chamber**

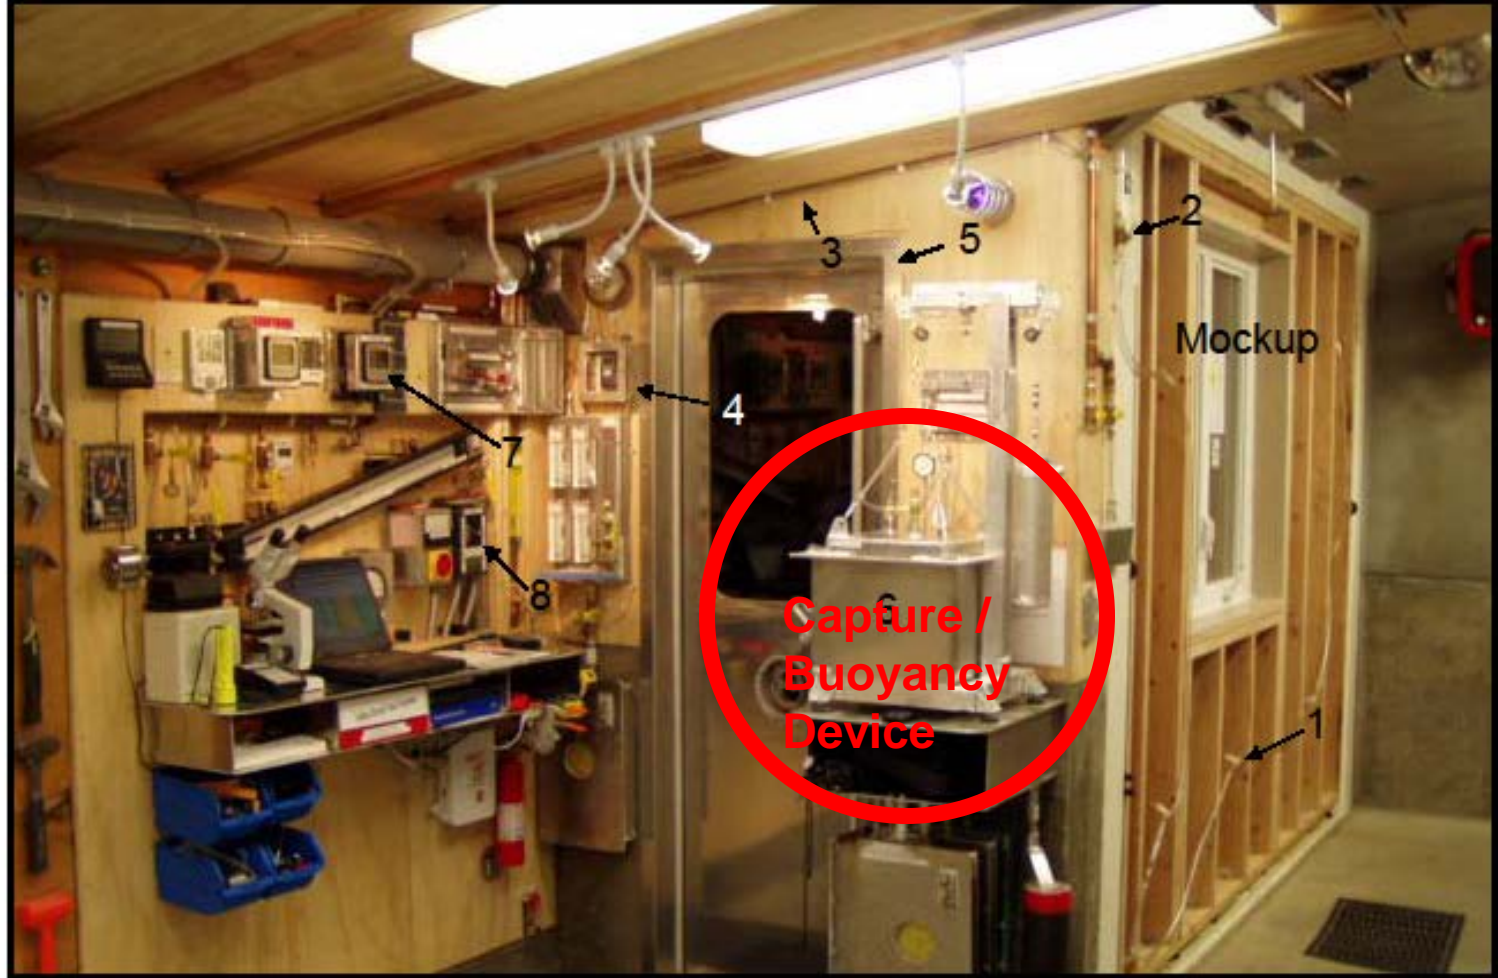
Prototype
for
exploded
view

1. Collection System
2. Activation Valve
3. Line to RH and Temp Sensor
4. RH and Temp Sensor
5. Line from RH and Temp Sensor
6. Air Flow Measuring Equipment
7. Smart Gauge
8. Speed Controller

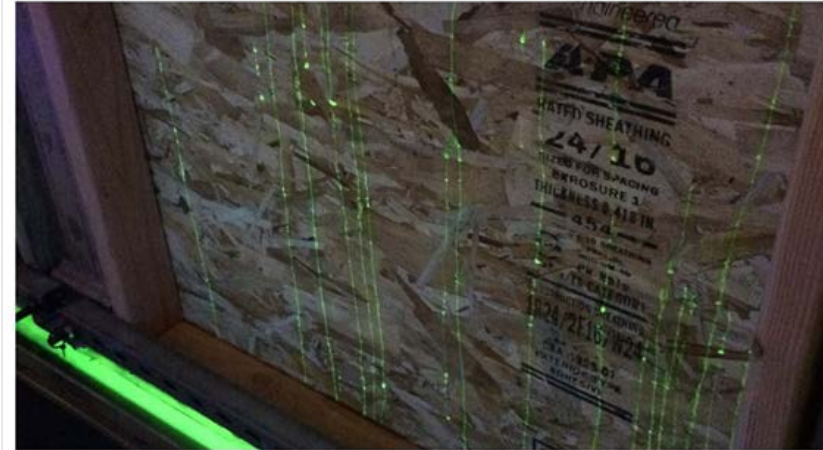
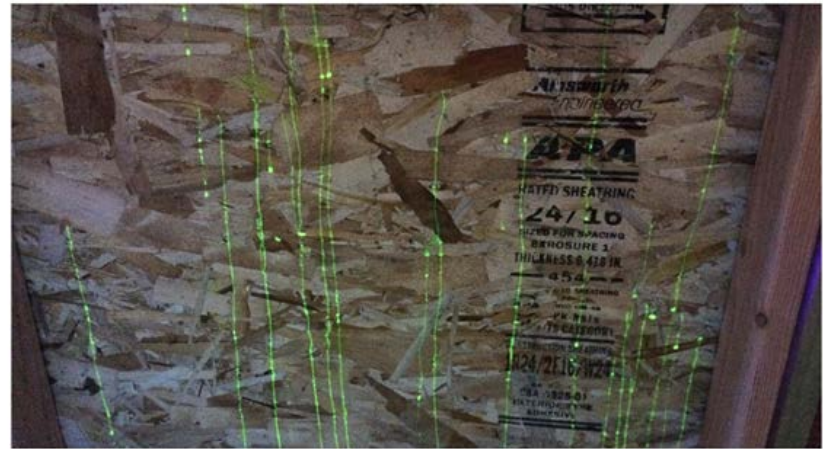
Tested OSB prior to and after wetting

- Prior to wetting, met ABAA standard 0.004 cfm/ft² at 1.57 psf (0.3 IWC) -- but just barely
- Wetted with simulated one-hour heavy rain
- Followed with simulated 25mph wind for 24 hours
- After wetting and drying: 0.0055 cfm/ft² at 1.57 psf (0.3 IWC)
- Fails the ABAA standard
- 37.5 % increase in air leakage
- Significant water transmission
