Journal of architectural
technology published by
Hoffmann Architects, Inc.,
specialists in the rehabilitation
of building exteriors.

Caring for Glazed Architectural Terra Cotta

Arthur L. Sanders, AIA and Kara L. Shypula, Assoc. AIA

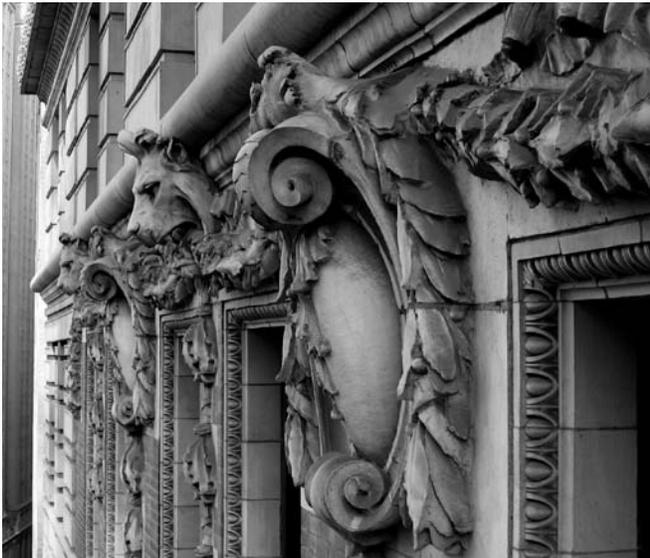
▲ Often finished in imitation of stone, terra cotta can be difficult to recognize and may be mistaken for cast stone, concrete, stone, or brick.

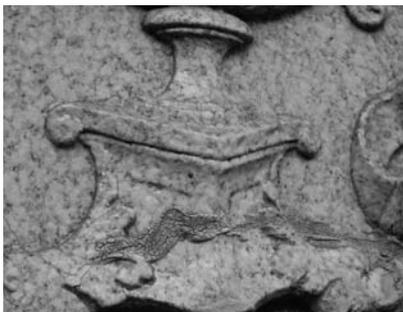
▲ Failed prior repair effort.

Many repairs fail prematurely because they do not address the root cause of distress or failure. Often, repair

materials are not durable and are incompatible with the existing terra cotta, creating a poor visual match and a short-term fix, at best. Where repairs fail, they tend to make deterioration worse.

Poor detailing, including failure to properly anchor the patch to the backup, leads to failure of not only the repair area, but also the surrounding terra cotta. For example, replacement brick and cement stucco are neither watertight nor flexible enough to accommodate movement, so they tend to pull free or crack and spall. Surface-applied sealants are likewise not watertight, and bituminous patches are ineffective and aesthetically unsuited to terra cotta repair. In an effort to keep out water, non-breathable coatings are sometimes applied; these have the effect of trapping water inside the terra cotta, particularly if the source of water entry has not been addressed.

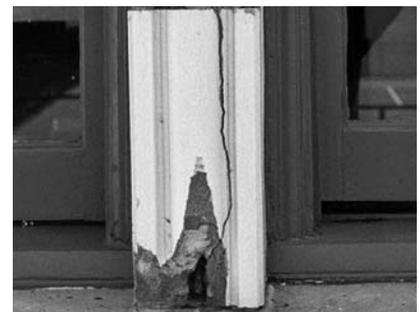
▲ Crack and spall caused by corroded steel.

As water penetrates, it comes in contact with embedded steel anchors and reinforcement. In historic applications, steel was often untreated, making it particularly susceptible to corrosion. As it corrodes, the steel expands, exerting pressure on the surrounding terra cotta and causing cracking and displacement. Embedded steel corrosion may be caused by unmaintained roof drainage systems, which admit water into the cladding assembly.

What makes embedded steel corrosion challenging to treat is that it tends to be difficult to diagnose unless it is severe. By the time symptoms are visible at the surface, corrosion is likely already advanced. Initial outward signs of metal anchoring deterioration might include staining and spalling. Total anchoring failure can result in loose terra cotta units, which are in danger of falling from the building.

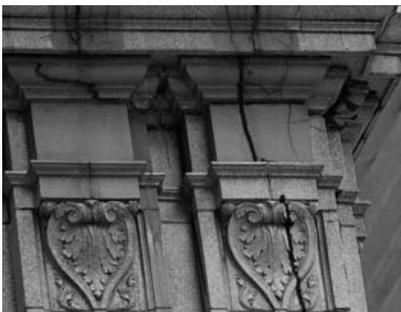
▲ Cracking at building corners.

Most high-rise buildings from the early 1900s had little or no provisions for movement, so unaccommodated thermal expansion and contraction, along with building-frame shortening under load, placed sufficient strain on building materials to cause displacement and cracking. Without proper expansion joints, buildings create their own, in the form of long cracks that admit significant water infiltration and invite further problems.

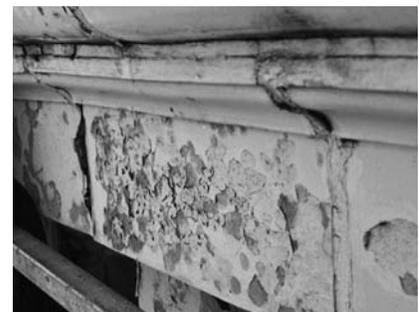
▲ Blistering coating.

For spalled glazing, coat or seal blistered areas to prevent water infiltration, using color-matched products. At lower stories where visual integrity is critical, the unit may need to be

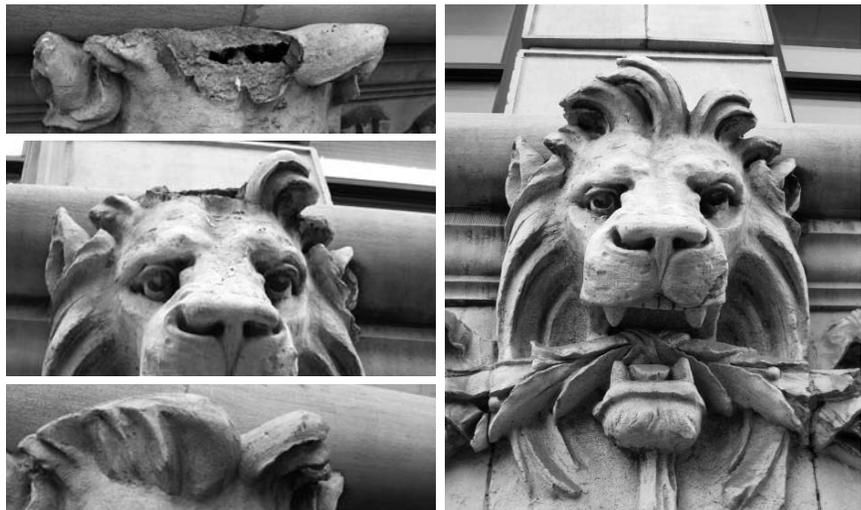
▲ Restoration of spalled terra cotta decorative element.

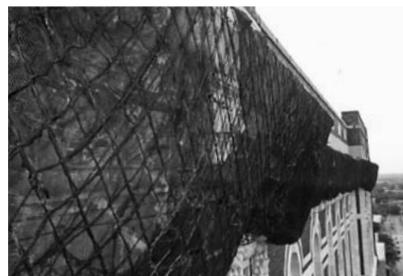
▲ Until permanent repairs are made, netting may be used to secure unstable terra cotta.

Where deterioration is so severe that pieces may fall from the building, temporary stabilization or replacement may be necessary to protect public

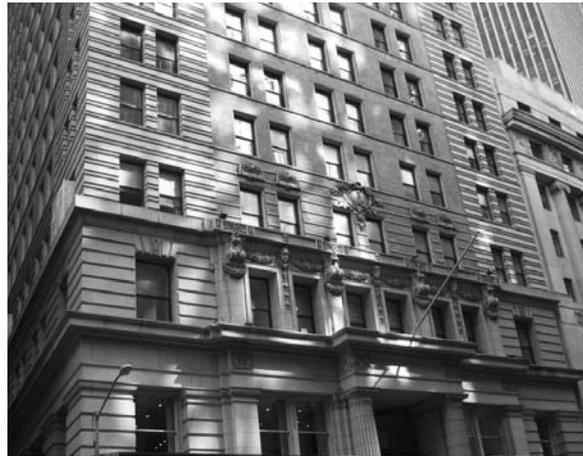
▲ Broad Exchange Building, 25 Broad Street in New York, New York. *Landmark Terra Cotta Facade Restoration.*

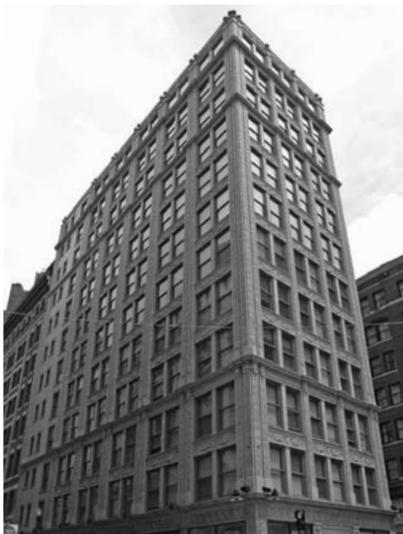
▲ Chauncy House in Boston, Massachusetts. *Facade Investigation & Terra Cotta Repair Design.*

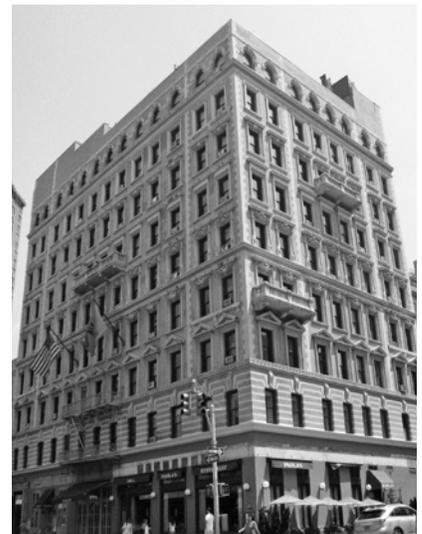
▲ Hotel Wales in New York, New York. *Landmark Terra Cotta Repair and Replacement.*
