Journal of architectural
technology published by
Hoffmann Architects, Inc.,
specialists in the rehabilitation
of building exteriors.

Caring for Glazed Architectural Terra Cotta

Arthur L. Sanders, AIA and Kara L. Shypula, Assoc. AIA

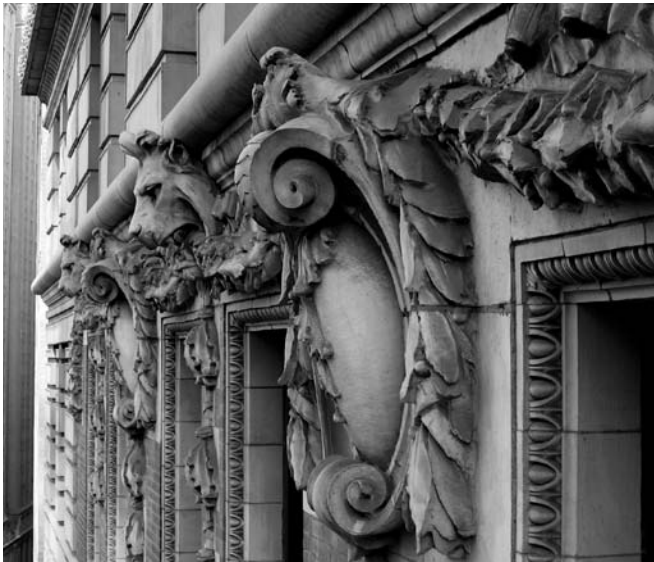
▲ Often finished in imitation of stone, terra cotta can be difficult to recognize and may be mistaken for cast stone, concrete, stone, or brick.

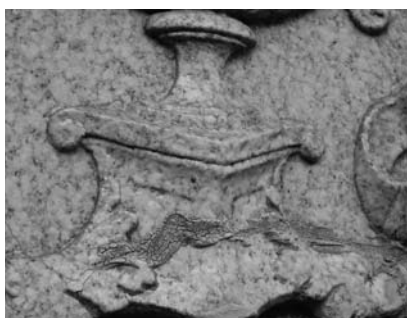
▲ Failed prior repair effort.

Many repairs fail prematurely because they do not address the root cause of distress or failure. Often, repair

materials are not durable and are incompatible with the existing terra cotta, creating a poor visual match and a short-term fix, at best. Where repairs fail, they tend to make deterioration worse.

Poor detailing, including failure to properly anchor the patch to the backup, leads to failure of not only the repair area, but also the surrounding terra cotta. For example, replacement brick and cement stucco are neither watertight nor flexible enough to accommodate movement, so they tend to pull free or crack and spall. Surface-applied sealants are likewise not watertight, and bituminous patches are ineffective and aesthetically unsuited to terra cotta repair. In an effort to keep out water, non-breathable coatings are sometimes applied; these have the effect of trapping water inside the terra cotta, particularly if the source of water entry has not been addressed.

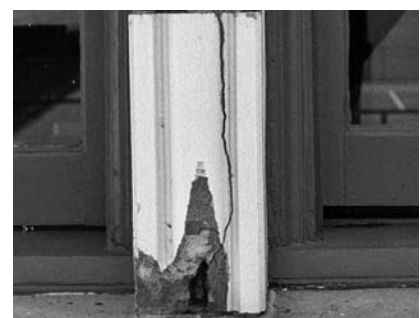
▲ Crack and spall caused by corroded steel.

As water penetrates, it comes in contact with embedded steel anchors and reinforcement. In historic applications, steel was often untreated, making it particularly susceptible to corrosion. As it corrodes, the steel expands, exerting pressure on the surrounding terra cotta and causing cracking and displacement. Embedded steel corrosion may be caused by unmaintained roof drainage systems, which admit water into the cladding assembly.

What makes embedded steel corrosion challenging to treat is that it tends to be difficult to diagnose unless it is severe. By the time symptoms are visible at the surface, corrosion is likely already advanced. Initial outward signs of metal anchoring deterioration might include staining and spalling. Total anchoring failure can result in loose terra cotta units, which are in danger of falling from the building.

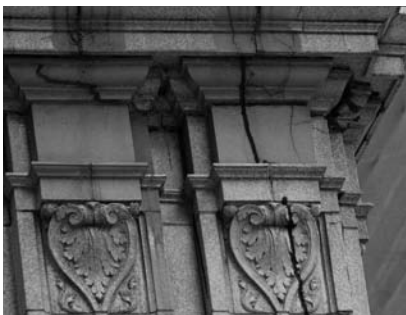
A Cracking at building corners.

Most high-rise buildings from the early 1900s had little or no provisions for movement, so unaccommodated thermal expansion and contraction, along with building-frame shortening under load, placed sufficient strain on building materials to cause displacement and cracking. Without proper expansion joints, buildings create their own, in the form of long cracks that admit significant water infiltration and invite further problems.

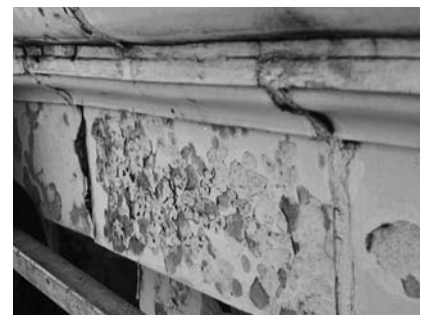
A Blistering coating.

When water enters the wall system through poor detailing, insufficient maintenance, rising damp, a leaking roof, or other sources, the impervious glaze may impede moisture migration and trap water inside the terra cotta unit. As temperature fluctuations increase pressure, sections of glazing or of the terra cotta itself may break off or *spall*. Glaze spalling tends to begin as blistering, when trapped water migrates to the surface and builds up pressure behind the glaze, eventually forcing pieces off the face of the unit. Glaze spalling may also be caused by corrosion of internal metal anchors.

For spalled glazing, coat or seal blistered areas to prevent water infiltration, using color-matched products. At lower stories where visual integrity is critical, the unit may need to be

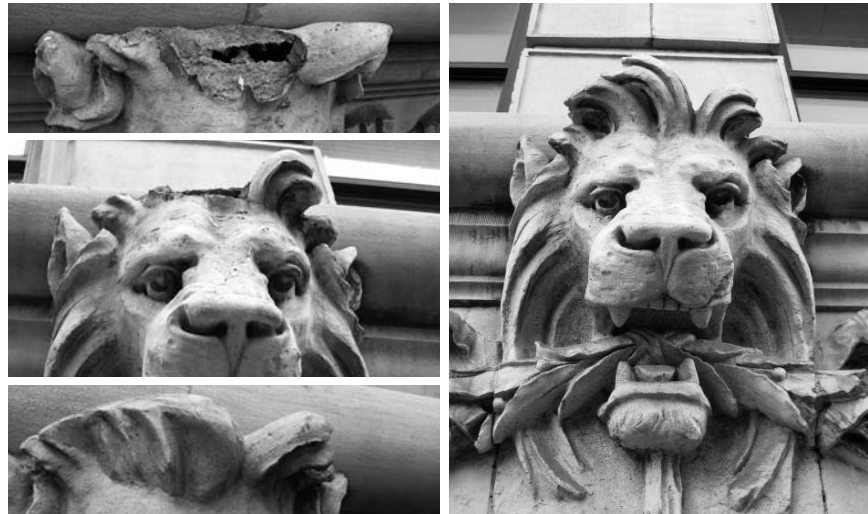
▲ Restoration of spalled terra cotta decorative element.

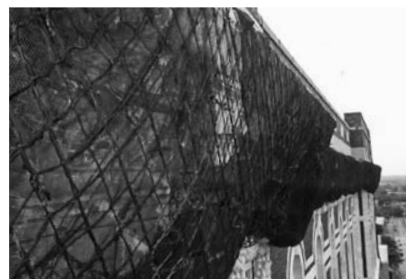
▲ Until permanent repairs are made, netting may be used to secure unstable terra cotta.

Where deterioration is so severe that pieces may fall from the building, temporary stabilization or replacement may be necessary to protect public
