Academy Journal

New Standard of Practice for the Design of MRI Facilities

New Standard of Practice for the Design of MRI Facilities
Robert Junk, AIA, and Tobias Gilk, Junk Architects
[Abstract](#) | [Article](#)

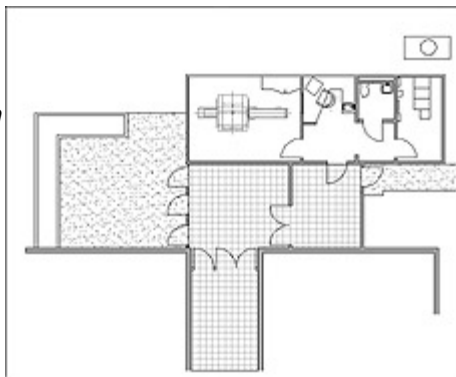
Figure 1. Re-created floor plan of Westchester Medical Center, MRI addition.

On July 27, 2001, a 6-year-old boy was receiving a postoperative scan at Westchester Medical Center in New York when a ferrous oxygen cylinder was brought into the magnet room. The magnetic force drew the cylinder into the bore of the magnet, where it struck the young boy. He died two days later from injuries sustained in the accident.¹

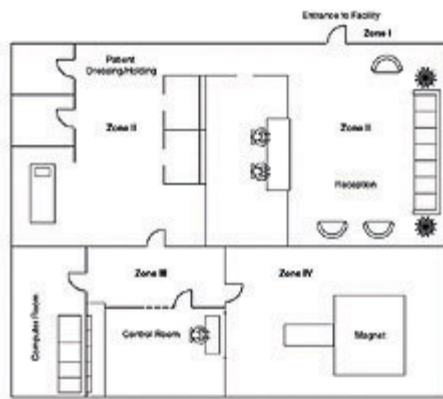
Figure 2. Reproduced from the ACR's "White Paper on MR Safety," combined papers of 2002 and 2004.

From a designer's standpoint, the clearest communication of this new responsibility came in the form of the diagrammatic floor plan, illustrating the 4-zone principle of sequential screening and access-controls, provided in the ACR's white paper.

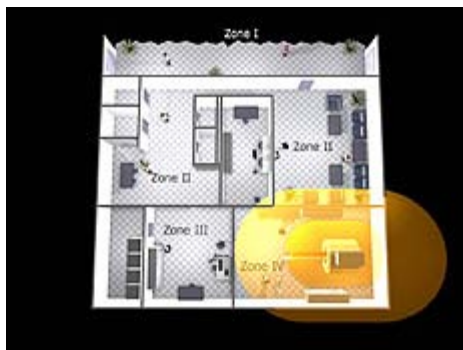
Figure 3. Normal and bloom extents of FDA exclusion zone of a typical 1.5 Tesla MRI superimposed on a CAD model of the ACR 4-zone diagram.

If interpreted literally, the diagram presents its own hazards, particularly when you overlay the FDA's 5-gauss exclusion zone from a typical MRI magnet over the ACR diagram. The 5-gauss exclusion zone penetrates the end wall of the MRI suite and has the potential of exposing persons to magnetic field strengths exceeding what OSHA and the FDA have determined to be the safe limits for unscreened persons.
