# Detection of Moisture and Water Intrusion Within Building Envelopes By Means of Infrared Thermographic Inspections

Antonio Colantonio, \*1 Public Works and Government Services Canada

## Abstract

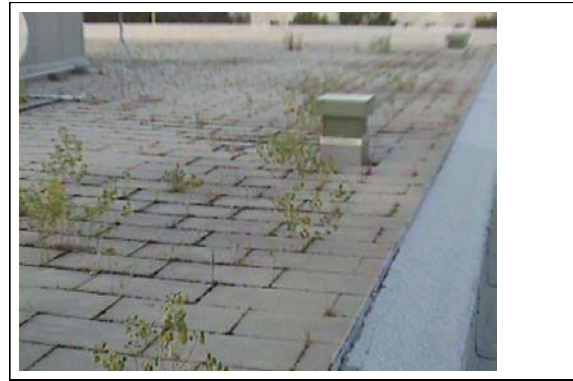
**Figure 4.** Visual of concrete clad insulation over inverted roof membrane, no visible wetting on concrete.

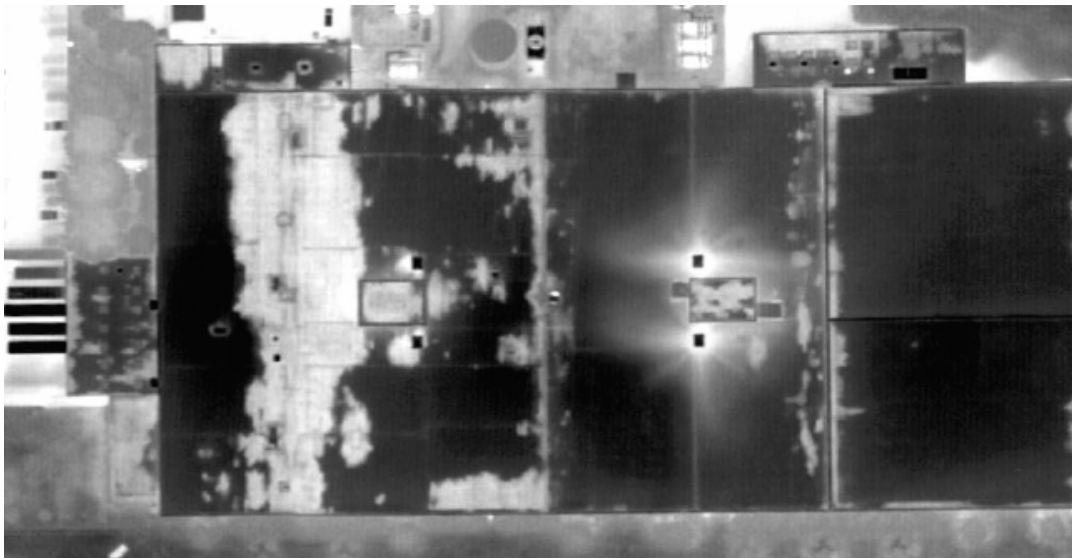
**Figure 7;** Aerial infrared image of moisture within insulation of conventional built-up roof. Note only one section of three requires replacement. The other two roof sections display minor roof leaks around curbs and flashings. (courtesy of AITScan and Stockton Infrared, Greg Stockton)

Detection of moisture within built-up roofs can be carried out by either walking over the roof assembly, surveying from higher adjacent roofs, or by fixed wing airplanes or helicopters. All are acceptable methodologies when suitable inspection conditions are present and appropriate infrared imagers are used.

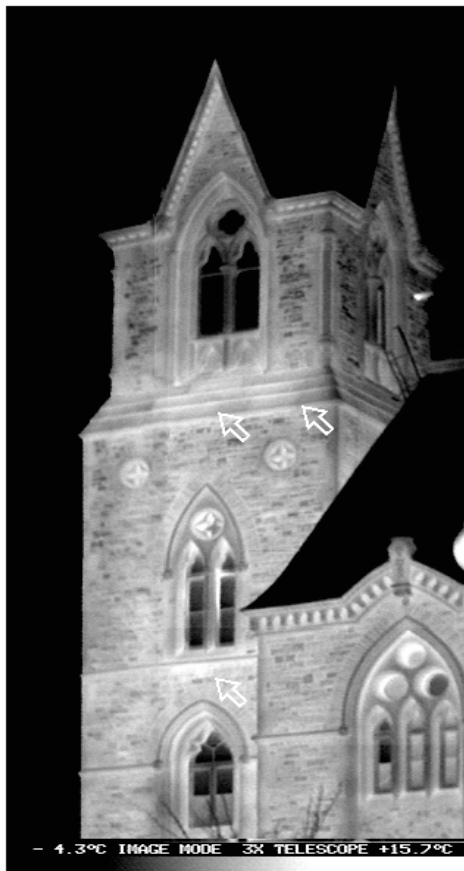
**Figure 10.** Neutral Building Pressure (0 Pa),  $T_o = -8^\circ\text{C}$ , No precipitation or snowfall for at least 7 days prior to inspection. Arrows point to suspected moisture accumulation within the limestone cladding due to rain and melt water throughout winter.

Rainwater penetration patterns are generally associated with the top section of walls and most likely around parapet walls. Most building only experience rainwater penetration at top floors unless located in areas with a high driving rain index, or during hurricanes or tornados. Other areas where rainwater penetration may occur are at sloped or protruding walls or drainage planes from upper wall sections. Window sills and parapets are examples of such drainage features. Sloped relief details in stone masonry walls are another example of such conditions. (See **Figure 10**)

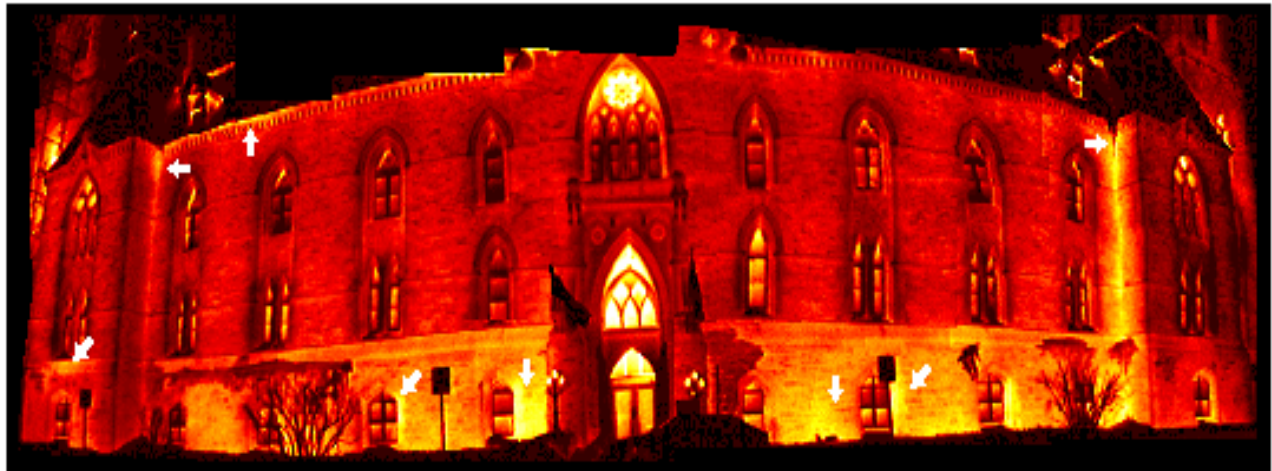
**Figure 11.** Ground floor of solid masonry wall assembly illustrates warmer surface temperatures due to rising damp from ground water in foundation wall.

Solid masonry walls with stone foundations without ground protection are susceptible to ground water absorption. Ground water wicks its way up the wall at the ground floor of the building through capillarity. Reduced thermal resistance values occur at the stone walls immediately above the ground during the heating season. This moisture may result in mortar deterioration throughout the wall thickness and be susceptible to freeze thaw on the outer sections. Infrared inspection of these walls can detect moisture accumulation by means of increased conductivity and surface temperatures. Thermal patterns are not mottled as in other types of assemblies but rather consistently warmer throughout the lower sections of the first floor adjacent to the grade around the building.

In general, surface temperature variations between the first floor walls and the rest of the building can only be discerned at exterior ambient temperatures below  $-5$  to  $-20^{\circ}\text{C}$ . Inspections carried out during higher temperatures require more sensitive infrared equipment to discern surface temperature variations due to ground water absorption. This type of thermal pattern is not always apparent since it is rather homogeneous in nature rather than mottled and variable.

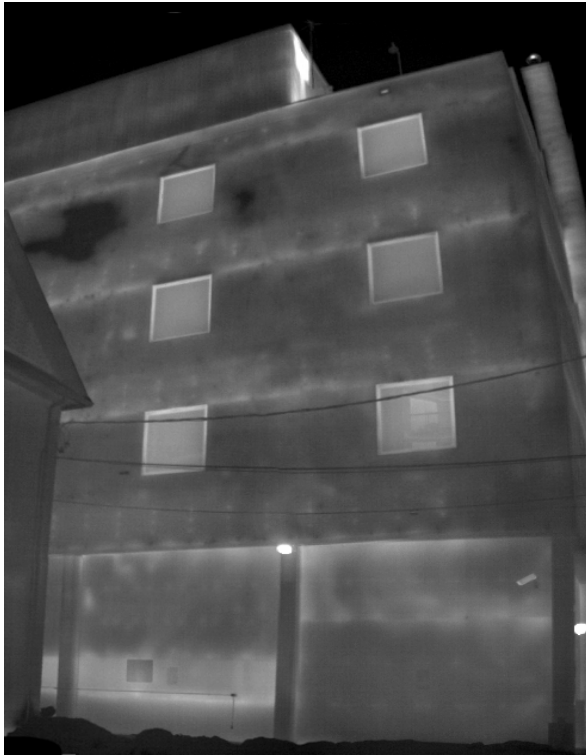
**Figure 22.** Negative Building Pressure (-140 Pa),  $T_o = 0^\circ\text{C}$  **Figure 23.** Positive Building Pressure (+40 Pa),  $T_o = 0^\circ\text{C}$   
Both images taken during same evening, 4-hour time span between the two images.

Phase change of moisture within porous cladding materials from a liquid to a solid occurs at temperatures slightly below freezing. Phase change from a solid to a liquid occurs when temperatures increase above freezing. In the phase change from a solid to a liquid, an endothermic reaction, melting ice within the wall is visible through reduced surface temperatures. Phase change from a liquid to a solid is an exothermic reaction and is visible through increased surface temperatures. These phenomenon occur independent of either positive or negative pressures. The accompanying thermal images in **Figures 22 to 23** illustrate the endothermic effects of melting ice within the building cladding.

The dark areas on the 4<sup>th</sup> floor masonry cladding illustrate the distinctive endothermic pattern generated by the phase change of melting ice within the masonry. It appears reasonably consistent during both the negative and positive inspections during the same evening. The cold areas above the window heads on the third and fourth floor windows are typical of air leakage into the building during negative building pressure conditions.

The moisture patterning in the wall due to accumulated moisture over the winter months appears warm around the floor slabs and is present during both the negative and positive pressure inspections. During the positive building inspection, these moisture patterns appear to be overpowered by the thermal patterns created by the air leakage through the walls from the building interior. Both images were taken during same evening, 4 hours between the two settings. Due to the lower exterior ambient temperatures, phase change phenomenon is not visible at low outside temperatures. Moisture accumulation is visible during both inspections, but more during positive building pressure inspections than slightly negative pressure inspections.

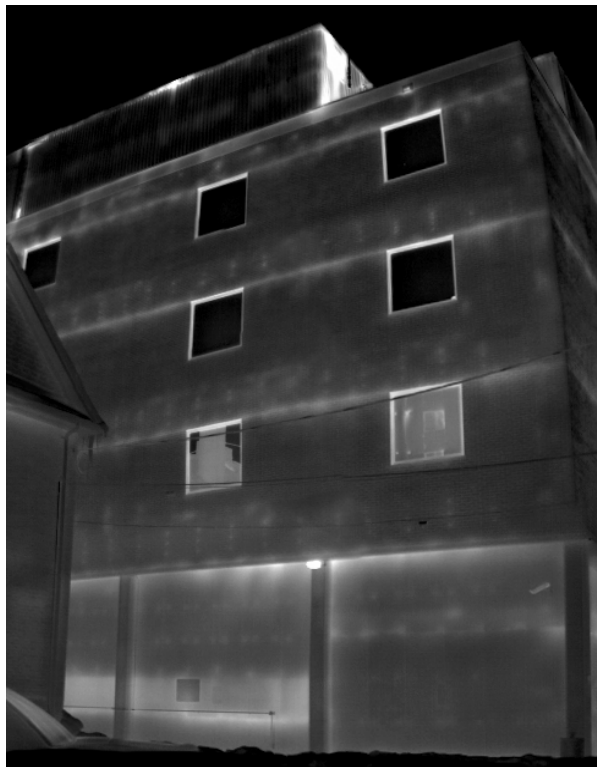
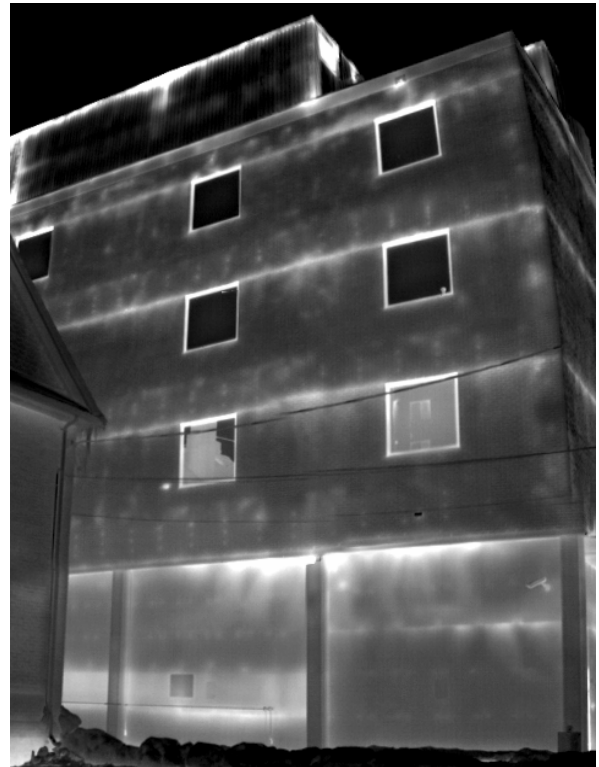
**Figure 24.** Negative Building Pressure (-8 Pa),  $T_o = -11^\circ\text{C}$  **Figure 25.** Positive Building Pressure (+25 Pa),  $T_o = -11^\circ\text{C}$
