Restoring Airtightness and Weather-Resistance to Window and Curtain Wall Systems

Test Report For

Connectivity Project - Glazing Restoration Testing

Kawneer AA900 and Trifab 450 Window Units Baseline Test Cant Bead Overlay Gasket

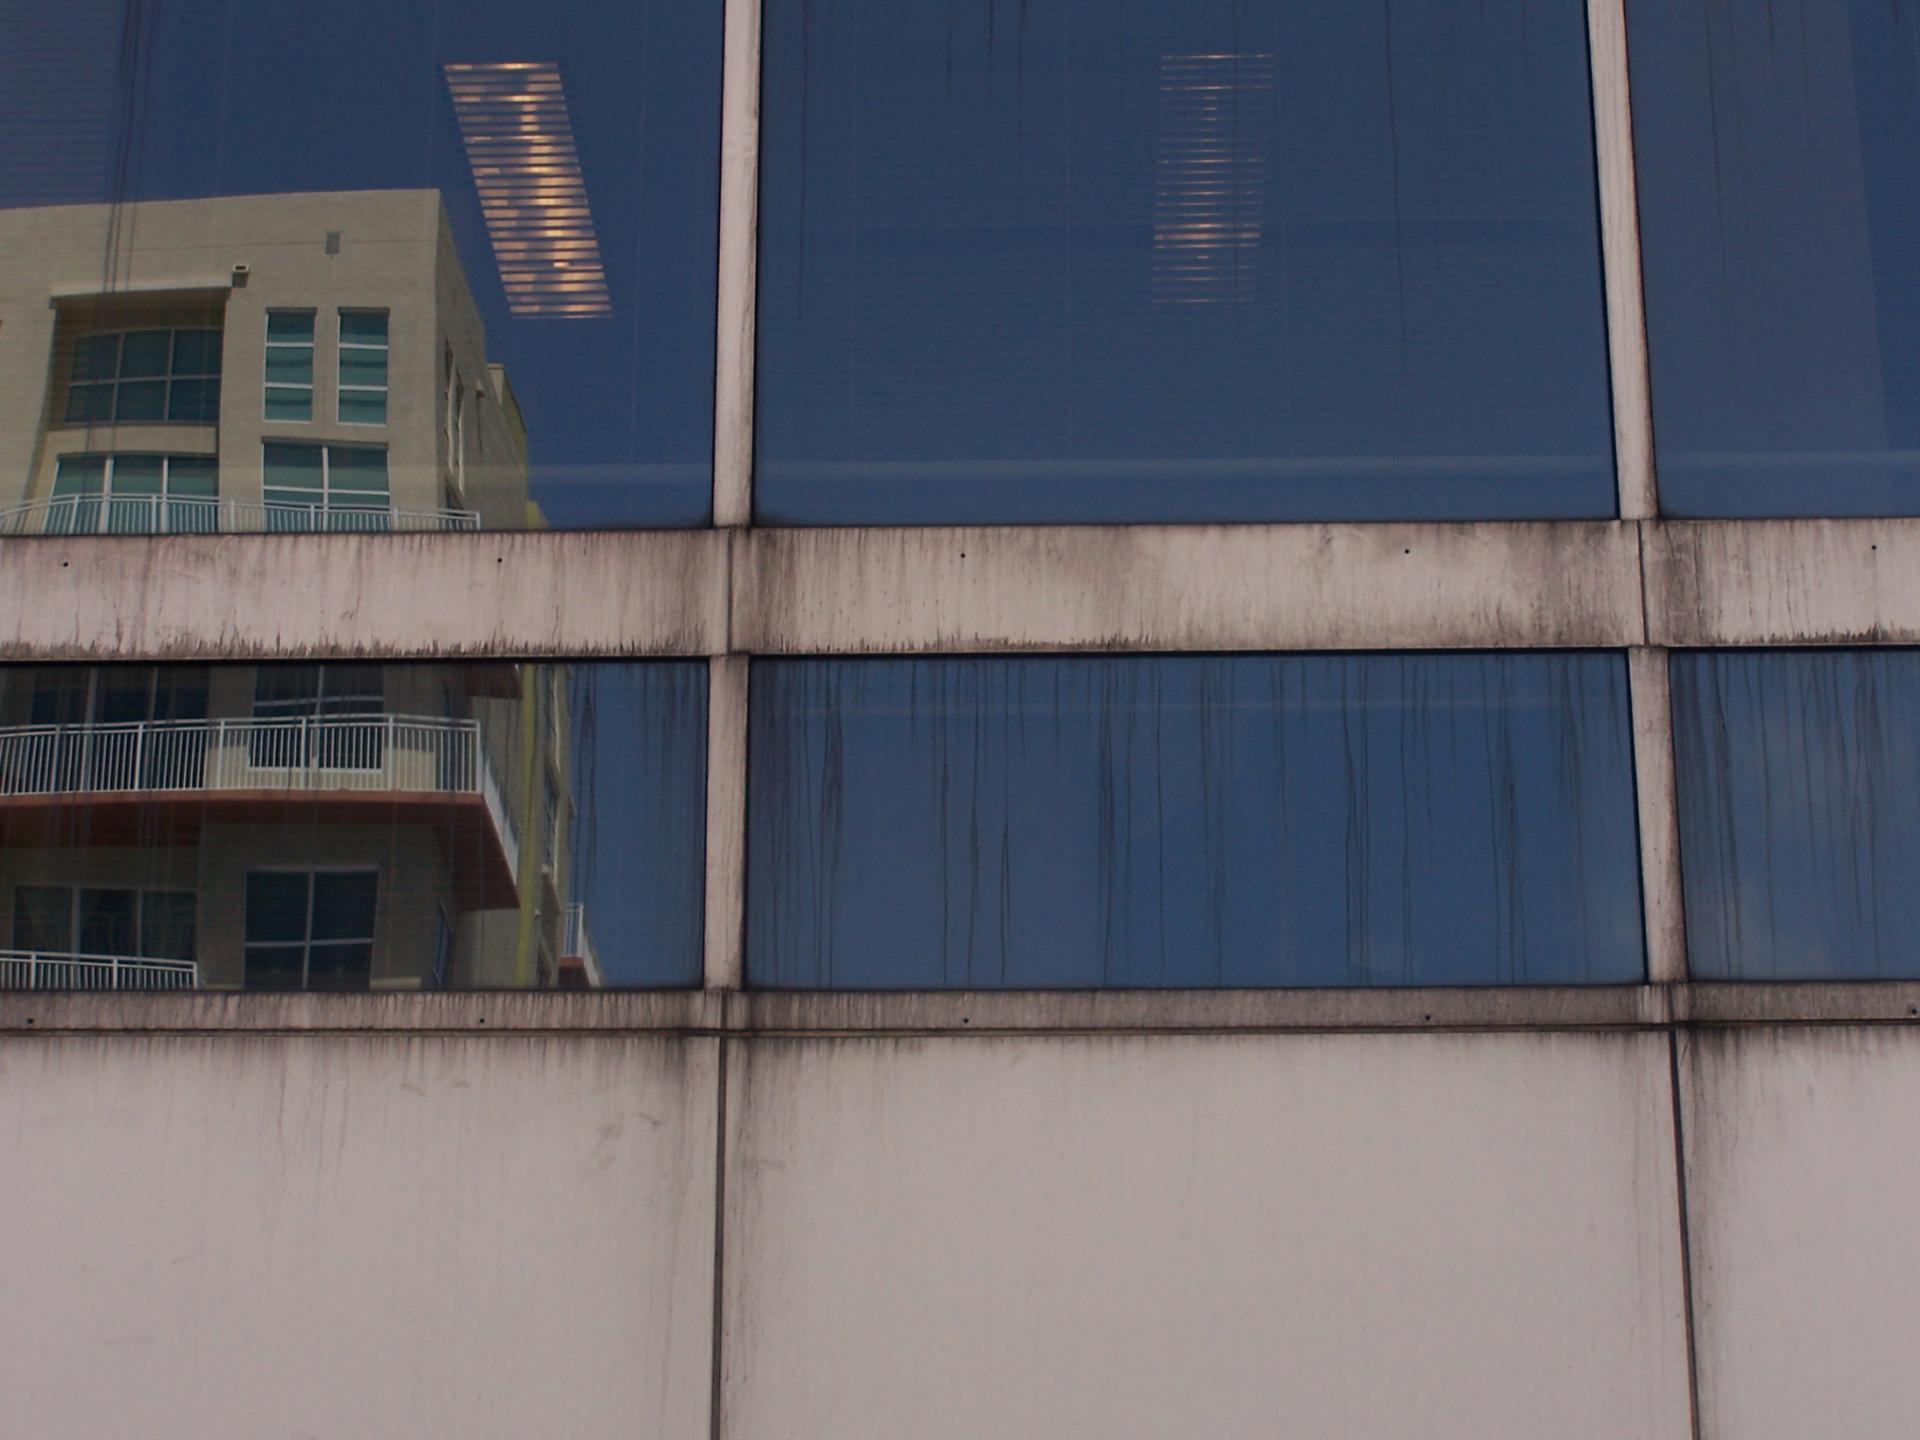
Not removing the gasket from the application may spread contaminates application the gasket to the glass and from the gasket to the glass and metal surfaces,

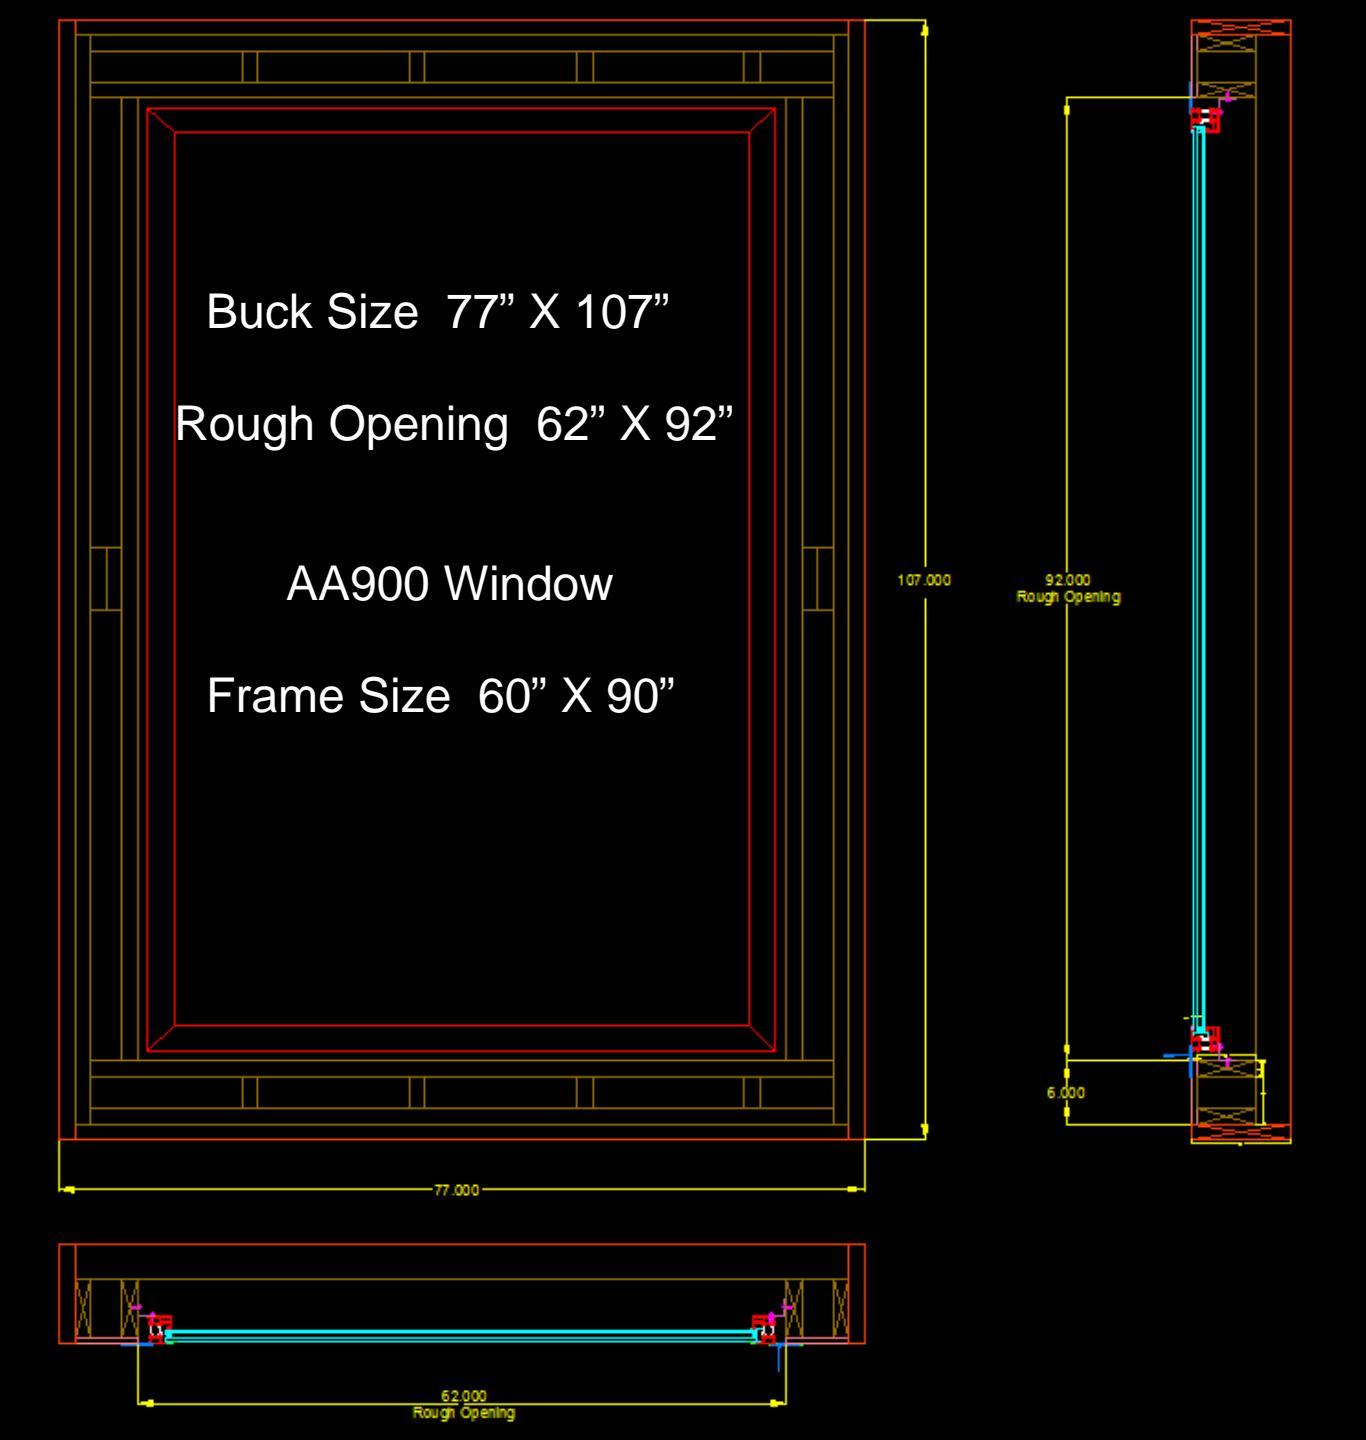
AA900 Window positioned on test wall for air and water testing

Cut sections of the exterior gasket to simulate leak points

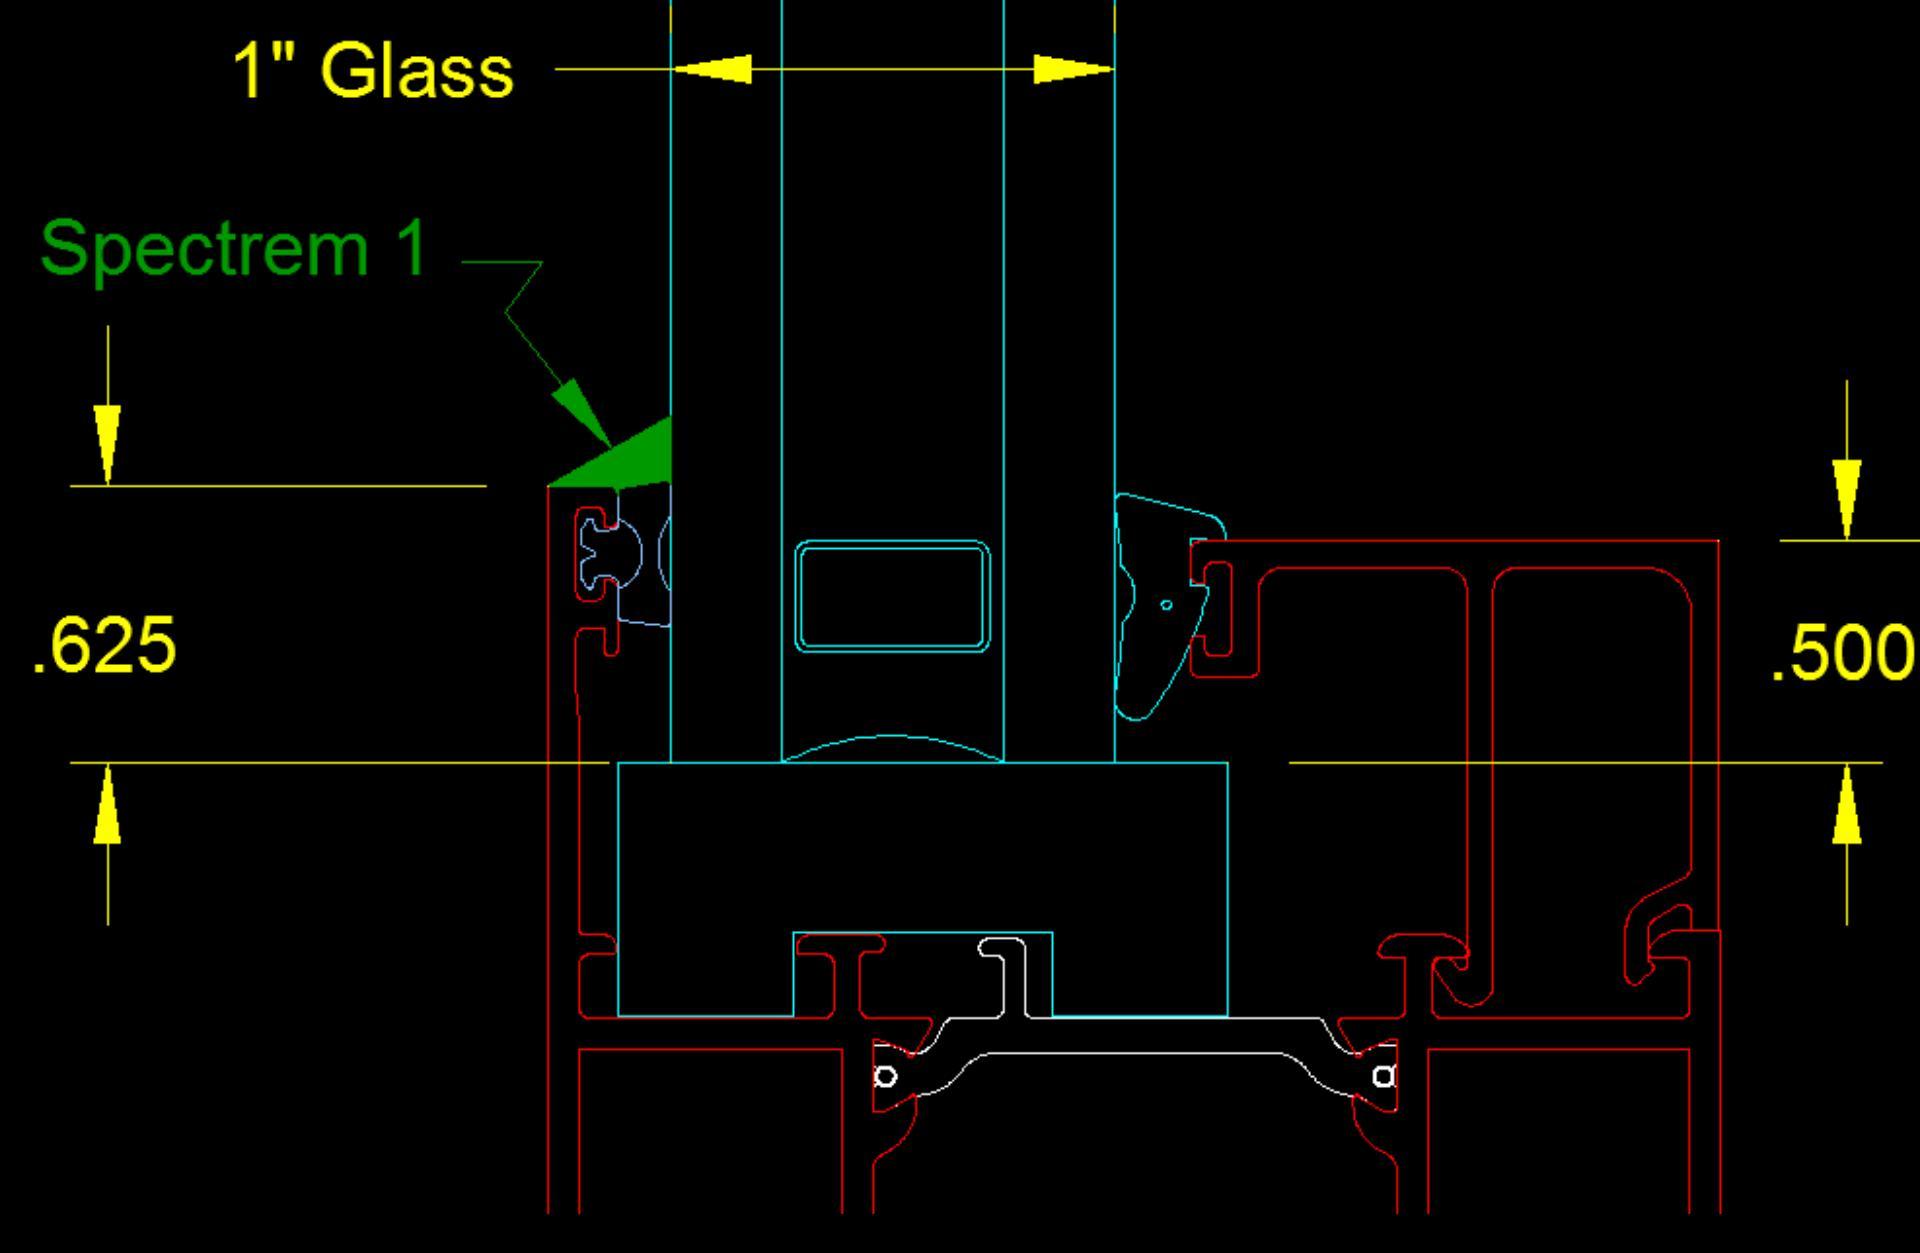
AA900 Window repair option with cap bead

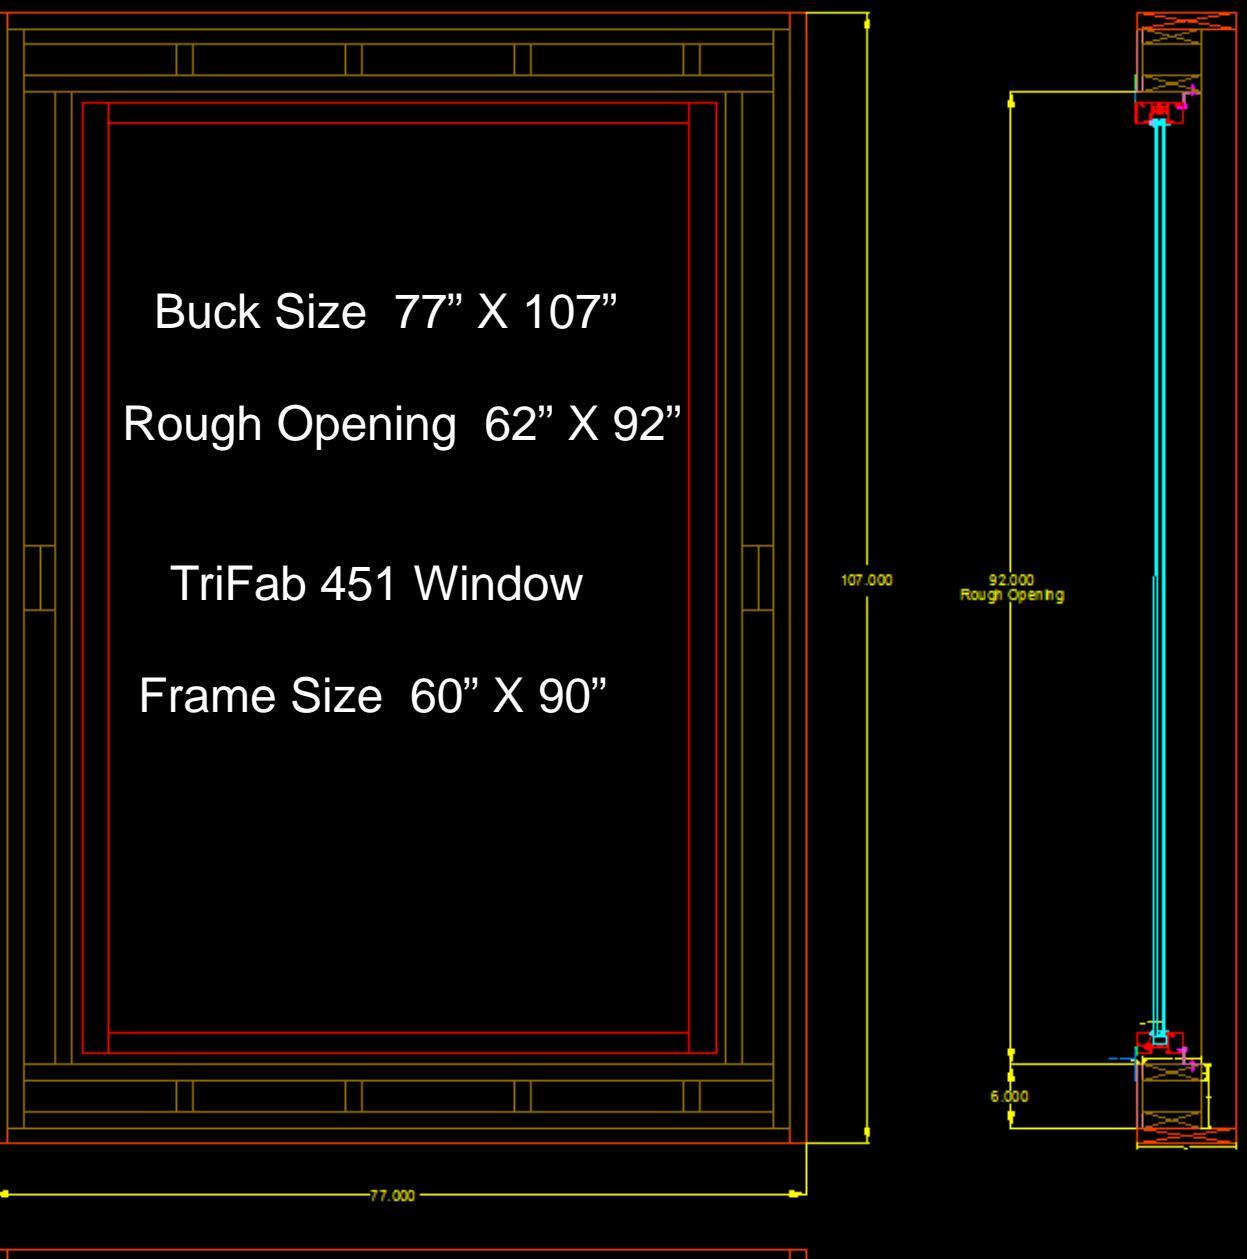
TriFab 451 Storefront System positioned on test wall for testing for air & water
