# Field Monitoring of Cold Climate Double Stud Walls with Cellulose and Low-Density Foam Insulation

Kohta Ueno<sup>1</sup>, Joseph W. Lstiburek, Ph.D., P.Eng.<sup>2</sup>

# ABSTRACT

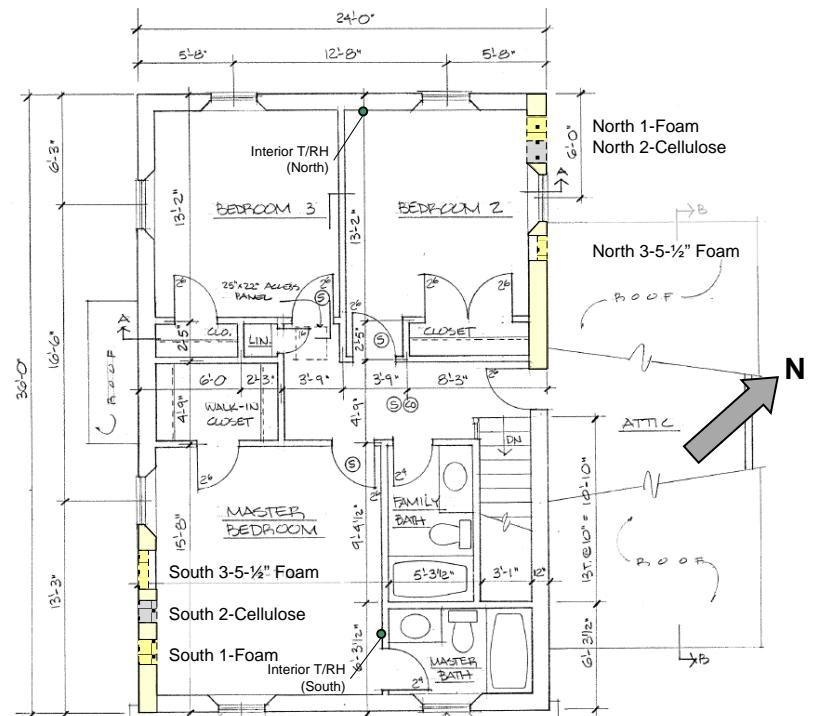
The test walls were installed in second-floor bedrooms (Figure 1). The test bays are indicated by the dotted patterns, and the guard areas (non-instrumented portions) are filled with full-thickness spray foam to maintain separation between adjacent bays.

Figure 1: Test walls shown on second floor plan, with guard bay insulation for separation

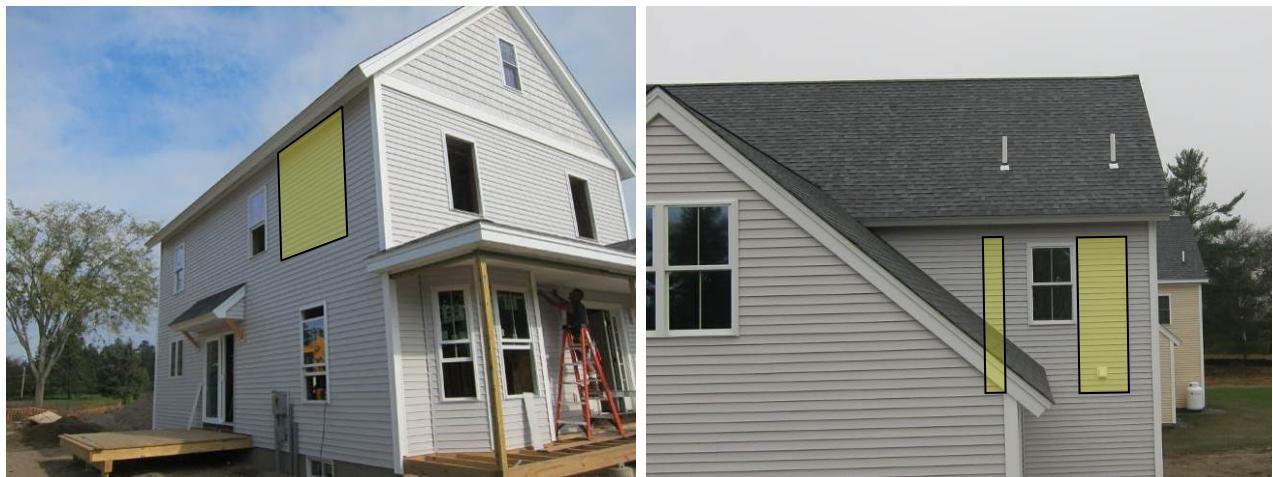
As shown in Figure 2 (right), the third bay ("control") on the north side is partially sheltered at the bottom by the sloping garage roof. No better location was available, due to the positioning of windows, bathrooms, and garage.

Figure 2: Test wall locations shown on exterior of house; south (L) and north (R) orientations

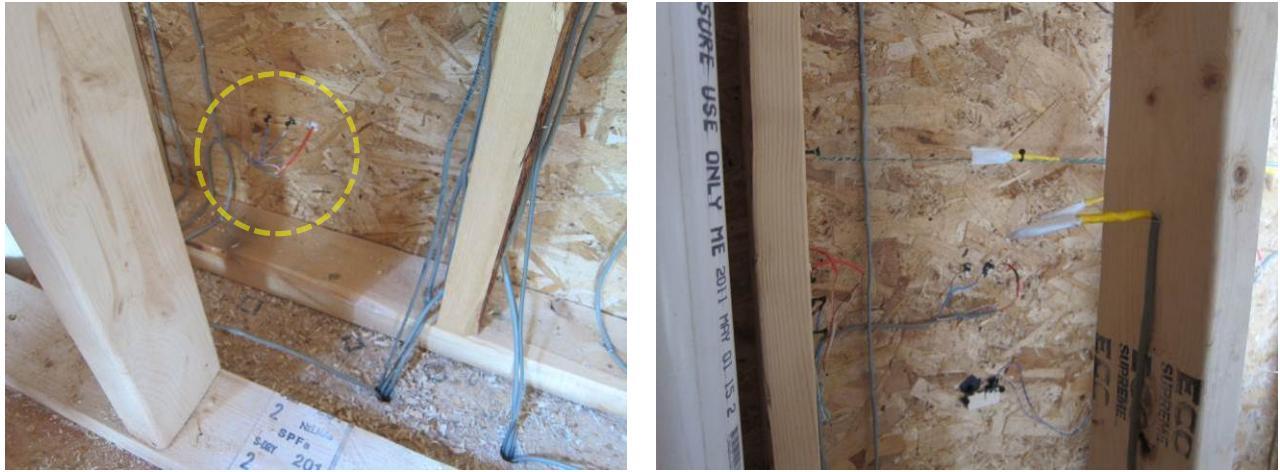
In Figure 3, the left-hand image shows a temperature and wood MC sensor installed at the exterior sheathing; the right-hand image shows typical conditions mid-height in the study bay, including temperature/RH (x3), sheathing MC, and stud MC. Another sensor was a wood-based relative humidity sensor (a.k.a. "wafer" sensor), installed at the inboard side of the sheathing, to measure conditions at the likely condensation plane. This sensor can differentiate between high relative humidity levels and condensation/liquid water conditions; it is described in more detail by Ueno and Straube (2008).

Figure 3: (L) Temperature and MC sensor at sheathing; (R) sensors at mid-height of stud bay

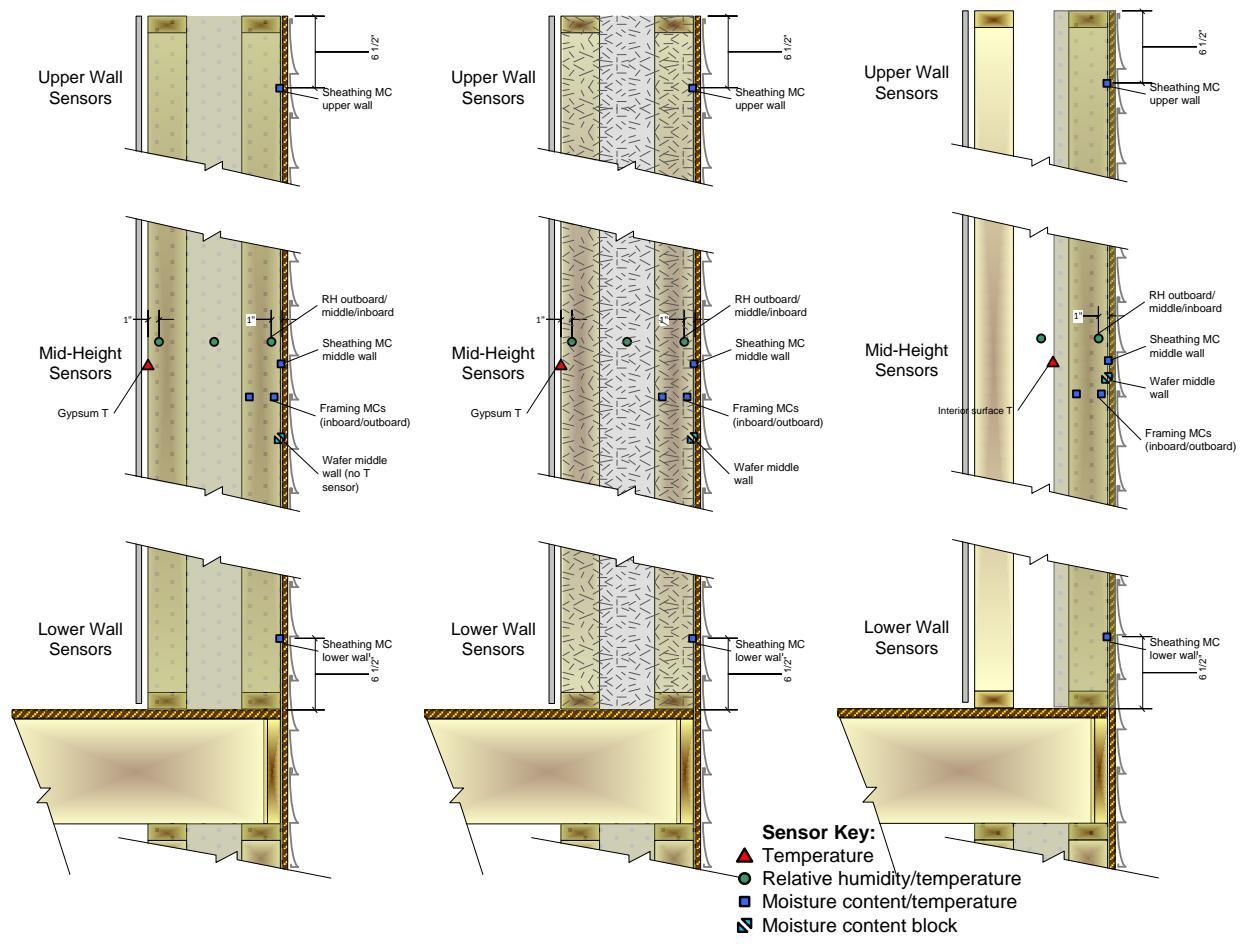
The instrumentation plan for this research is shown in Figure 4; sensor packages are further described in the bullets below.

Figure 4: (L) Instrumentation diagram for 12" ocSPF; (C) 12" cellulose; (R) 5-1/2" ocSPF

• Sheathing moisture content is a key indicator for long-term durability; therefore, three sheathing MC/temperature sensors were installed at each wall (upper/middle/lower).

- The outermost stud MC was monitored at inboard and outboard edges.
- Temperature and RH were monitored at three depths mid-height in the stud bay (outboard/middle/inboard), which allows measurement of temperature and humidity gradients.
- The "wafer" sensor was installed at the inboard surface of the exterior sheathing, to measure surface humidity conditions at the likely condensing plane.
- A temperature sensor was installed at the interface between the insulation and the interior gypsum board.

The sensor complement is identical in the two 12" thick insulation (spray foam and cellulose) wall test bays. At the "shorted" or "control" bay (N3/S3), the sensor count is reduced. There is a "dead" air space between the interior gypsum board and the interior face of the stud bay spray foam. This is not an ideal comparison, but was required to keep the interior gypsum board in plane at this occupied house. Temperature and RH conditions within the void space are being recorded directly, for comparison with interior conditions.

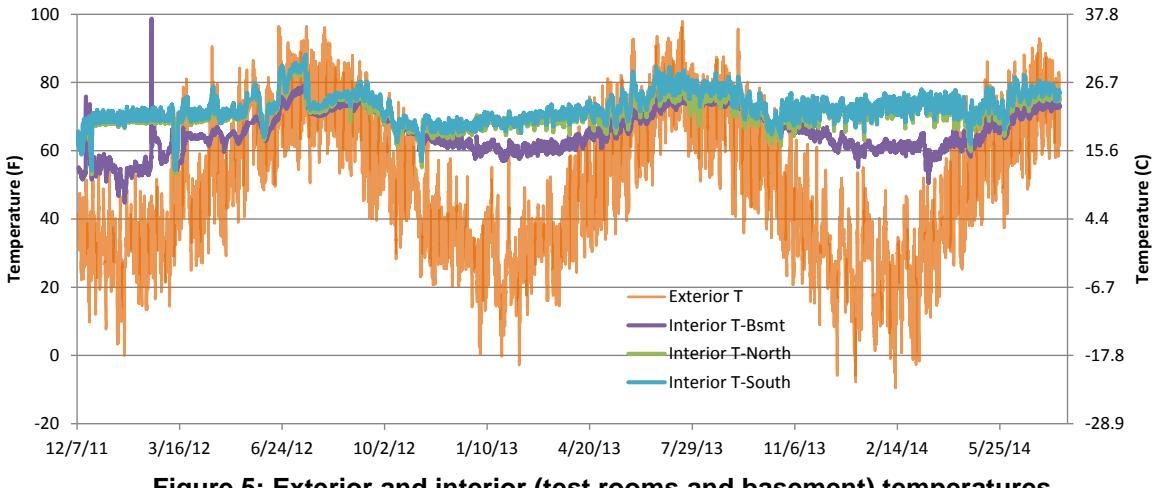
Roughly 32 months of data were collected and analyzed (December 2011 through July 2014), which covered roughly three winters (one partial). Interior and exterior temperatures are shown in Figure 5. Winter 2011–2012 was exceptionally mild (5220 HDD Base 65°F/2900 HDD Base 18°C versus 6220/3445 HDD climate normal); winter 2012-2013 was closer to normal (6050/3360 HDD), and winter 2013-2014 was very cold (6730/3740 HDD). Interior winter temperatures held steady in both north and south bedrooms in the 65°-72°F (18-22°C) range, except for a period in March 2012 when the heating system was inadvertently turned off.

Figure 5: Exterior and interior (test rooms and basement) temperatures

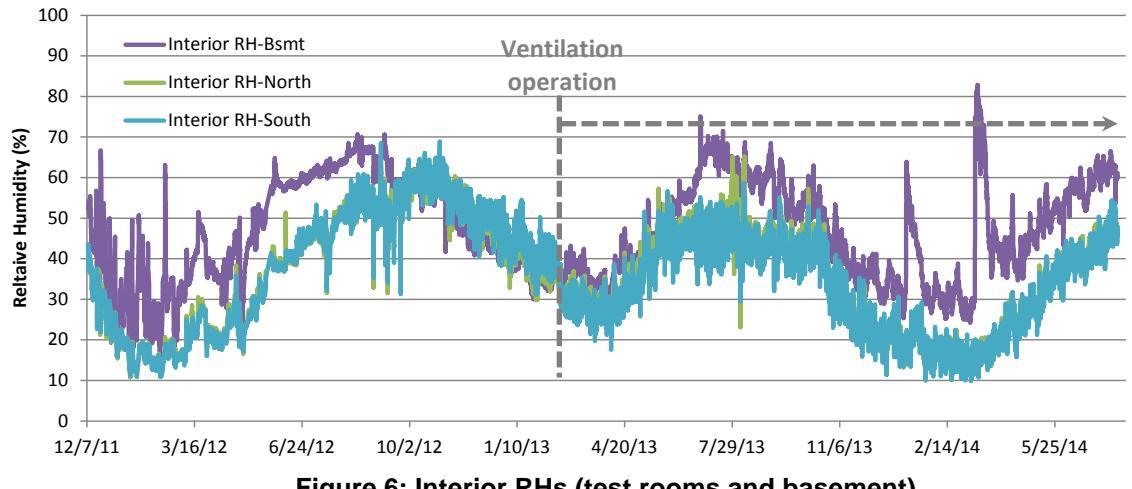
Interior RH conditions are shown in Figure 6; in the first winter, interior RH levels fell to the 10%–20% range for much of the first winter, which are exceptionally dry conditions. There was no occupancy through the winter, and therefore no interior moisture generation (occupants, showering, cooking), explaining the low RH levels. However, drying of construction moisture was occurring during the winter. Basement RH levels were higher, as would be expected due to lower temperatures. In the second winter, the house was occupied by a family of four, and the ventilation system was not operated consistently; in addition, the house is very airtight (1.1 air change per hour at 50 Pascals/ACH50). This resulted in high wintertime humidity levels of 40-50% for most of the early winter. The ventilation system was put in operation in late winter (mid-February 2013), resulting in lower interior RHs (20-35%). The third winter had interior RHs in the 10-30% range; the spikes in basement RH levels were due to basement flooding issues.

Figure 6: Interior RHs (test rooms and basement)

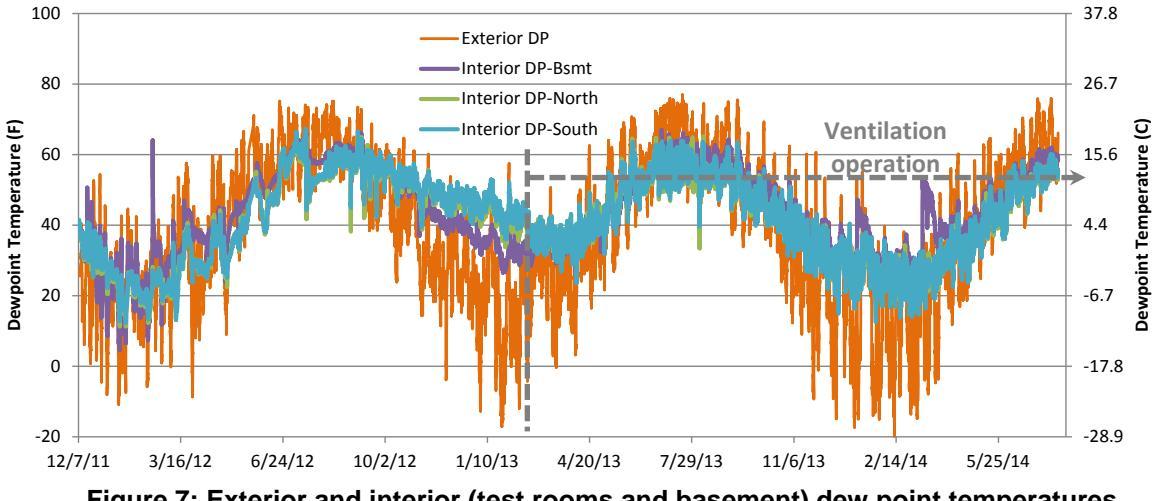
Interior temperature and RH conditions were used to generate dew point temperatures (absolute air moisture content), which were plotted with outdoor dew points (Figure 7). Interior moisture conditions essentially tracks outdoor conditions in the first winter, as would be expected without interior moisture generation. But in the second winter, interior dewpoints were higher in early winter (40-50°F/4-10°C), with drier conditions after ventilation (30-40°F/-1-10°C). The third winter had dew points between these extremes.

Figure 7: Exterior and interior (test rooms and basement) dew point temperatures

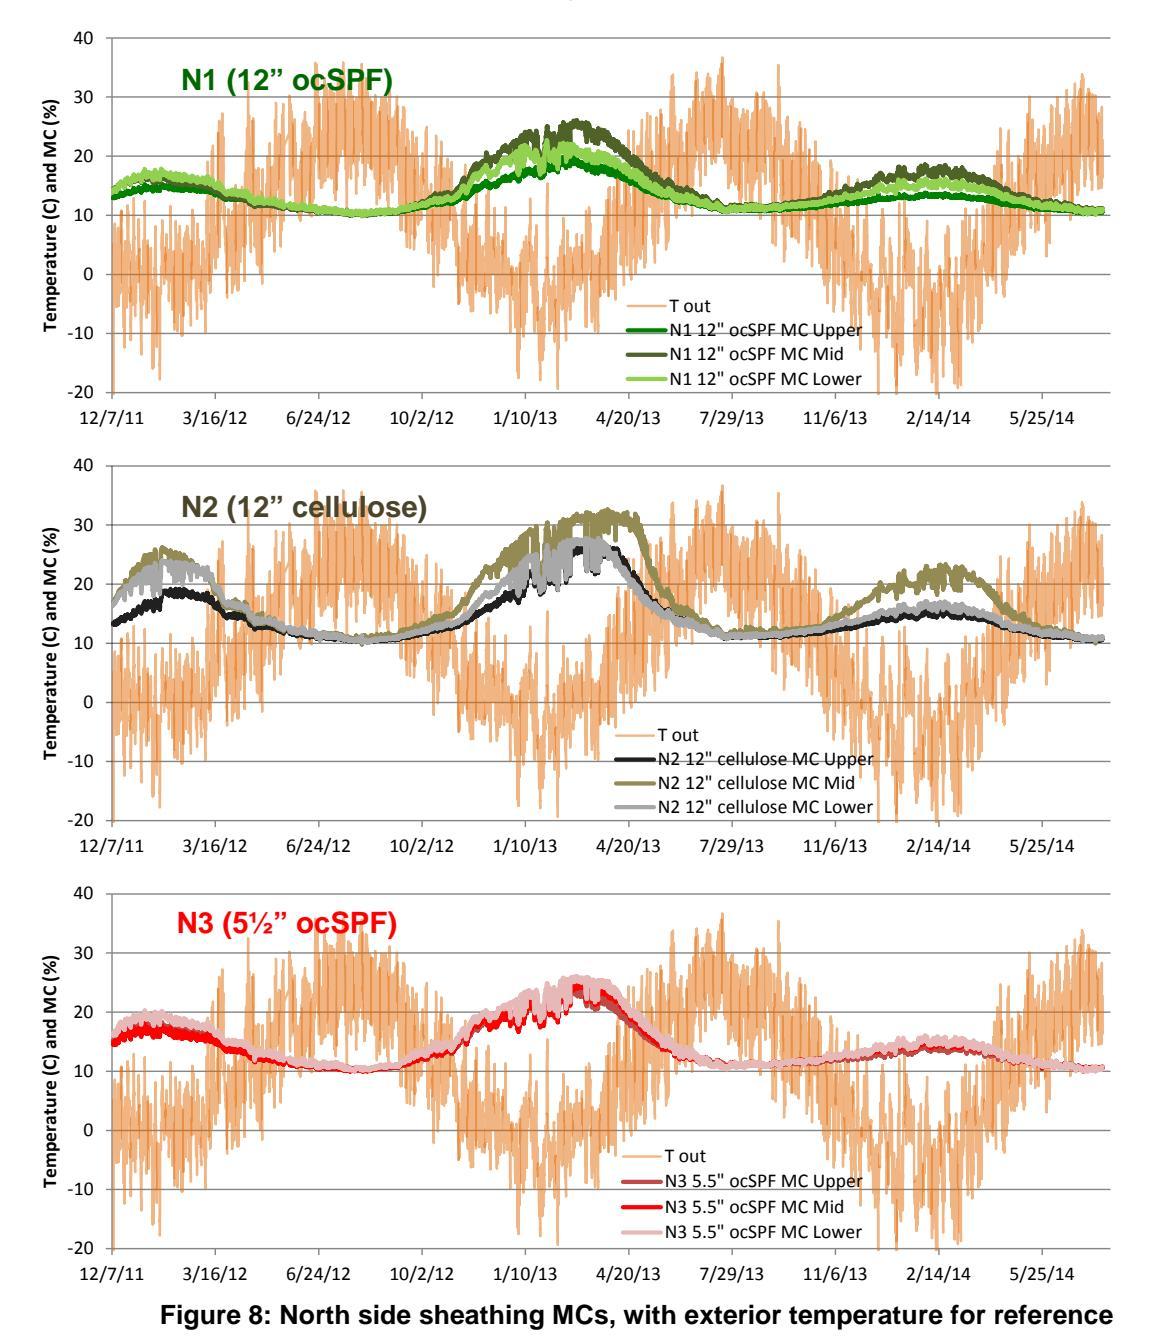
Sheathing MCs for the north-facing walls are shown in Figure 8; they show the expected seasonal rise and fall, with peak MCs in wintertime. However, the different boundary conditions in the three winters resulted in different responses from the walls.

In the first winter, the north 12" ocSPF wall (N1) showed a peak wintertime sheathing MC near 12%–15%; the 5- $\frac{12}{2}$ " ocSPF wall (N3) was similar to N1, but with slightly higher peak MCs (15%–20%). However, the 12" cellulose wall (N2) showed considerably higher MCs, in the 20%–28% range. The first winter had low interior RH levels. In the following summer, MCs fell to the safe range (10-12% MC).

However, the second winter, with interior RH levels in the 40-50% range, resulted in much higher sheathing MCs. The north 12" ocSPF wall (N1) showed a peak wintertime sheathing MC near 20%–26%; the 5-½" ocSPF wall (N3) had similar behavior to N1 (24%–26% peaks). The 12" cellulose wall (N2) showed very high MCs, in the 25%–33% range. Again, in the following summer, MCs fell to the safe range (10-12% MC).

In the third winter (moderate interior RH, cold outdoor conditions), behavior was similar to the first winter. The north 12" ocSPF wall (N1) showed a peak wintertime sheathing MC near 15%–18%; the 5-½" ocSPF wall (N3) was slightly drier than N1, with peak MCs of 15%–16%. Again, the 12" cellulose wall (N2) had higher MCs, in the 15%–23% range, but much drier than the second winter. Also, all walls dried to safe levels in the summer.

The MC anomalies seen in the second winter at high MC levels (sudden jumps in MC) coincide with freezing temperatures; it is likely that freezing of bound water in the sheathing results in different electrical resistance response, and thus measured MC. The MC trends during non-freezing condition are likely more representative of actual conditions.

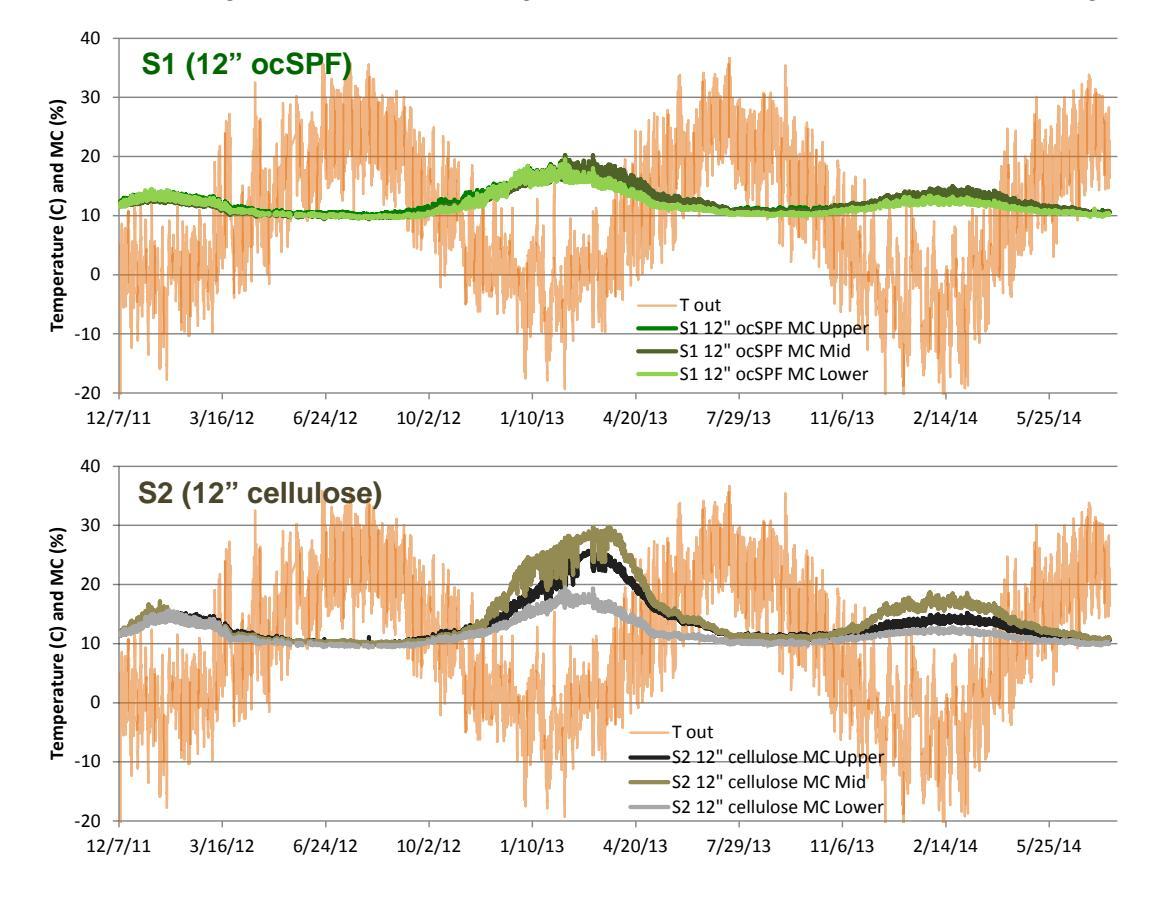
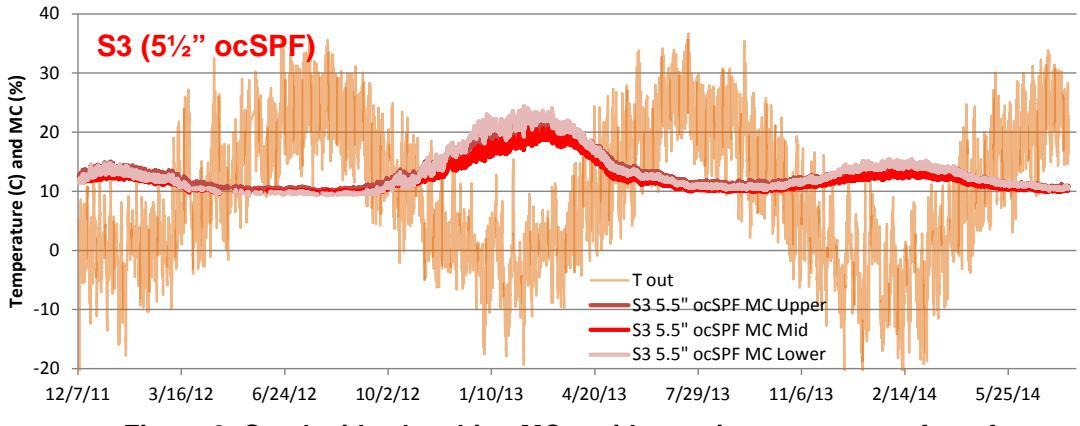
Figure 9: South side sheathing MCs, with exterior temperature for reference

The south walls have a similar pattern to the north walls; the 12" cellulose wall (S2) has higher wintertime peak MCs than the ocSPF walls. In the second winter, the cellulose MCs rise to the 17-30% range: this is much higher than the ocSPF walls. All walls dry to the 8% range in the summer; the intermittent data seen during summertime indicate periods drier than the measurement range of the data logger (wood electrical resistance is too high for measurement).

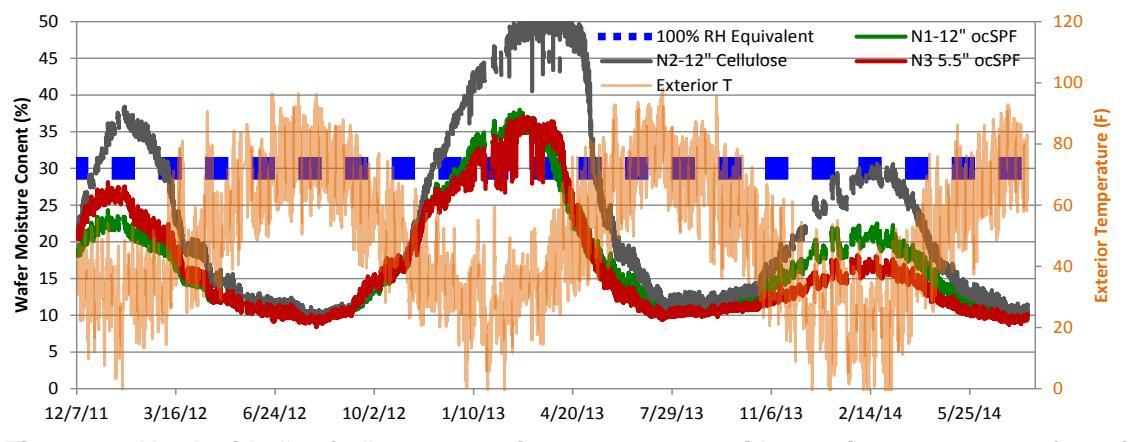
Other sensors were examined to confirm the sheathing MC behavior. The "wafer" sensor results for the three north-facing walls are plotted in Figure 10, which reflect conditions at the exterior sheathing-to-insulation interface.

Figure 10: North side "wafer" sensor moisture contents, with exterior temperature for reference

The response of these wood-based sensors should be understood when interpreting these results. Based on previous work (Ueno and Straube 2008), the "wafer" sensors come to equilibrium with 100% RH conditions (closed box containing water) at 28%–30% MC (blue line). However, immersing the sensors in liquid water increases their MC to the 40%–45% range.

The "wafer" response is consistent with the sheathing MC measurements. In the first winter, 12" of open cell foam remains the driest through the winter, followed by 5-½" of open cell foam. The cellulose wall shows much higher wintertime peak moisture levels, consistent with condensation occurring at the sheathing. In contrast, the open foam walls remain below the 100% RH level. During the following summer, all "wafer" sensors dry to the 9%–12% moisture content range. In the second winter, all "wafer" sensors show MC peaks well into the condensation range, with significant condensation at the 12" cellulose wall. Again, the wafer dries in the following

summer. In the third winter, similar patterns to the first winter are seen, except that 12" of open cell foam (N1) and 5-1/2" of open cell foam (N3) change order (although both are well below 100% RH). The wafer MC measurements had anomalies during freezing conditions; these anomalies are removed in the Figure 10 and Figure 11, for legibility.

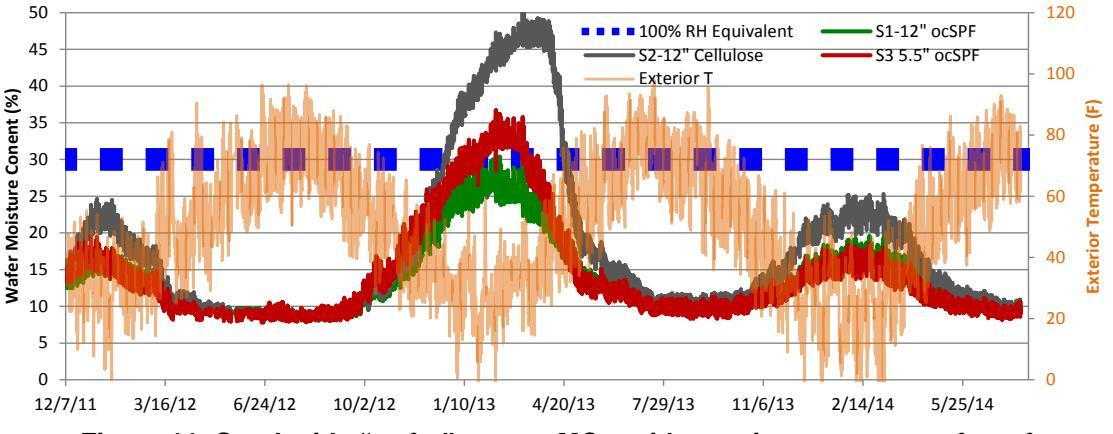
The south-facing wall "wafer" results are shown in Figure 11; again, patterns are analogous to the previous sheathing MC measurements. The cellulose wall shows the highest moisture levels, but drier than the north walls. In the second winter, significant condensation is indicated in the cellulose wall; again in the following summer, the wafers return to the dry range. In the third winter, all measurements are below 100% RH-equivalent.

Figure 11: South side "wafer" sensor MCs, with exterior temperature for reference

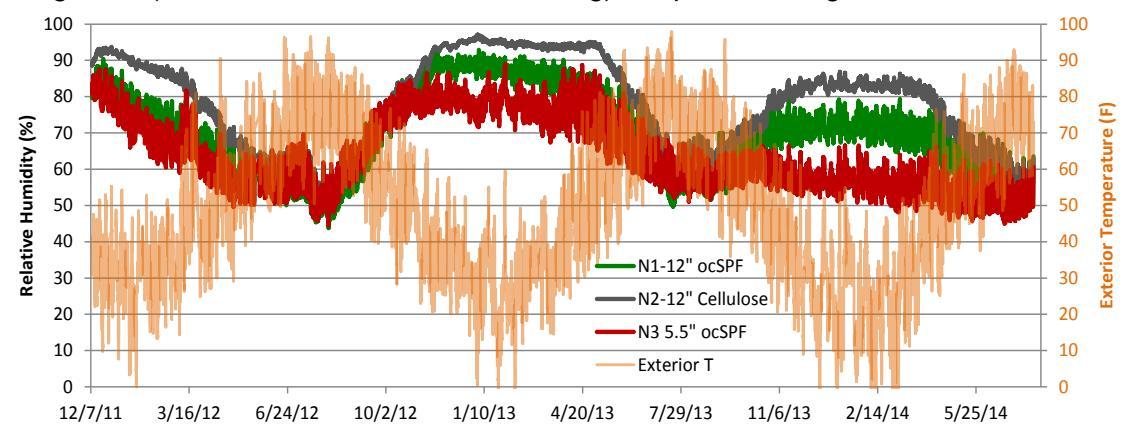
The RH measurements further corroborate the previous results; measurements for the northfacing walls (outboard side, 1" off the sheathing) are plotted in Figure 12.

The temperatures (at the RH sensors) follow the expected wintertime pattern: N1 and N2 (12" insulation) are close to identical (tracking outdoor conditions), and N3 (5-½" ocSPF) is slightly warmer (due to reduced insulation inboard of the sensor). This results in lower RHs in N3. In the first the summer, all RH sensors at the sheathing fall to the 50%–65% range, as the temperature gradient and moisture drive are inward, away from the sheathing. In the second winter, the RHs have the same relationship, but the elevated RHs occur over an extended time period through the winter. The RH results are consistent with previous measurements: the cellulose wall has higher humidity levels at the sheathing than the ocSPF foam walls.

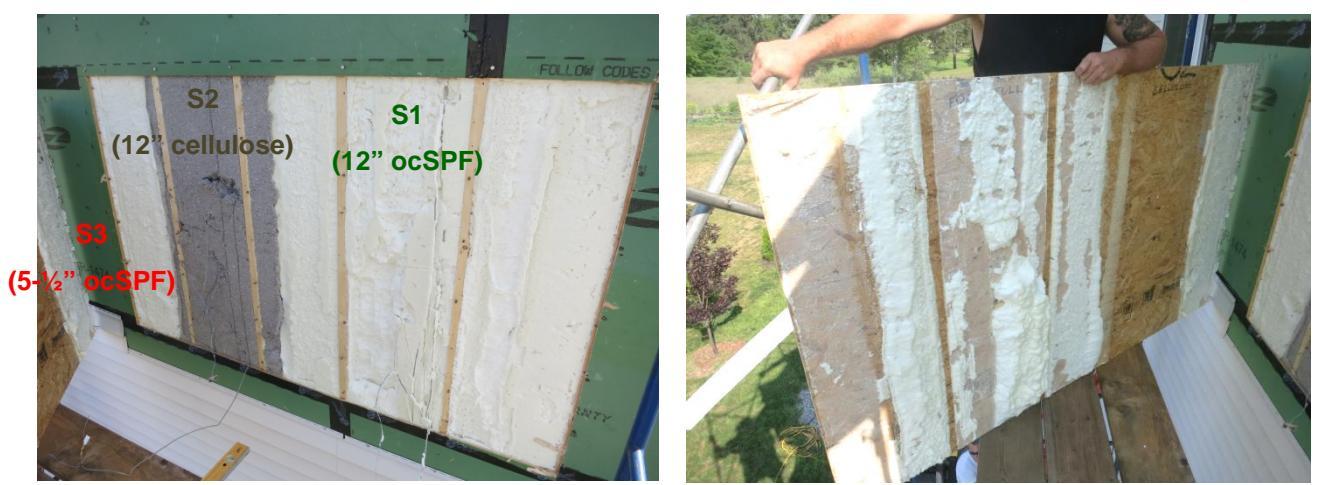
At the conclusion of this monitoring experiment, the test walls were temporarily disassembled to examine conditions, relating the monitored data to actual damage and conditions. The south-facing walls are shown in Figure 13.

Figure 13: South-facing test walls (L) test bays and insulation; (R) wall sheathing conditions

The sheathing was removed on north and south orientations; disassembly pulled "divots" of adhered ocSPF out of the stud bay insulation. The sheathing condition was surprisingly good on both orientations, considering that all measurements indicated liquid water condensation for extended portions of the winter, especially in the cellulose wall. There was no visible mold growth, staining, water rundown evidence, or delamination at the sheathing or the framing. Minor evidence of damage included slight grain raise at the cellulose wall (compared to the ocSPF walls), and minor rusting of nails and staples. The dense-pack cellulose all remained in place during the disassembly; no evidence of settling was seen at the opening. All materials were dry to the touch. The moisture content "wafers" at the insulation-sheathing interface had slight discoloration consistent with wetting, but no visible signs of mold growth.
